ANNUAL ENVIRONMENTAL MANAGEMENT REPORT - 2017

DRAYTON MINE

Name of Operation:	Drayton Mine
Name of Operator:	MALABAR COAL (DRAYTON MANAGEMENT) PTY LTD
Development Consent/Project Approval	PA 06_0202 (as modified) and DA 106-04-00
Names of holder of Development Consent / Project Approval	MALABAR COAL (DRAYTON MANAGEMENT) PTY LTD
Titles / Mining Leases:	CL229, CL395, ML1531, A173
Names of holder of Titles / Mining Leases:	MALABAR COAL (DRAYTON MANAGEMENT) PTY LTD
Water License:	Various (see Appendix A)
Names of holder of Water License:	MALABAR COAL (DRAYTON MANAGEMENT) PTY LTD
MOP Commencement Date:	1 st JULY 2015
MOP Completion Date:	30 th JUNE 2020
AEMR Commencement Date:	1 st JANUARY 2017
AEMR Completion Date:	31 st DECEMBER 2017

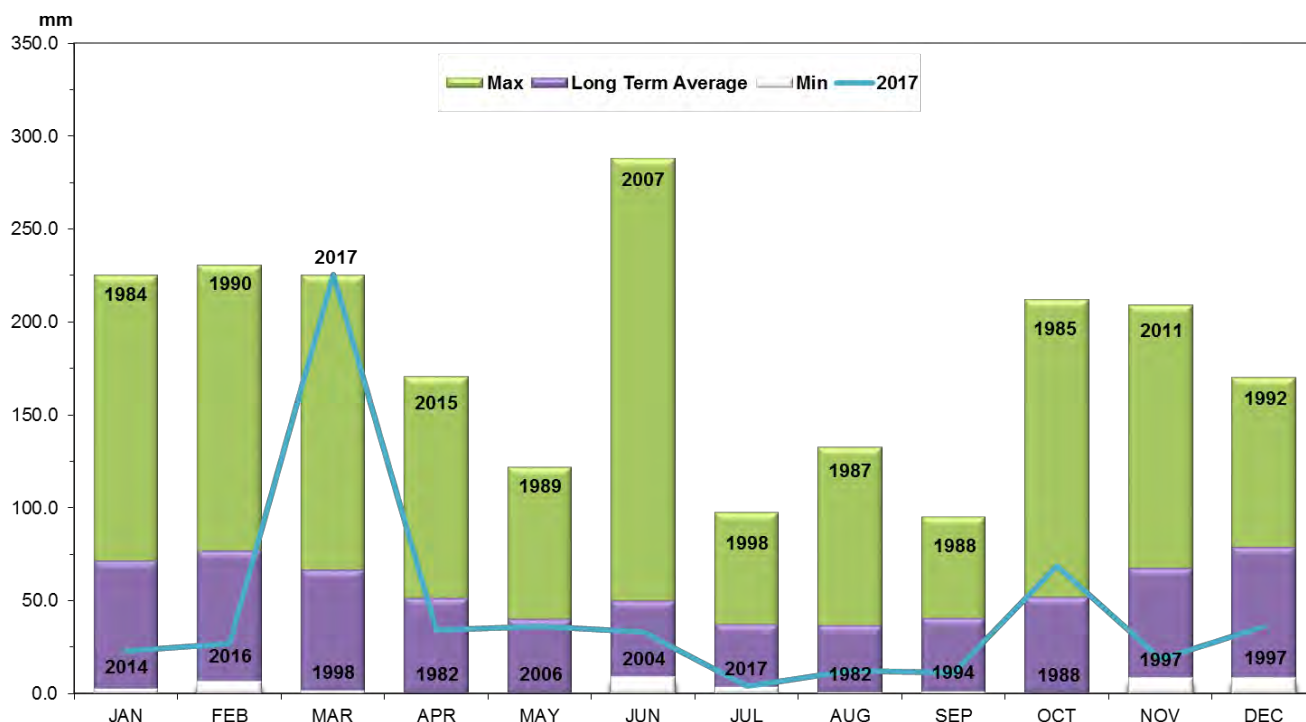
Figure D: Rainfall history 1981 to 2017

Rainfall Pattern and History (1981 - 2017)

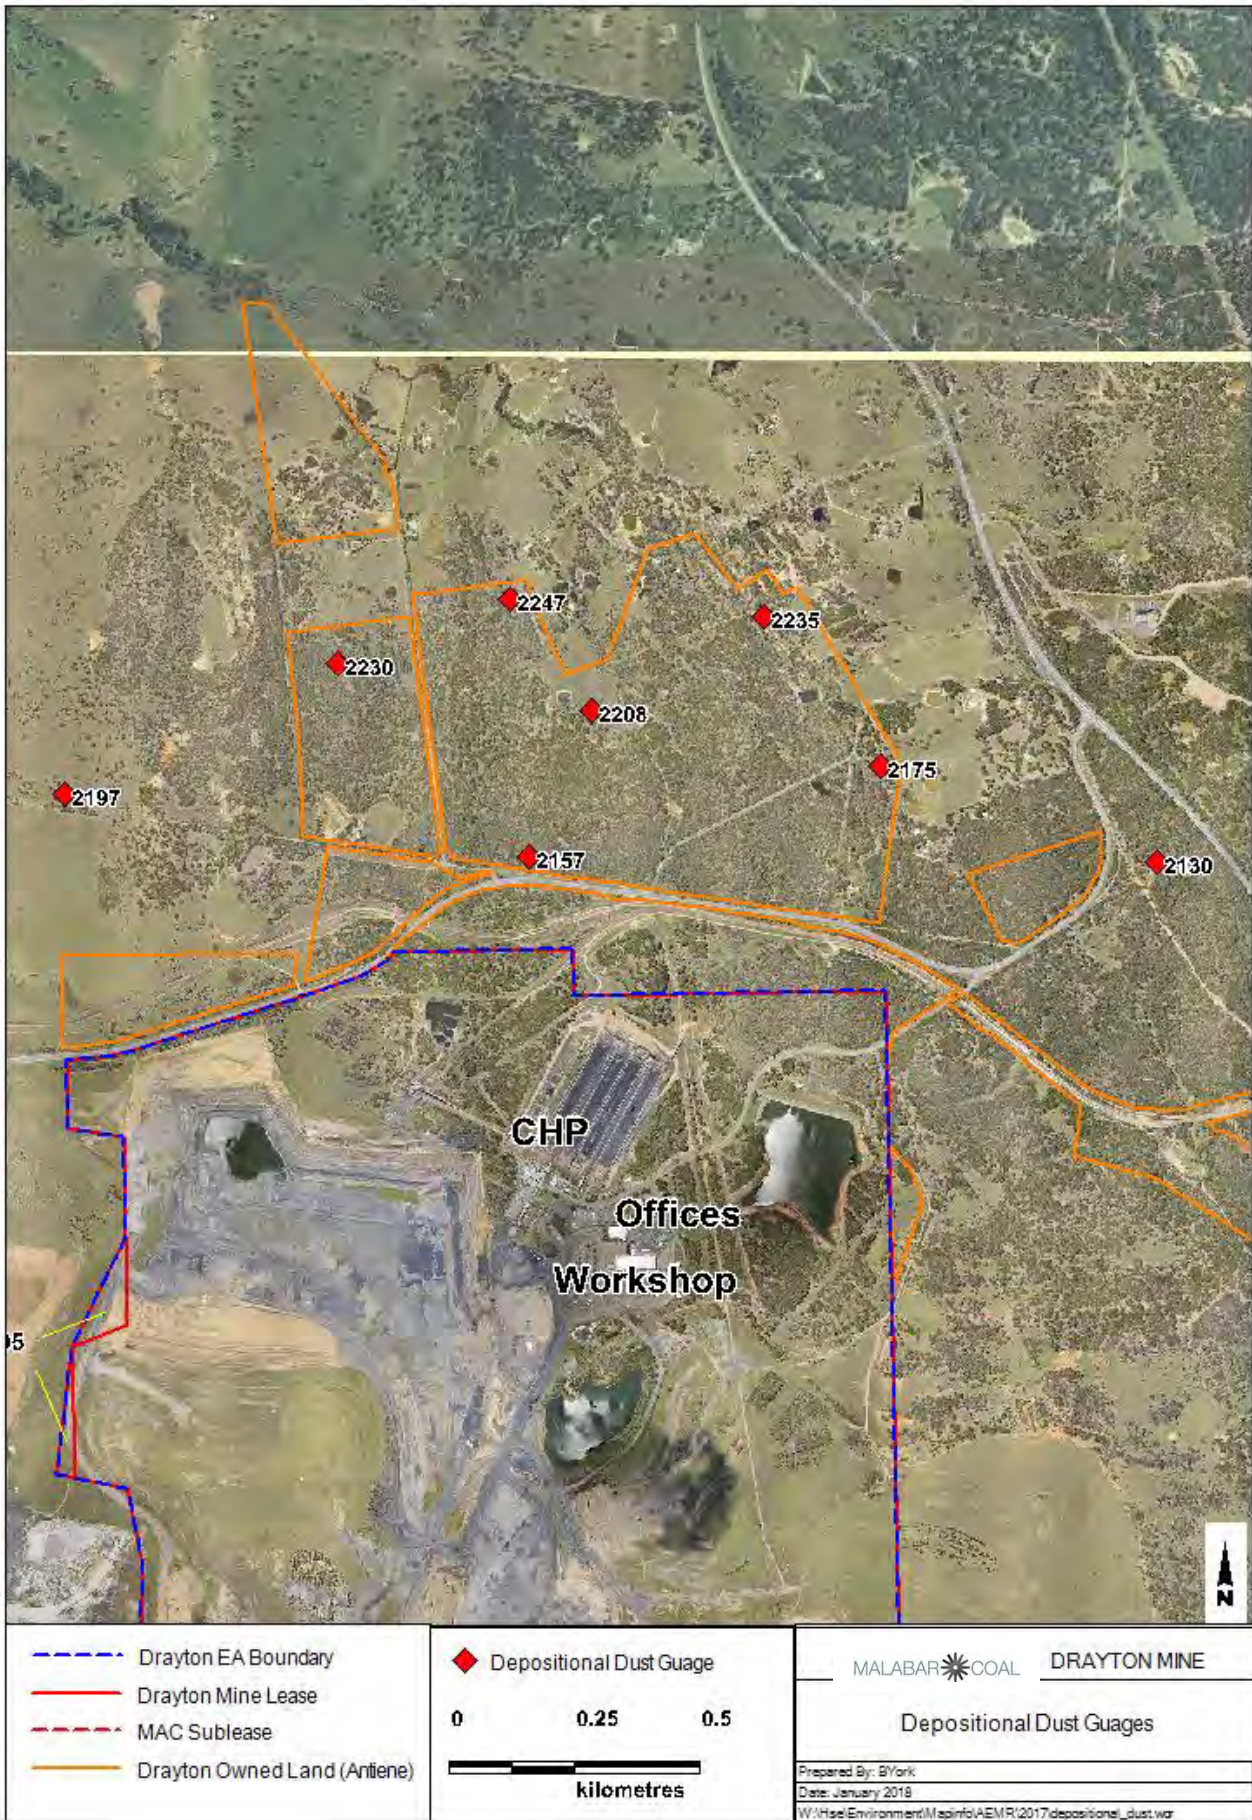
Figure E: Depositional Dust Monitoring Sites

Dust depositional gauges have been in operation for the life of the mine. The eight depositional gauges used for compliance are situated to the north of the lease boundary, and in the vicinity of the residential areas around the mine (see **Figure E**).

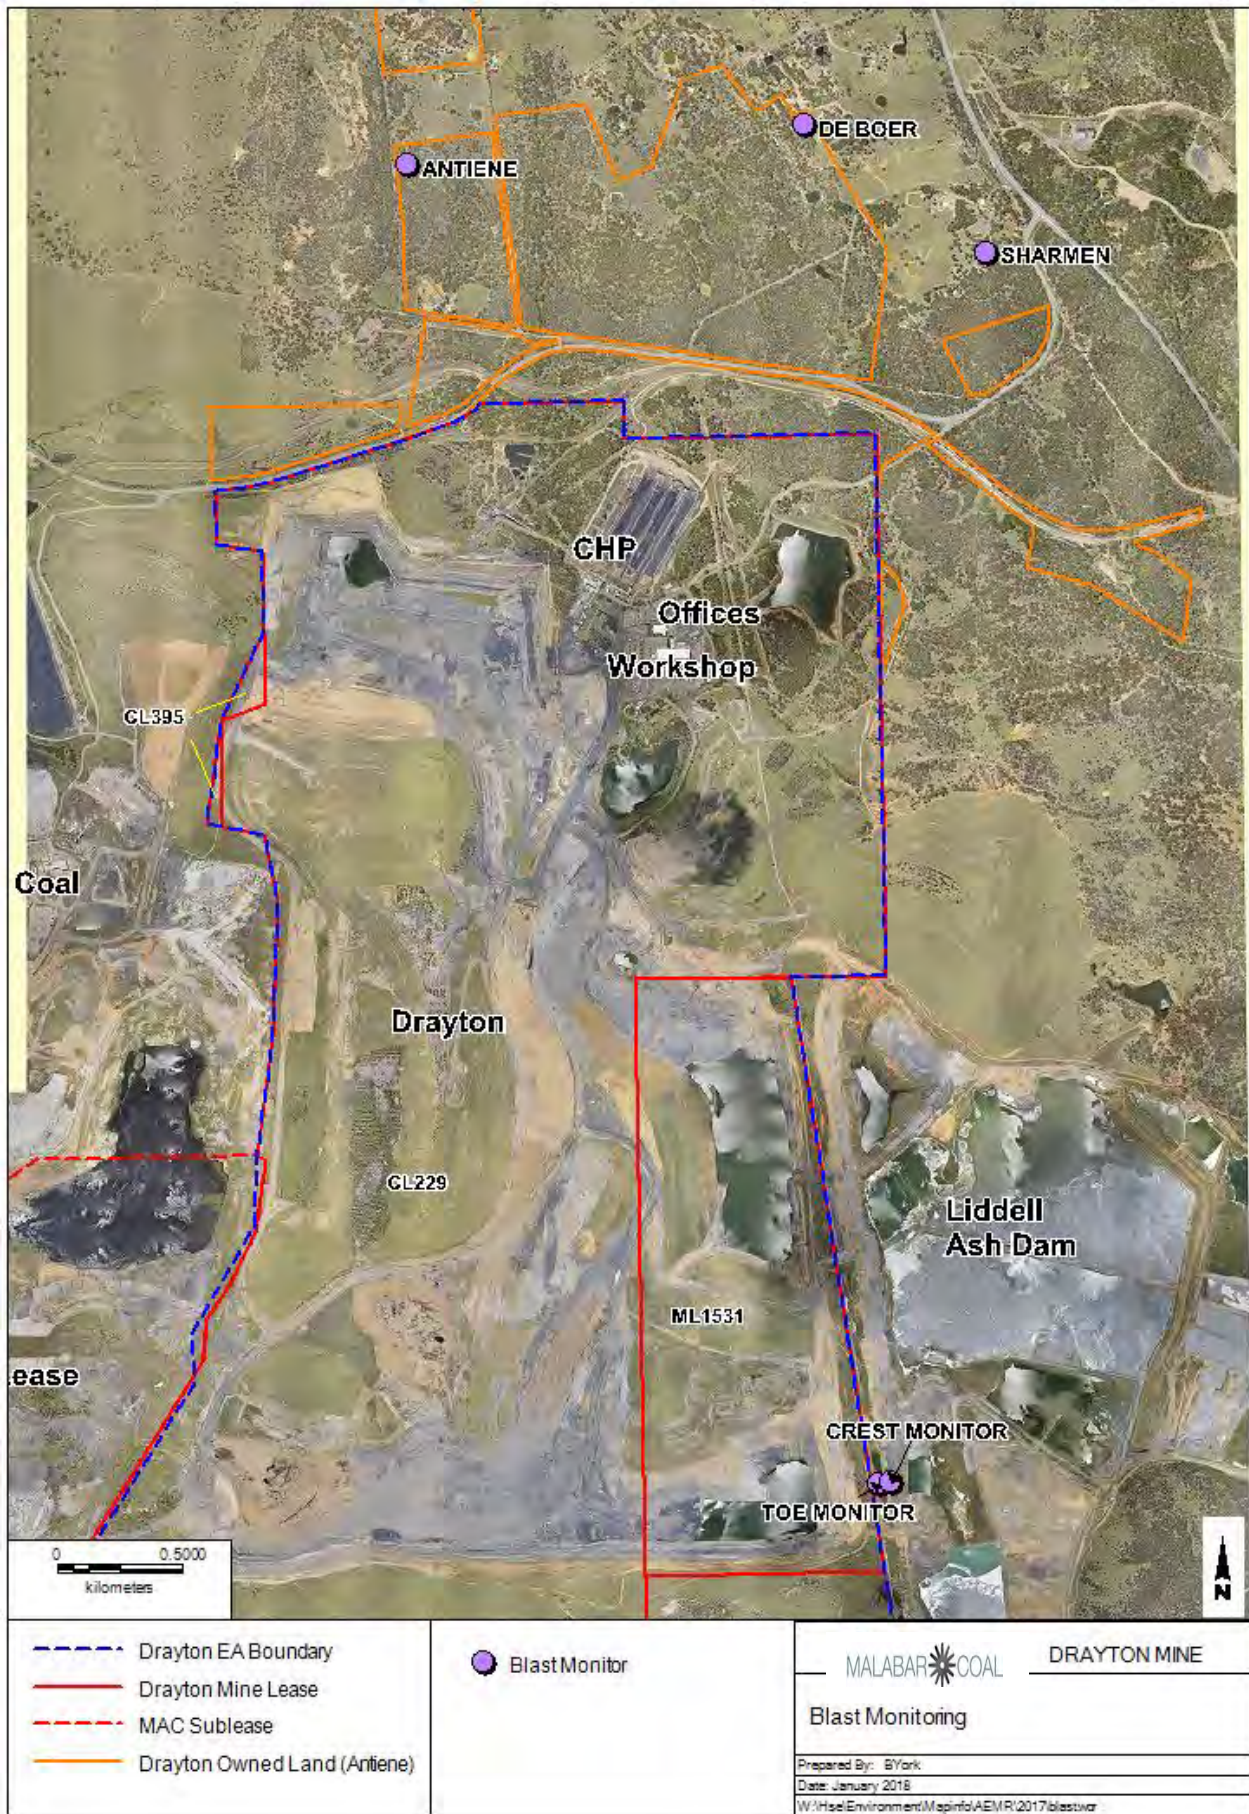
Figure K: Blast Monitoring Sites

Drayton used an internet based blast monitoring system which gives access to immediate blasting information for all blasts. The blast monitoring units also allow additional monitoring to be undertaken in specific locations as required. The units operate between approved blasting hours and automatically trigger once a vibration or overpressure event is recorded. There are three community based blast monitors at locations in the Antiene area and two monitors at the Ash Dam, one on the toe, and one on the crest of the wall. The locations of the five blast monitoring units are shown in **Figure K**.

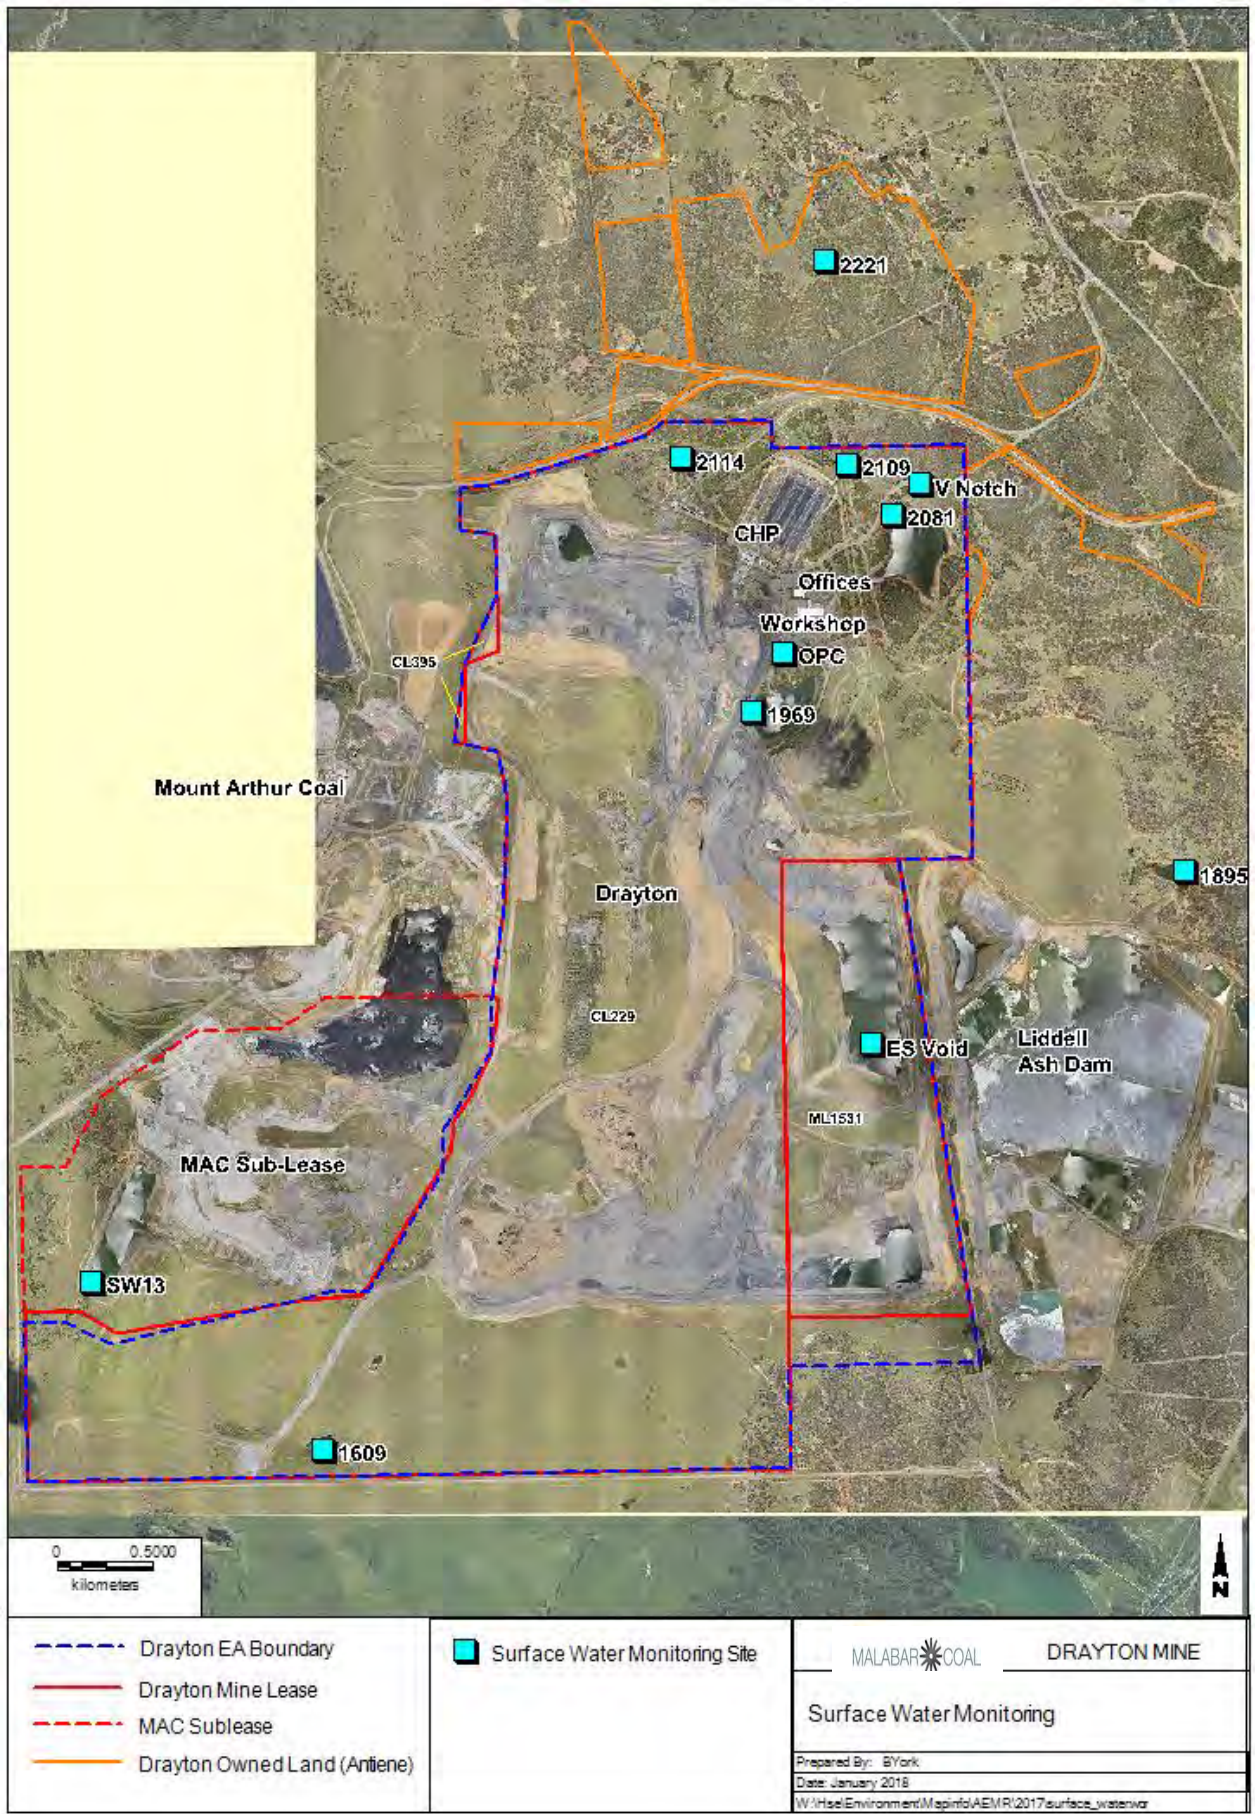
Figure O: Surface water monitoring sites

- pH
- Electrical Conductivity (EC)
- Total Dissolved Solids (TDS)
- Suspended Solids (SS)
- Bicarbonates
- Soluble Ions (Sodium, Magnesium, Chloride, Sulphate, Calcium and Potassium)

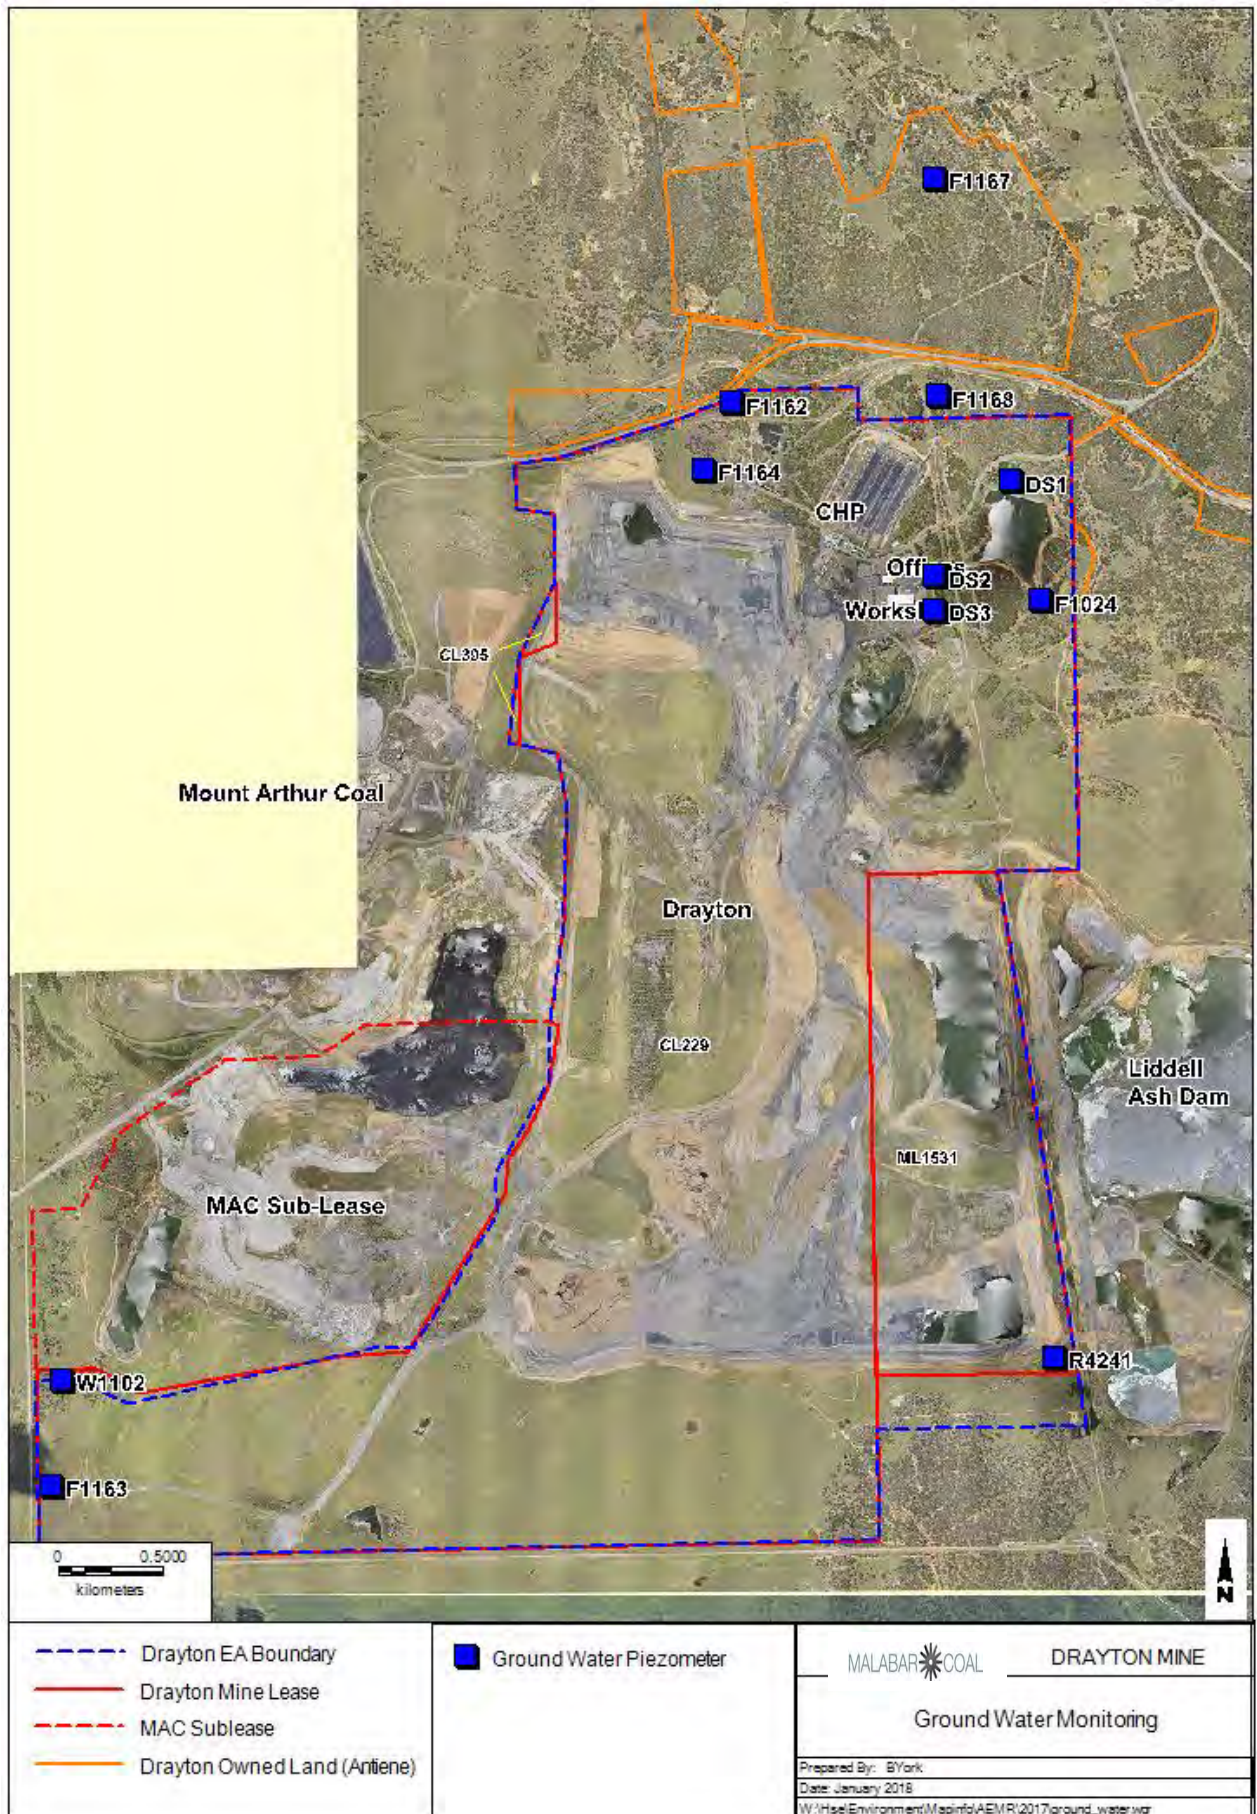
Figure P: Groundwater Monitoring Sites

The locations of the current piezometers are shown in **Figure P**.
