ANNUAL ENVIRONMENTAL MANAGEMENT REPORT

MAXWELL INFRASTRUCTURE

Annual Environmental Management Report 2018

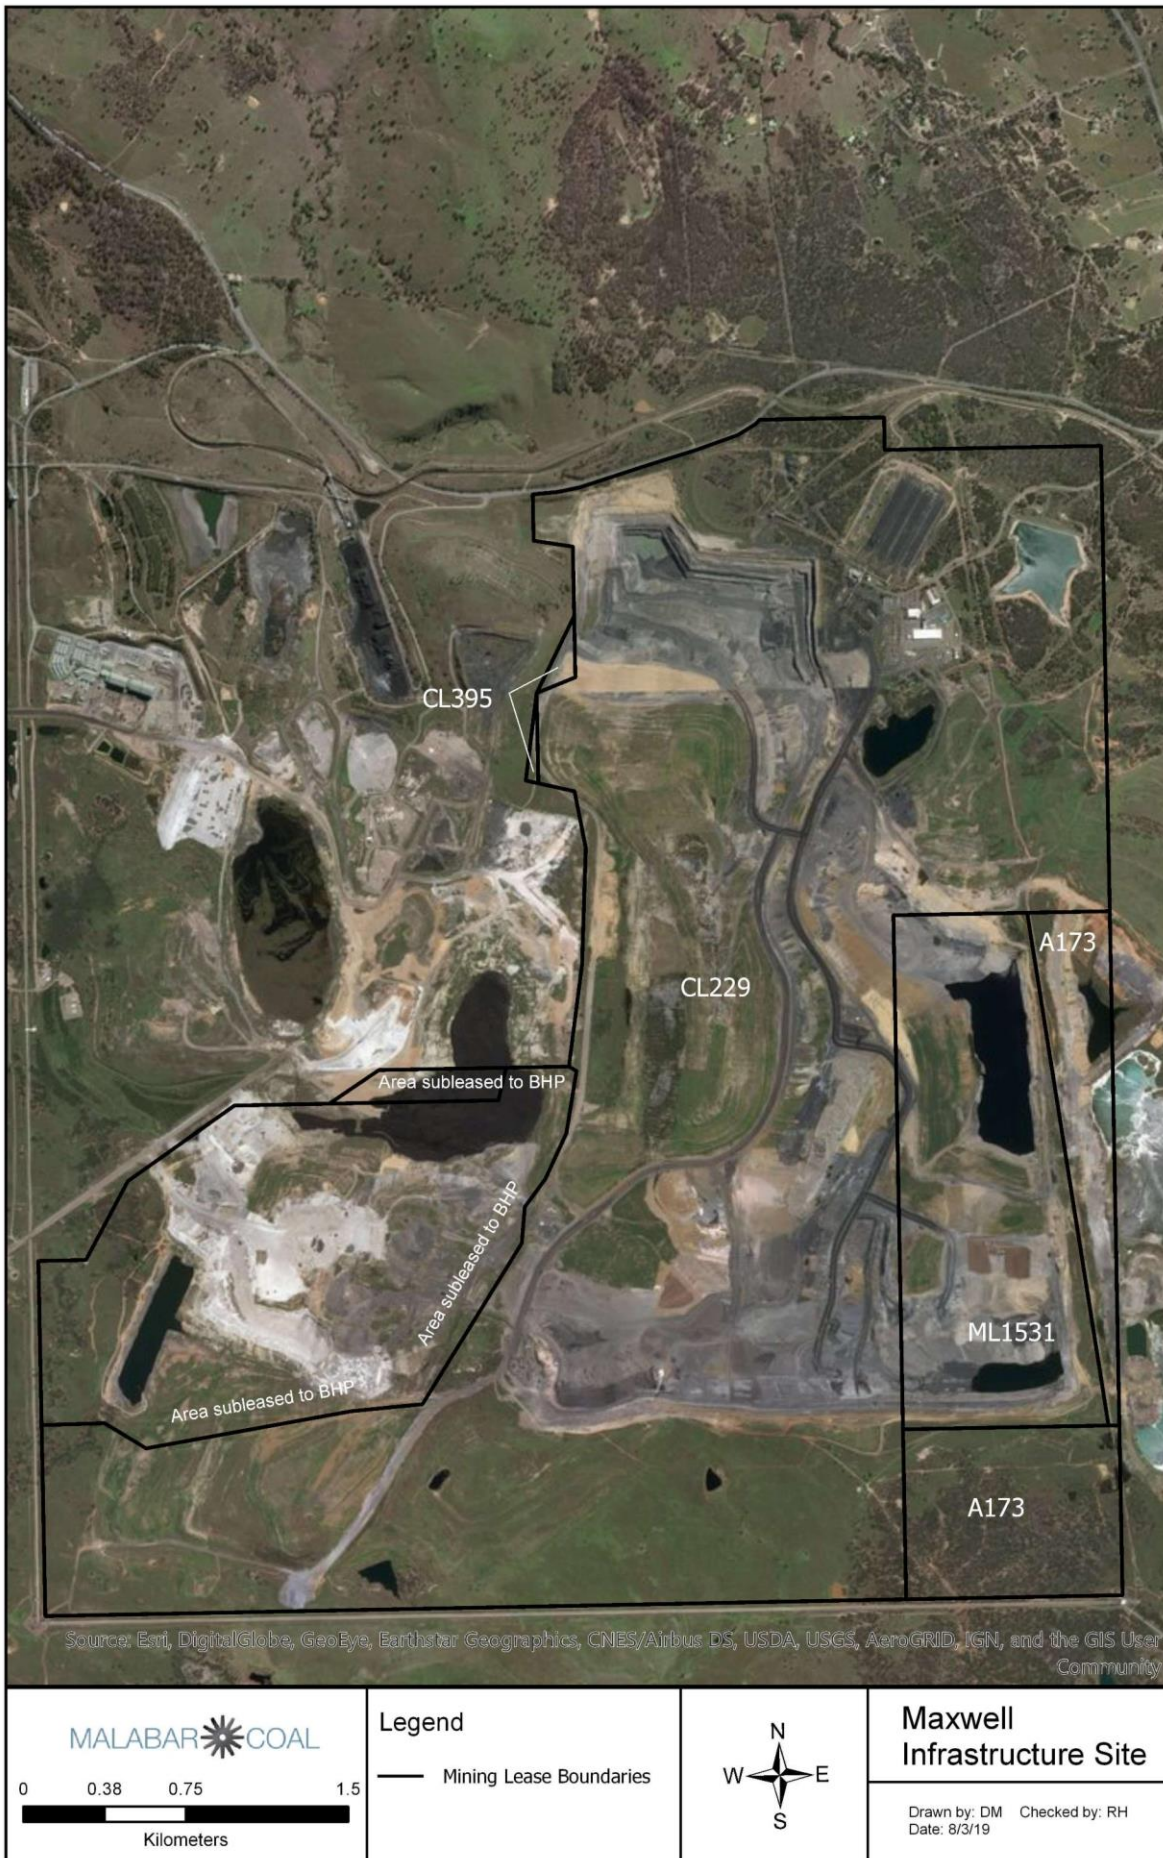
Figure 2. Lease boundaries

The regional context of the site is shown in **Figure 1**. Maxwell Infrastructure is bordered by Mt Arthur Coal to the west and AGL Macquarie's Bayswater Power Station adjoining the eastern and southern boundaries. The Antiene rural residential area exists to the north of the site. Lease boundaries for the site are shown in **Figure 2**.

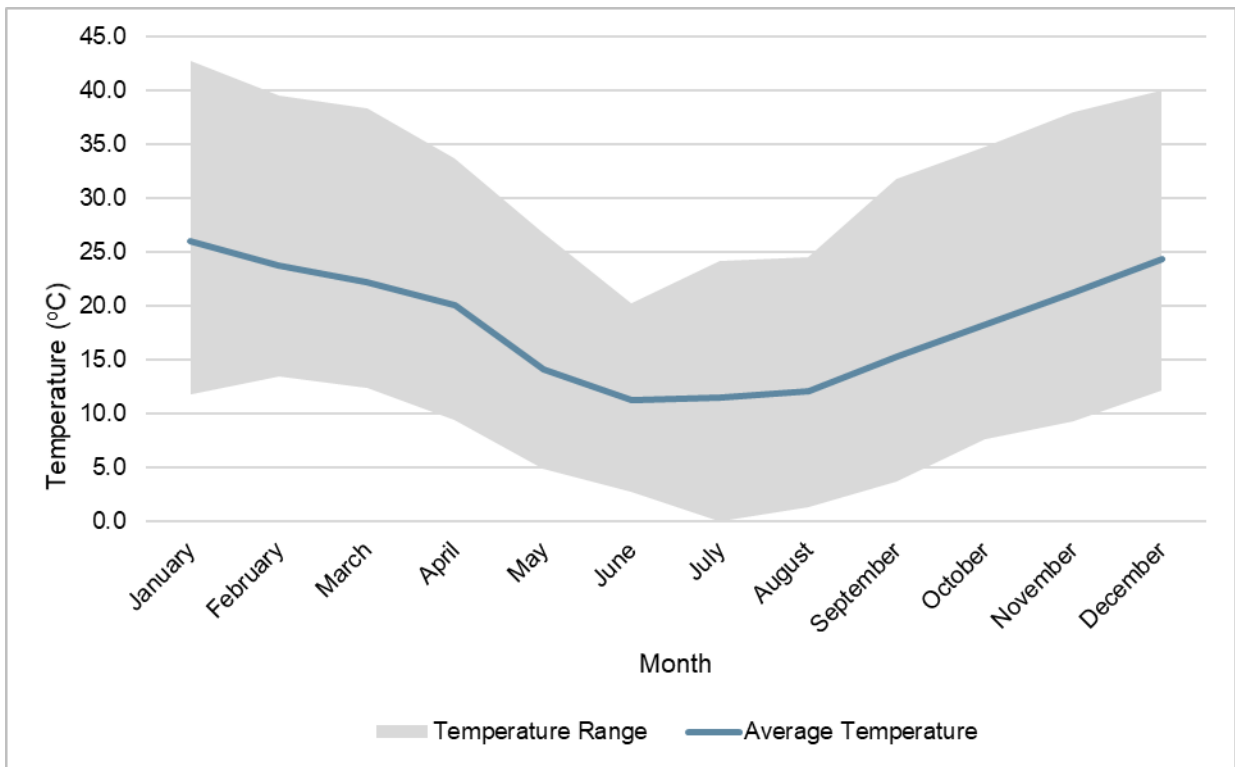
Figure 3. Temperature by month for the reporting period

During the reporting period, temperature trends were similar to previous years with a peak in summer and trough in winter. This is shown in **Figure 3**. Average temperatures were higher than previous years in the summer months.

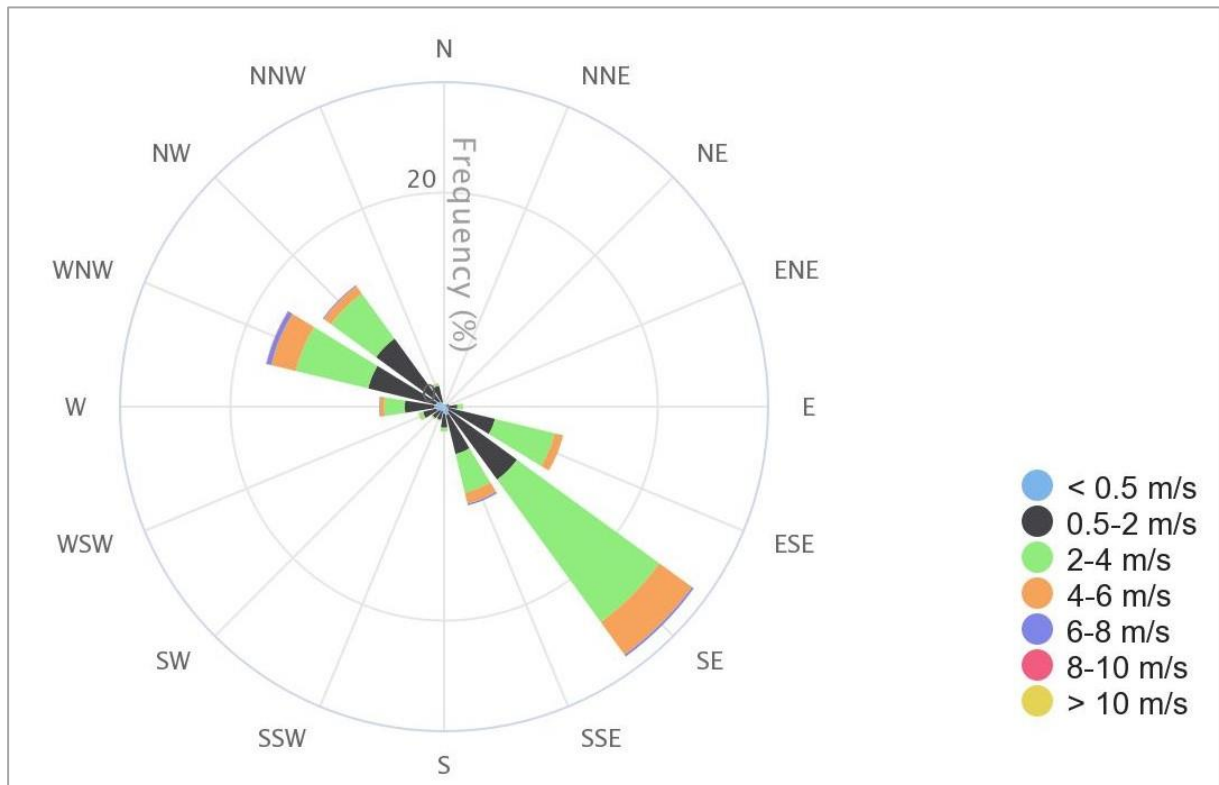
Figure 4. Wind speed and direction for the reporting period

A summary of wind monitoring over the reporting period is presented in **Figure 4**. Consistent with previous years, and consistent with the geography of the Hunter Valley, the predominant winds were from the south-east and north-west to west-north-west. Consistent with previous years, winds from the south-east dominated during the warmer months and winds from the north-west dominated during the cooler months. Wind speed throughout the reporting period was predominantly in the range of 0.5 to 4 metres per second (m/s).

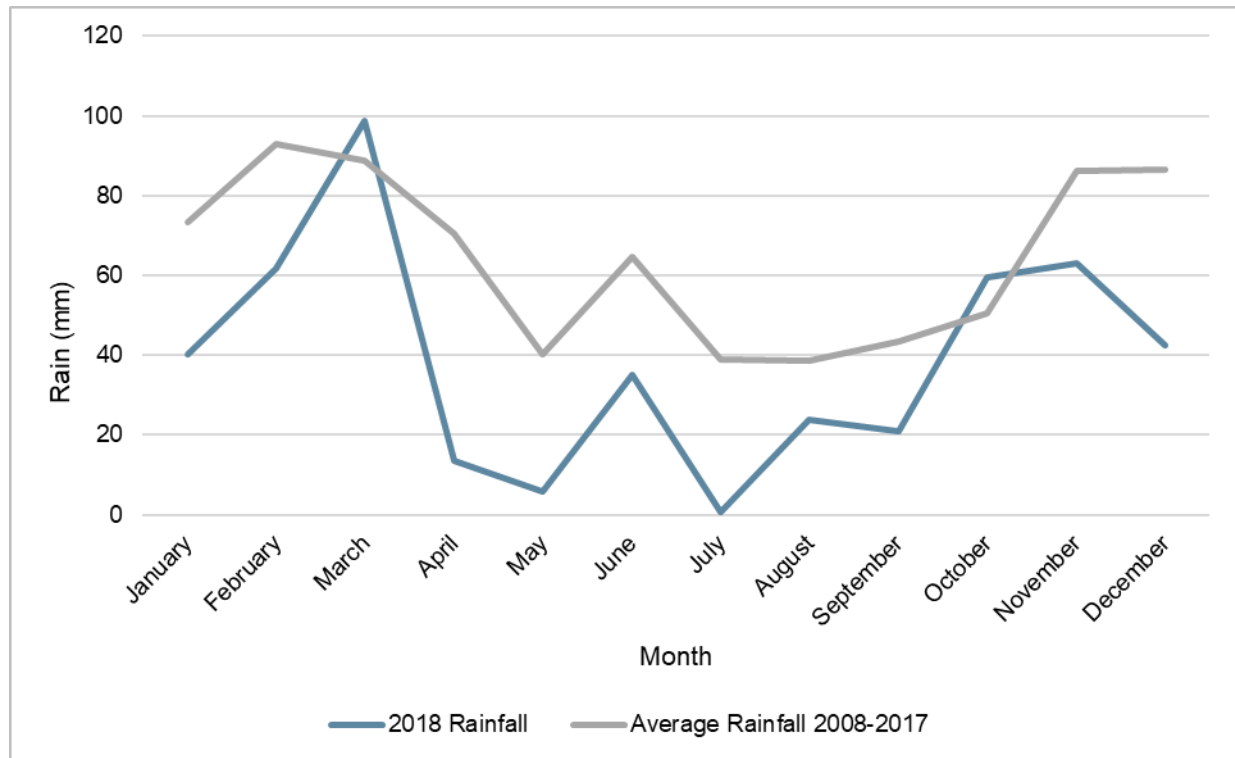
Figure 5. Rain by month for the reporting period with historic comparison

Rainfall recorded during the reporting period was below average. This can be seen in **Figure 5**, which shows monthly rainfall during the reporting period compared to the average monthly rainfall for the previous 10 years. The decrease in rainfall was consistent with the NSW Department of Primary Industries Climate Unit predictions in the [NSW State Seasonal Updates](#) that local conditions ranged from intense drought to drought-affected from April 2018 onwards. Consistent with previous years, rainfall was generally higher during the warmer months.

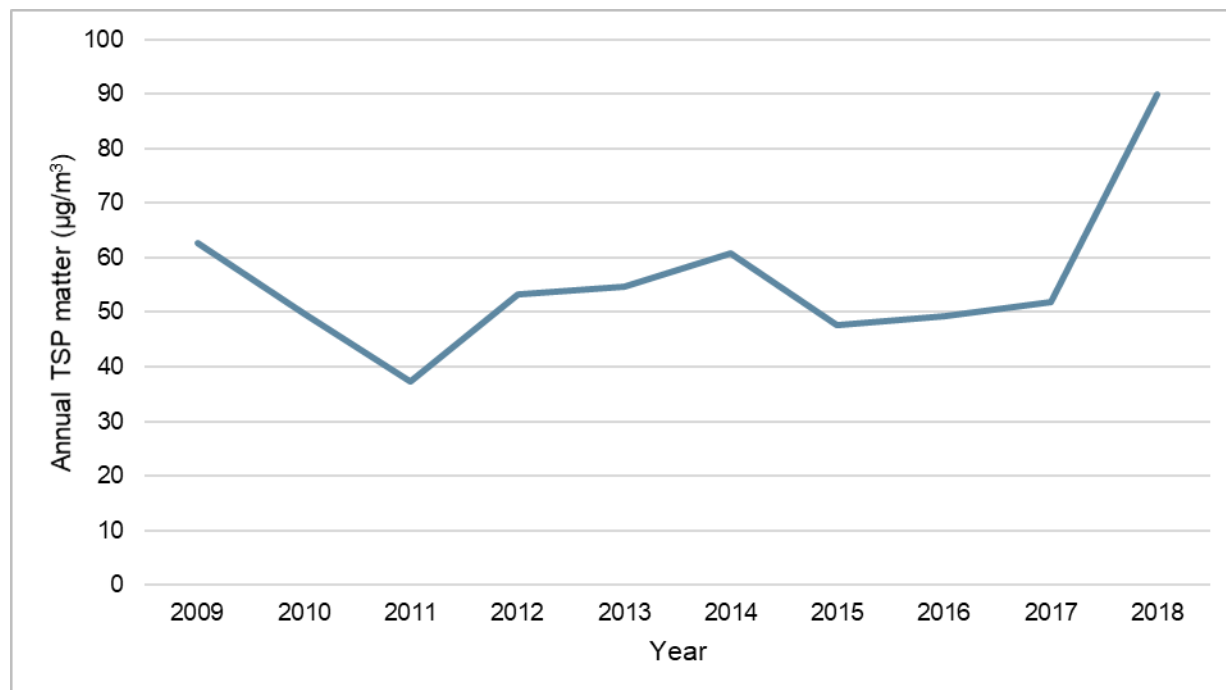
Figure 6. Long-term results for TSP

Investigations into the increase in the TSP level during the reporting period found that the elevated levels were being influenced by cattle feeding by a leasee in an exposed area immediately adjacent to the Lot 22 monitor and were not attributable to impacts from the Maxwell Infrastructure site.

Note. Following investigations, it was determined that the elevated 2018 result was not attributable to impacts from the Maxwell Infrastructure site.

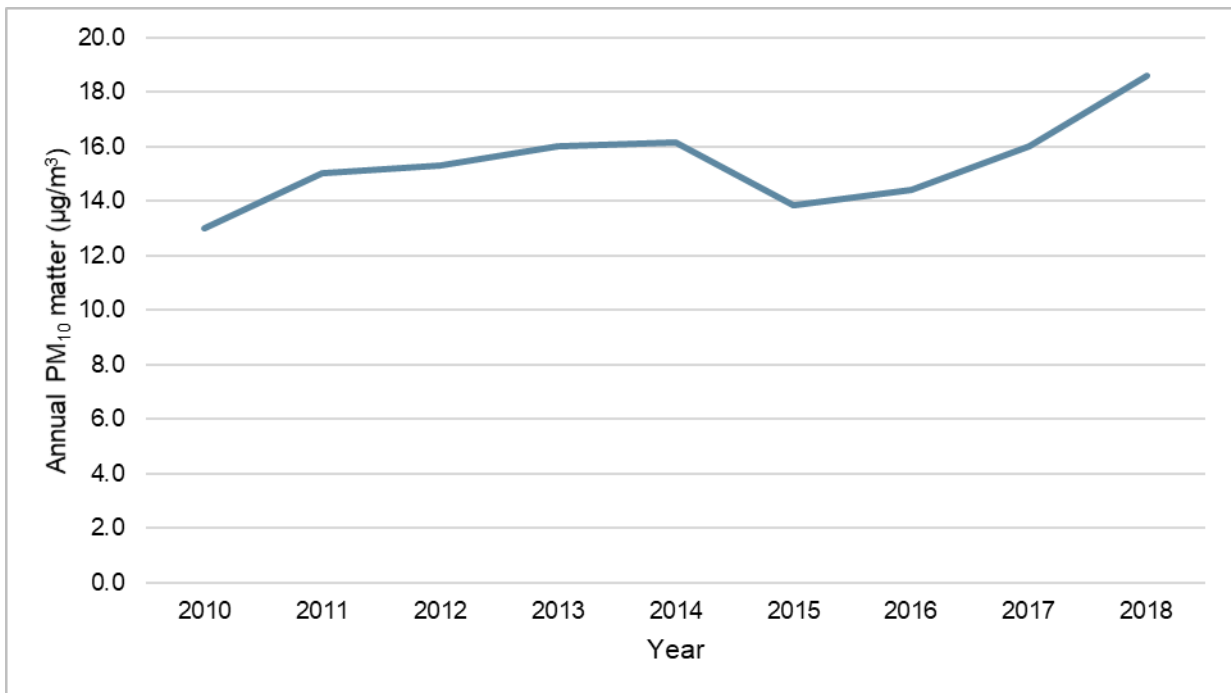
Figure 7. Long-term results for PM₁₀

All 24-hour PM₁₀ levels for the reporting period are presented in **Appendix 4**. The 24-hour criterion of 50 µg/m³ was exceeded on six days during the reporting period. Investigations into each of these exceedances determined that these results occurred on days when the monitor was **not** generally downwind of the operation. Rather the exceedances were consistent with regional conditions and **not** attributable to operations at the Maxwell Infrastructure site. Whilst exceedances were not attributable to the Maxwell Infrastructure site, the results have still been included in the long term annual PM₁₀ data. Details of these exceedances are provided in **Section 12.2**.

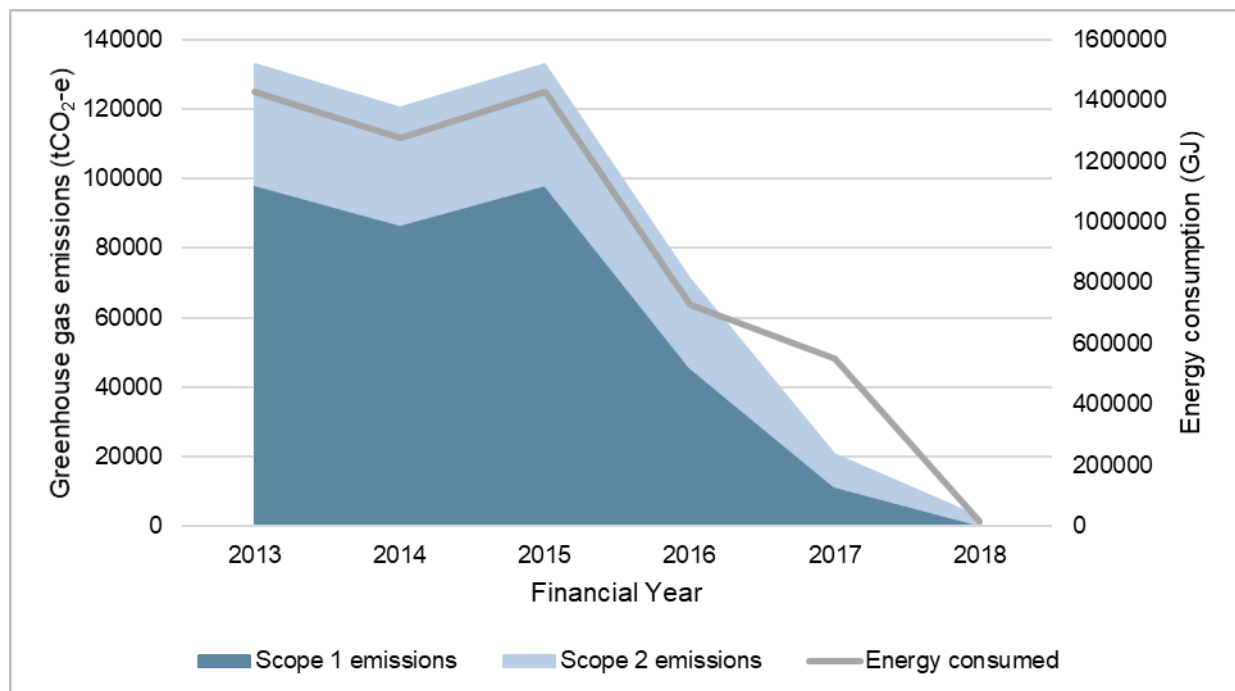
Figure 9. Long-term greenhouse gas emissions and energy consumption

Annual estimations of GHG emissions and energy use at the Maxwell Infrastructure site are calculated over financial years, in line with National GHG and Energy Reporting requirements. As shown in **Figure 9**, GHG emissions and energy use decreased following the cessation of mining during FY17 and as expected this trend continued during FY18.

GHG emissions and energy consumption were below National GHG and Energy Reporting thresholds for the FY18 period. Approximately 16,423 GJ of energy was consumed during FY18 and approximately 2,534 tCO₂-e was emitted from site activities. Of this, 602 tCO₂-e were scope 1 emissions and 1,932 tCO₂-e were scope 2 emissions.

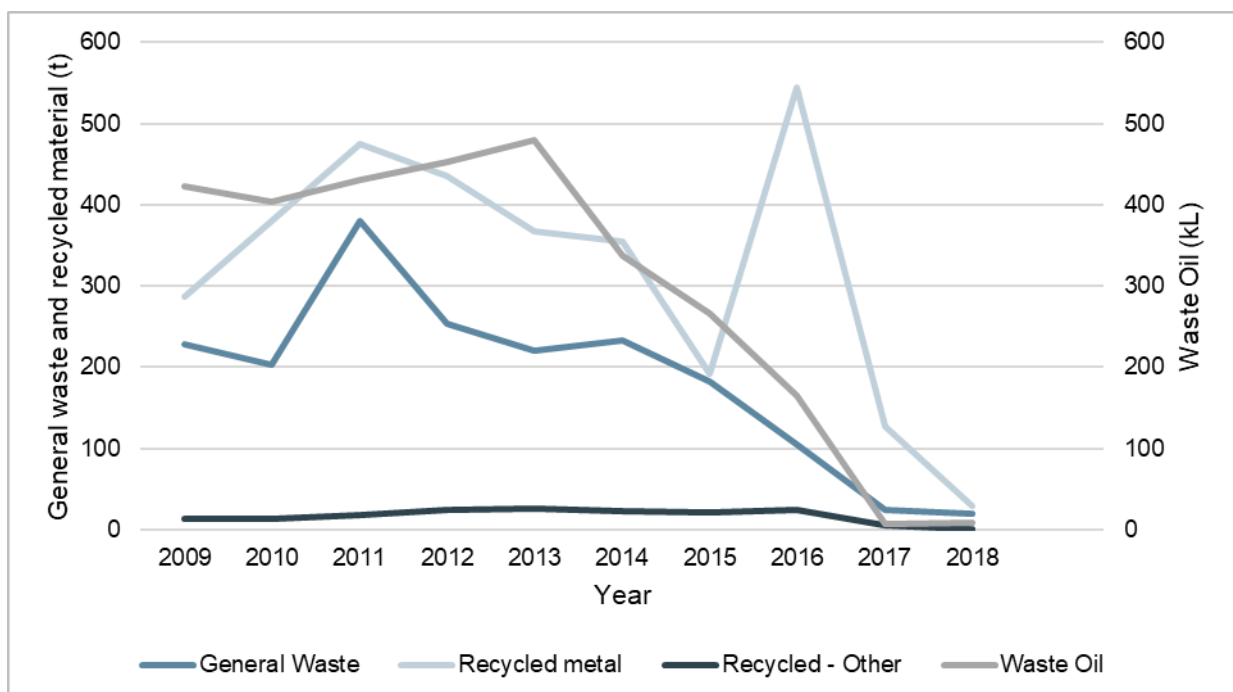
Figure 10. Long-term waste stream quantities

Waste and recycling streams are monitored monthly at the Maxwell Infrastructure site. Quantities of the major waste and recycling streams over the past 10 years are shown in **Figure 10**. This comparison shows that waste significantly reduced with the cessation of mining in late 2016. This is commensurate with the reduction in resource use associated with the reduced operational activity at the site.

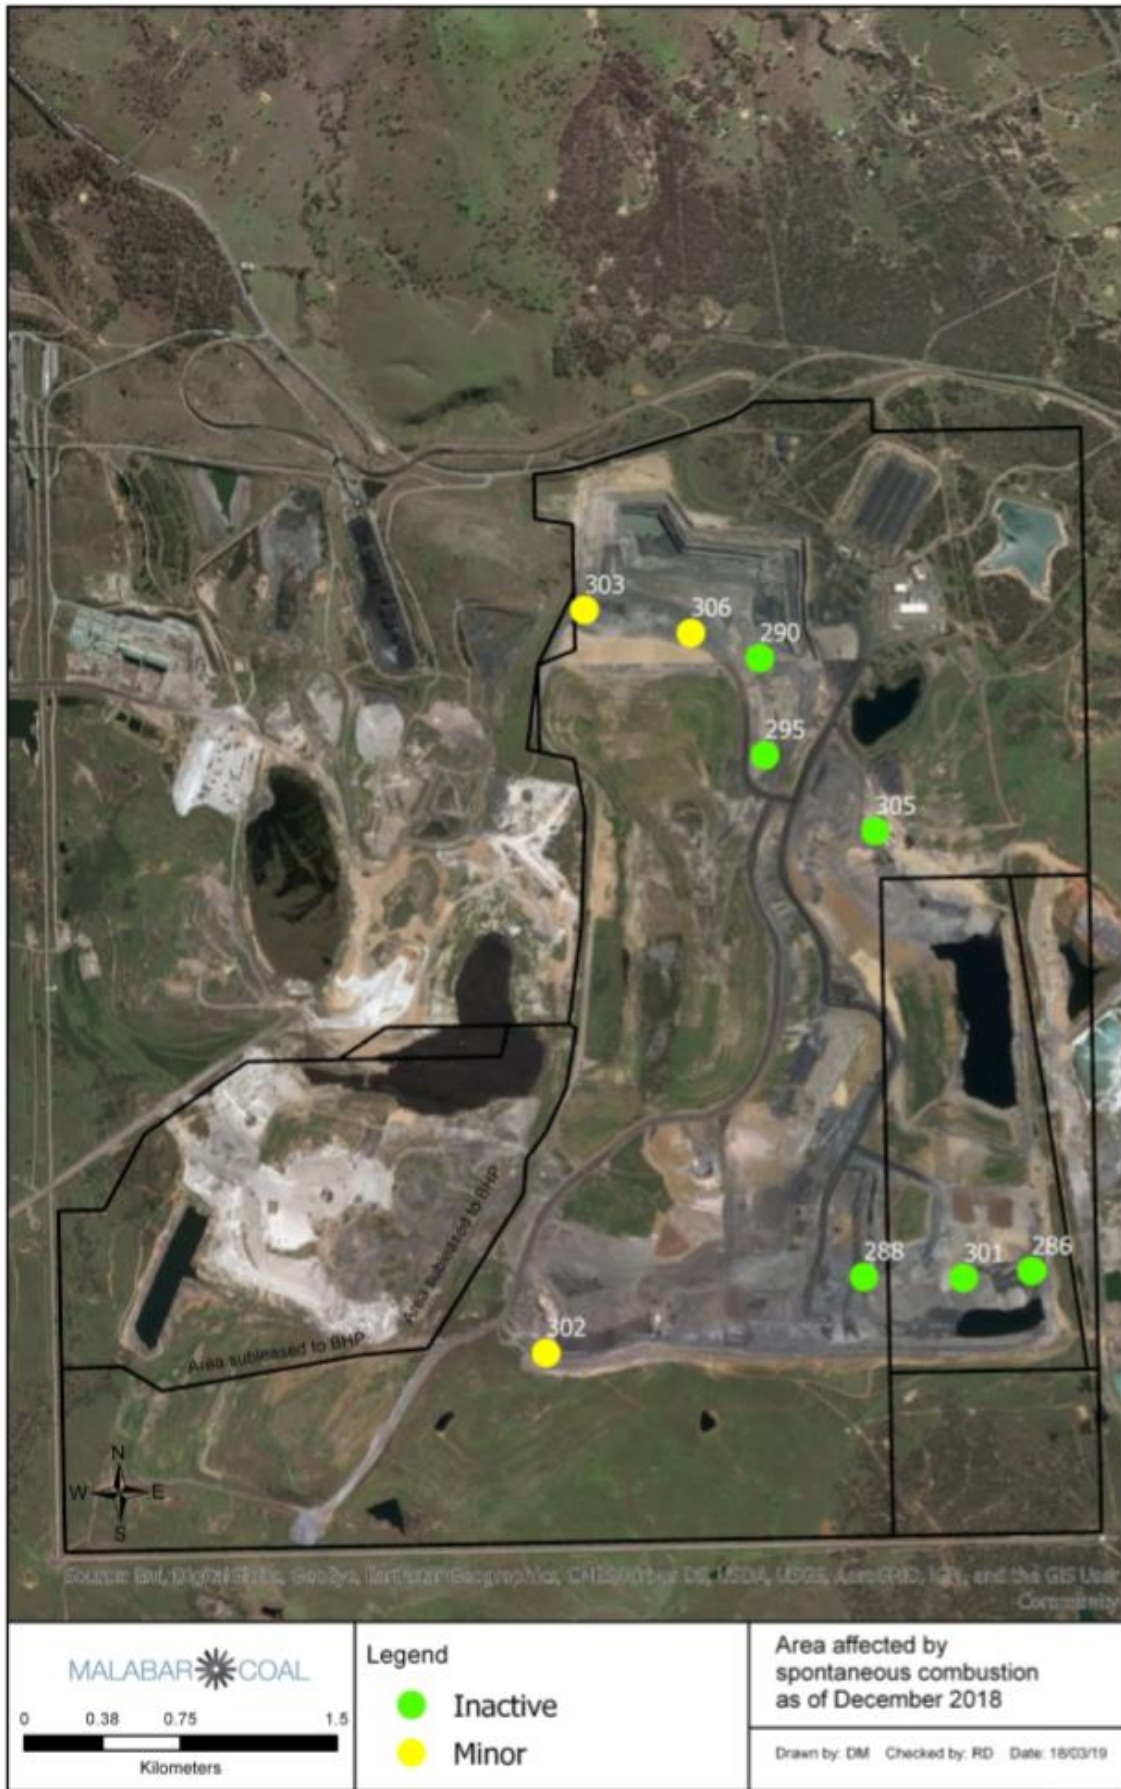
Figure 11. Locations affected by spontaneous combustion

During the reporting period, works to address spontaneous combustion were focused in the north of the mine at locations 290, 303, 305 and 306. As shown in **Table 11**, approximately 1,170 m² was estimated to be affected by spontaneous combustion which is higher than recent years.

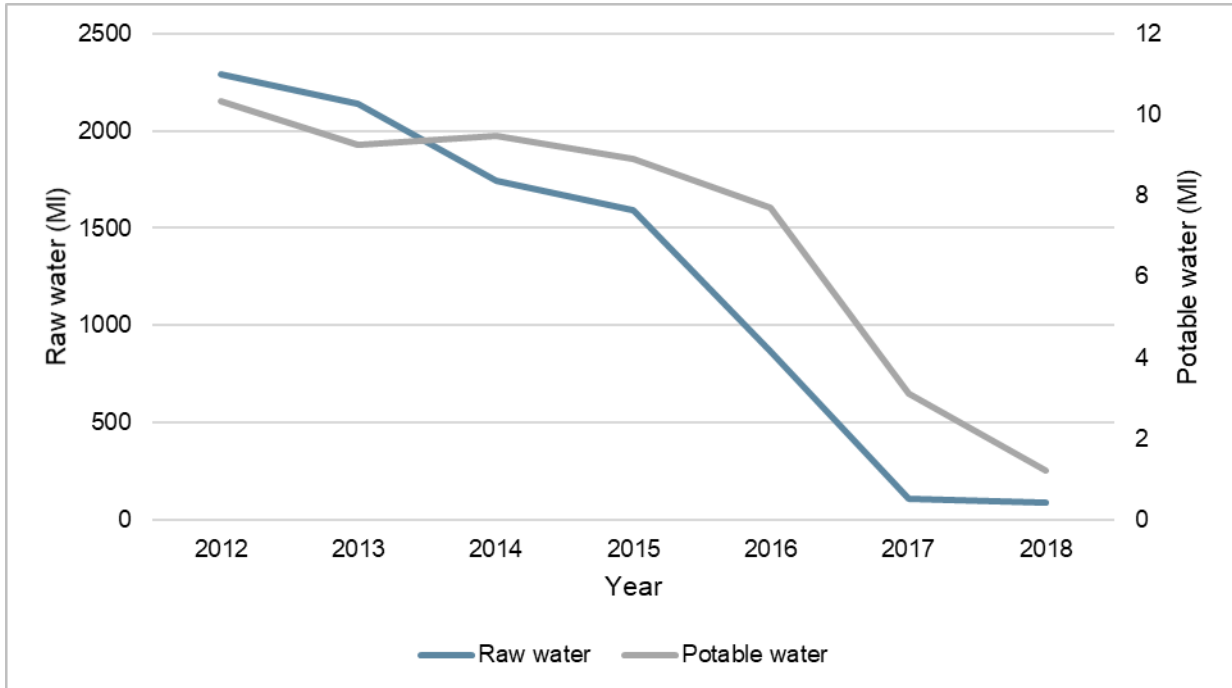
Figure 12. Long-term water consumption

Water stored on site in storages increased from approximately 10,581 MI to 12,304 MI in the reporting period, indicating that water consumption was well within the limits required to

maintain the site's closed raw water system, with no active intake or output of water. This is also demonstrated by the input-output statement of the water accounting framework in **Appendix 7**.

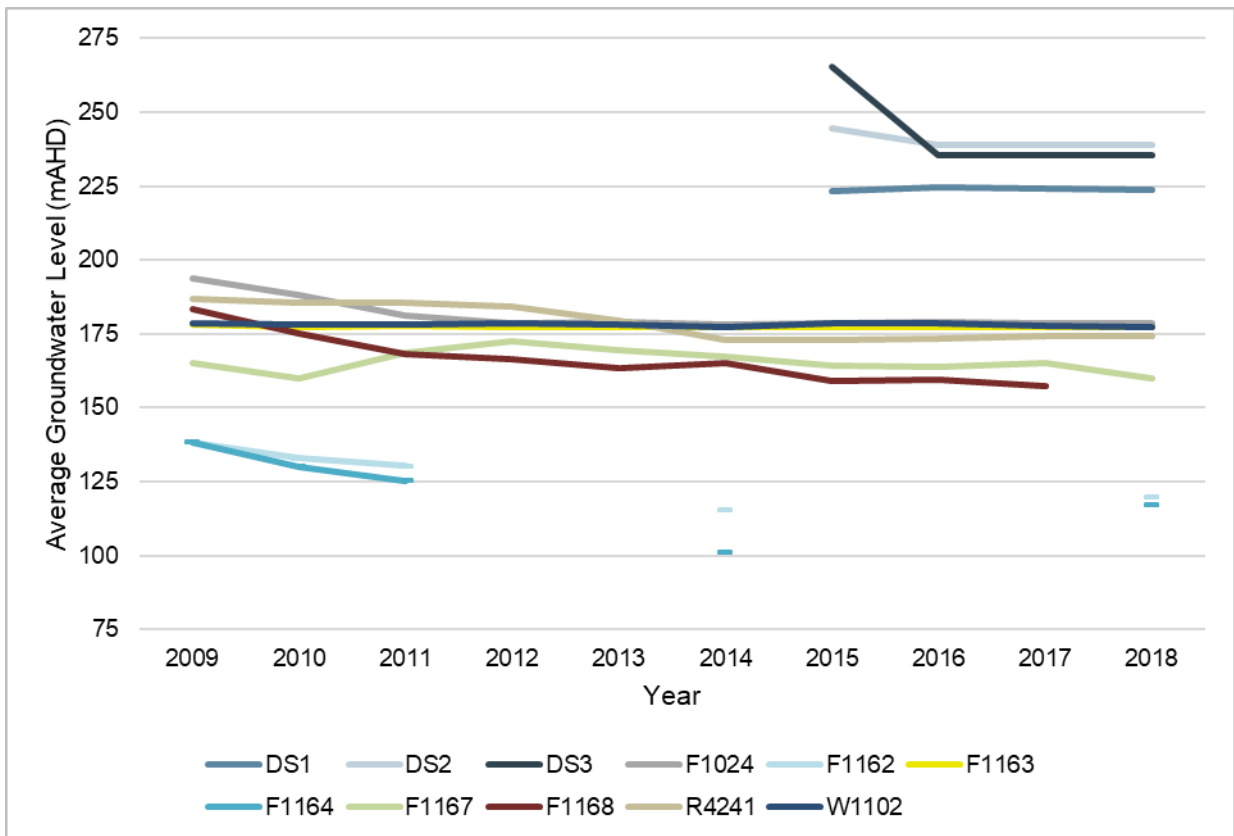
Figure 13. Long-term groundwater levels

Groundwater levels, measured monthly at Maxwell Infrastructure, have remained stable over the reporting period. The long-term groundwater levels at monitoring locations over the past 10 years is displayed in **Figure 13**. This shows that, consistent with the predicted “cone of depression” around the mine area, groundwater levels have lowered or remained stable at monitoring locations surrounding the mine over this time.

The elevation of groundwater levels has also remained above the elevation of the water surface in the voids, indicating that there is an inflow of aquifer water into the voids as predicted in the EA and supported by the site water balance model discussed in **Section 8.1**. This is apparent in **Figure 14** where contours have been calculated from the groundwater levels recorded in the reporting period in combination with water levels in the mine voids, in the absence of groundwater bores in the mine area.

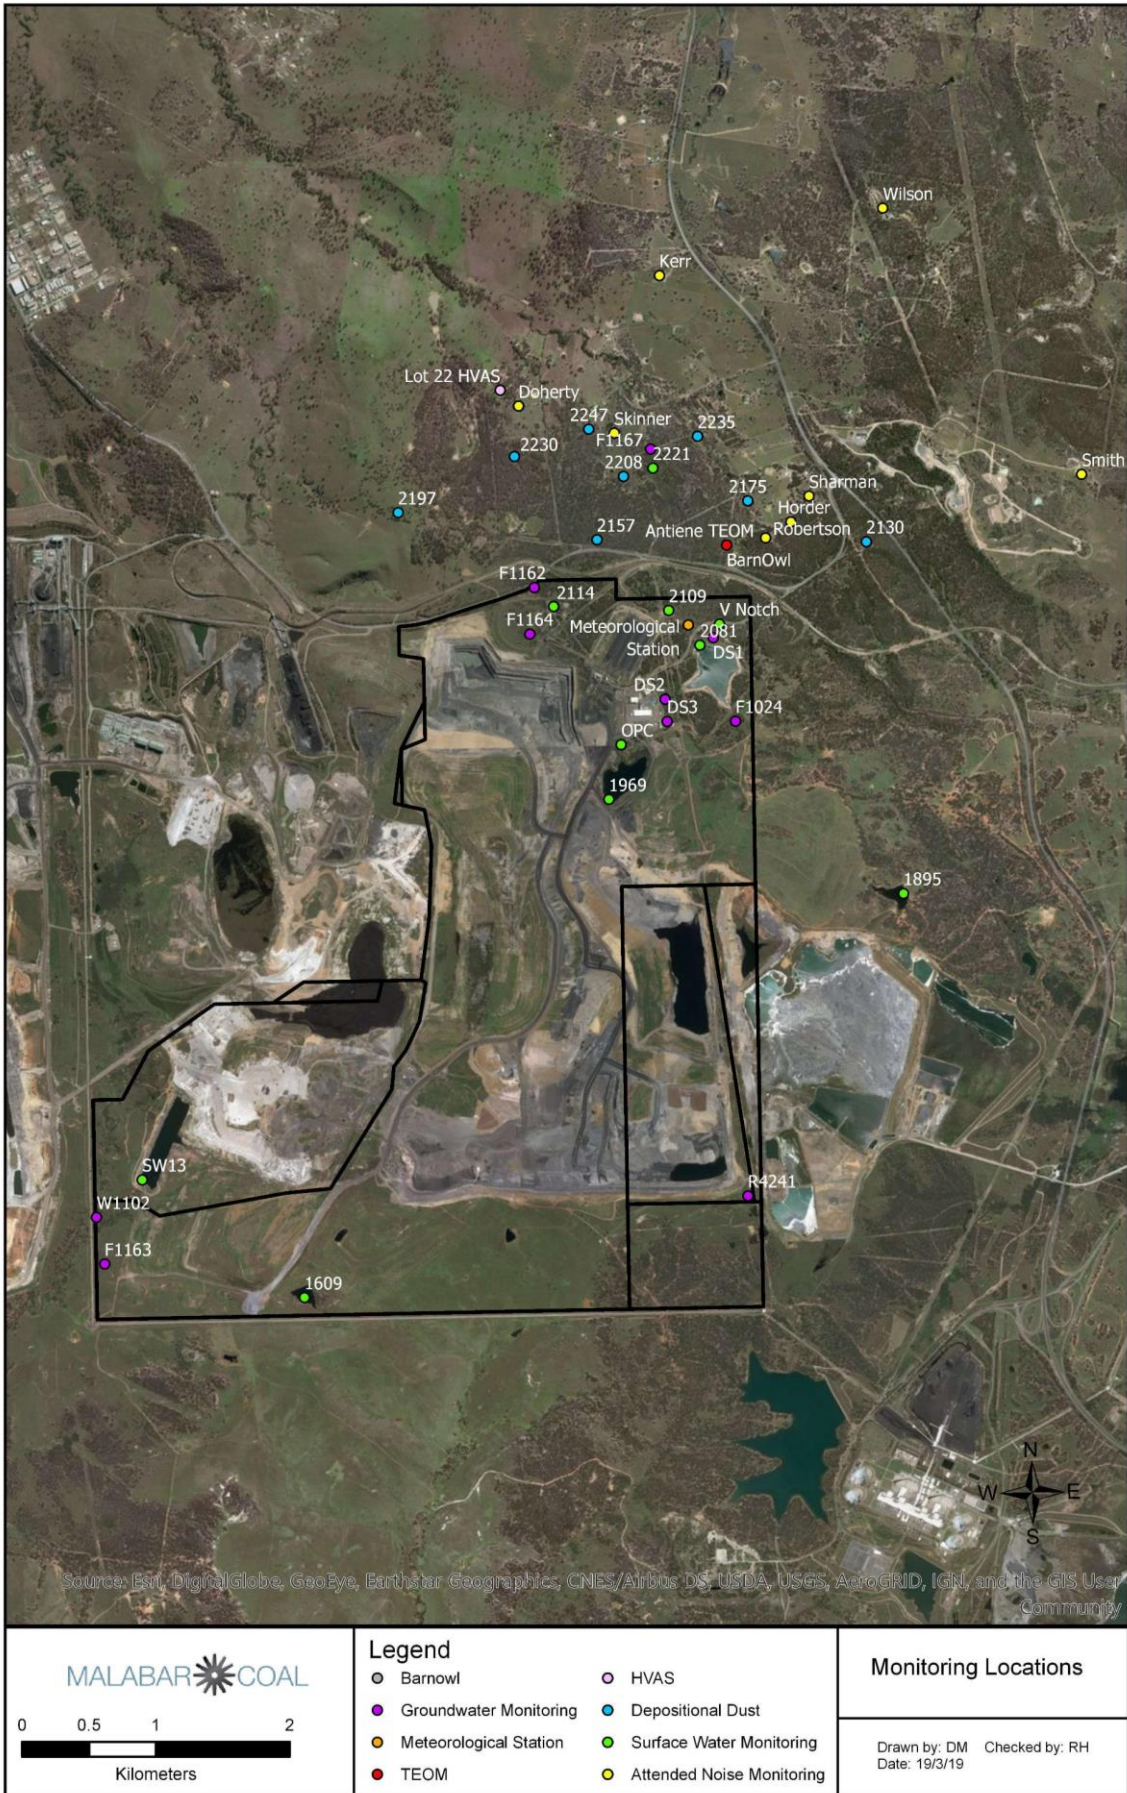
Figure 18. Environmental monitoring locations

Meteorological conditions such as wind speed, wind directions, temperature, rainfall, solar radiation and humidity are monitored at the site's meteorological station (see **Appendix 2**).
