ANNUAL ENVIRONMENTAL MANAGEMENT REPORT

MAXWELL INFRASTRUCTURE

Annual Environmental Management Report 2019

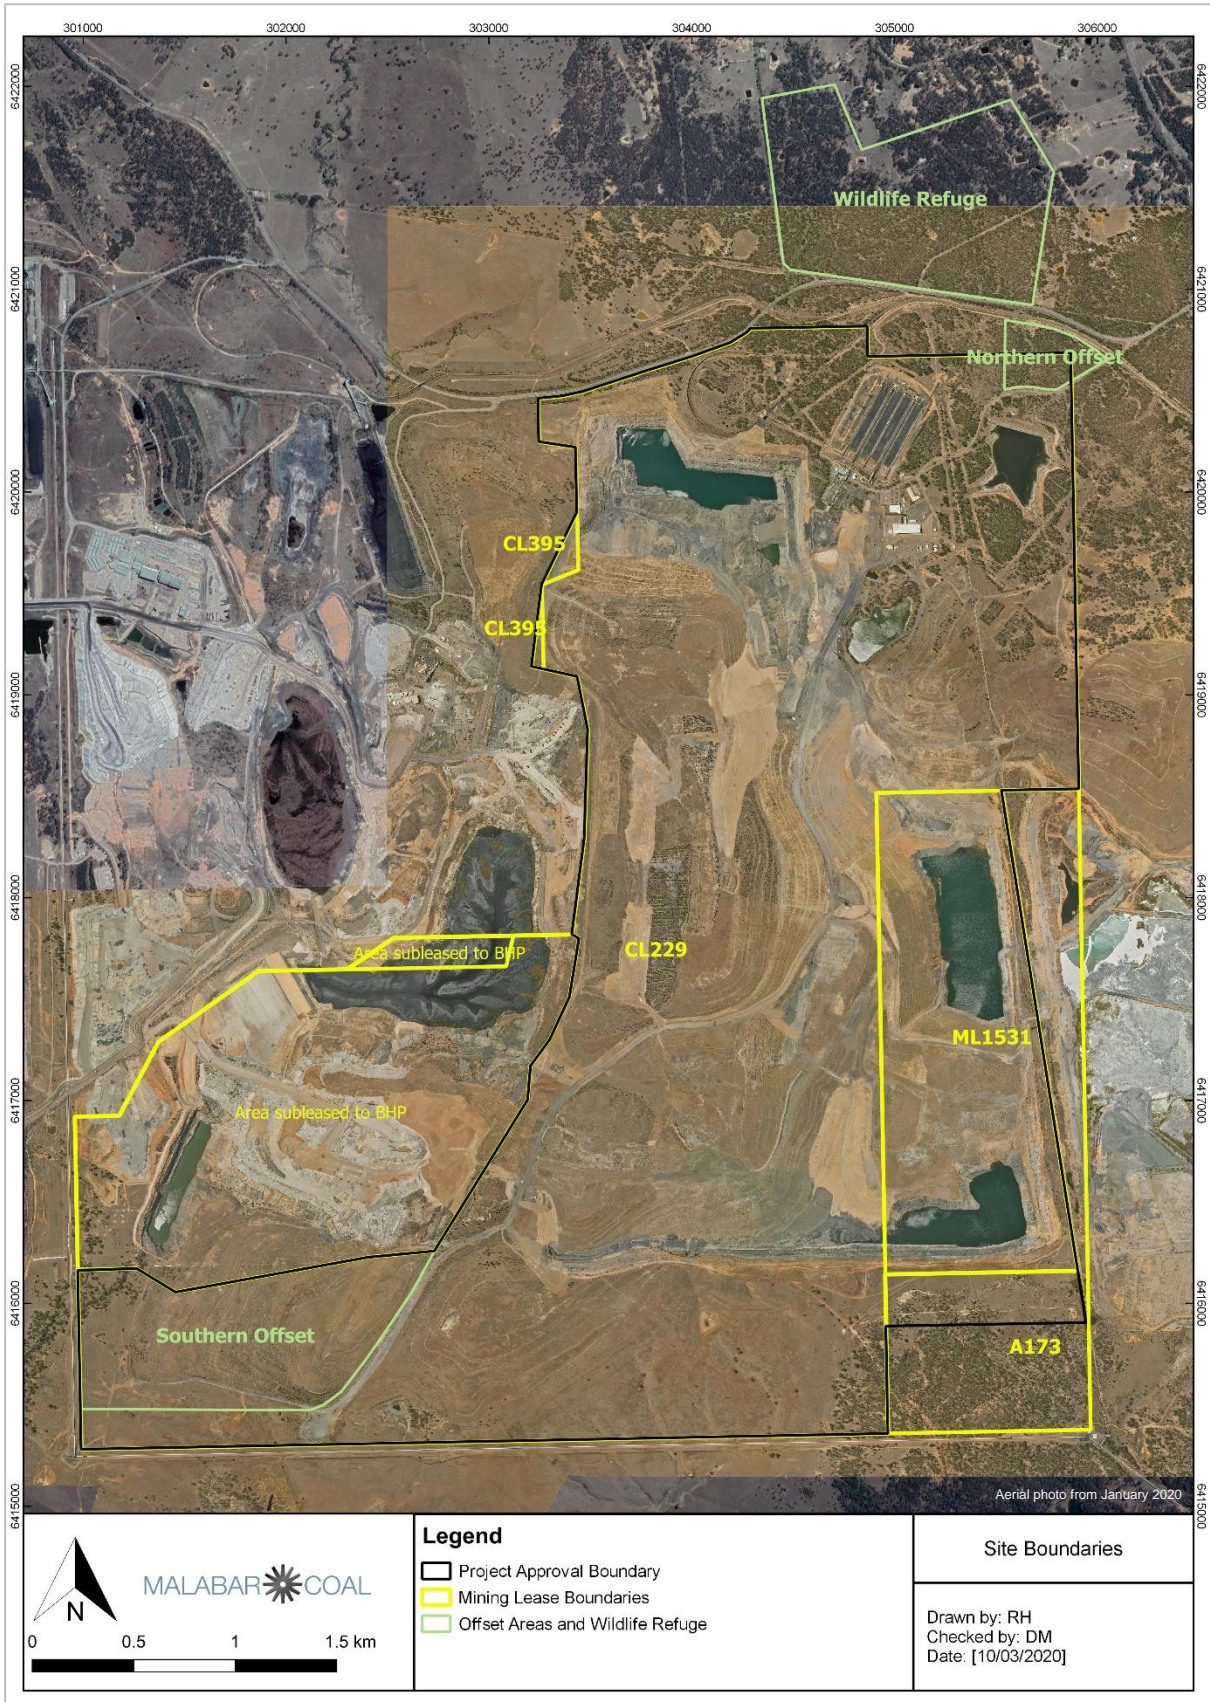
Figure 2. Site boundaries

The regional context of the site is shown in **Figure 1**. Maxwell Infrastructure is bordered by Mt Arthur Coal to the west and AGL Macquarie's Bayswater and Liddell Power Stations adjoining the eastern and southern boundaries. The Antiene rural residential area exists to the north of the site. The Project Approval (PA) boundary, lease boundaries and biodiversity offset areas for the site are shown in **Figure 2**. This figure also shows the current operational disturbance footprint.

Action required	Requested by	Action taken
Please update Figure 2 to include the development consent boundaries and offset areas.	DPIE – Planning and Assessment	Figure 2 in the 2019 AEMR has been updated to include development consent boundaries and offset areas.
Undertake an assessment of the risks to the rehabilitation of the Site. The Rehabilitation Risk Assessment must identify and evaluate all potential risks to achieving the final land use and the specific measures to be implemented to mitigate those risks and have regard to the AS NZS ISO 31000:2009 Risk Management – Principles and Guidelines to support any rehabilitation risk assessment.	DPIE - Resources Regulator	A Rehabilitation Risk Assessment was undertaken on 28 January 2020, prior to the due date.
Prepare a Draft Maxwell Infrastructure Rehabilitation Risk Assessment Report which encompasses the Rehabilitation Risk Assessment undertaken in Direction 1 and submit it to nswresourcesregulator@service-now.com.	DPIE - Resources Regulator	A draft Rehabilitation Risk Assessment Report was prepared and submitted to DPIE - Resources Regulator on 4 March 2020.

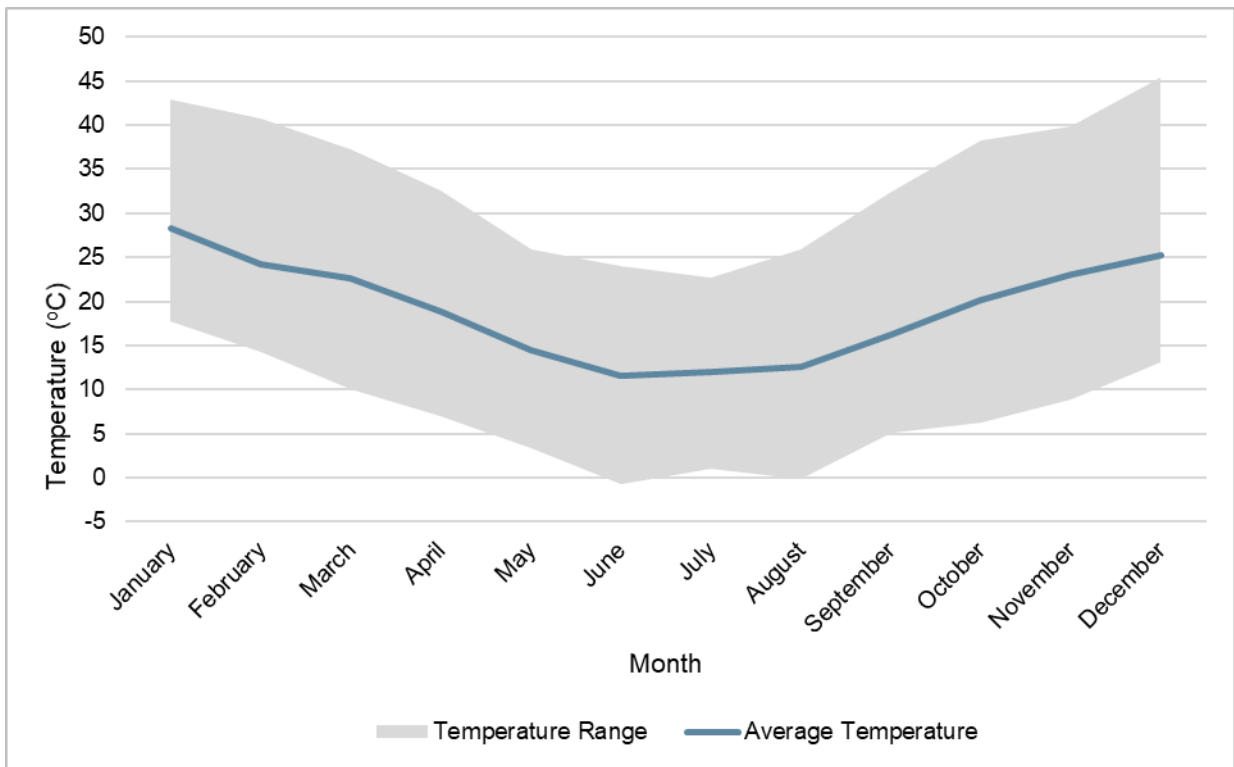
Figure 3. Temperature by month for the reporting period

During the reporting period, temperature trends were similar to previous years with a peak in summer and trough in winter. This is shown in **Figure 3**. However, average temperatures were slightly higher than previous years, particularly in the warmer months. This peaked in January when the average temperature recorded was 4.4 degrees Celsius (°C) higher than the average temperature recorded in January for the previous five years.

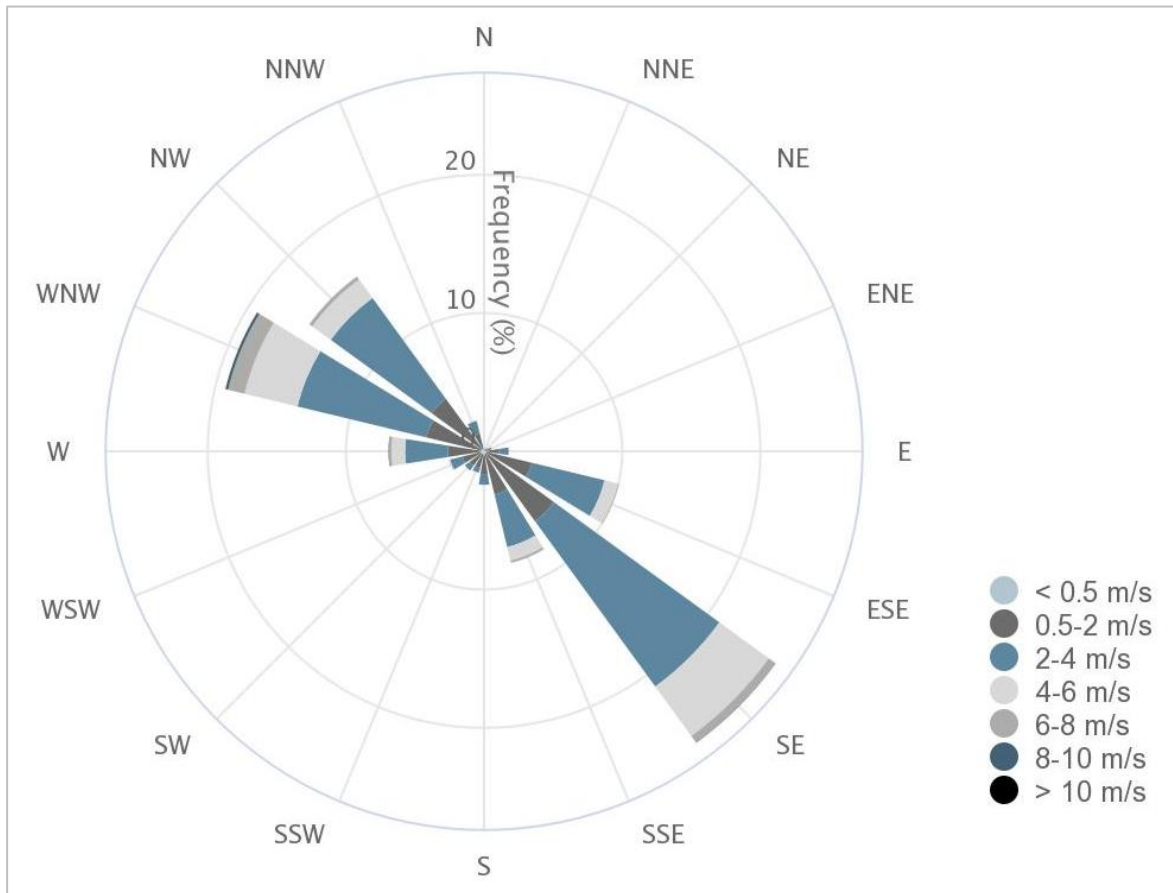
Figure 4. Wind speed and direction for the reporting period

A summary of wind monitoring over the reporting period is presented in **Figure 4**. Consistent with previous years, and consistent with the geography of the Hunter Valley, the predominant winds were from the south-east and north-west to west-north-west. As in previous years, winds from the south-east generally dominated during the warmer months and winds from the north-west generally dominated during the cooler months. Wind speed throughout the reporting period was predominantly in the range of 0.5 to 4 metres per second (m/s).

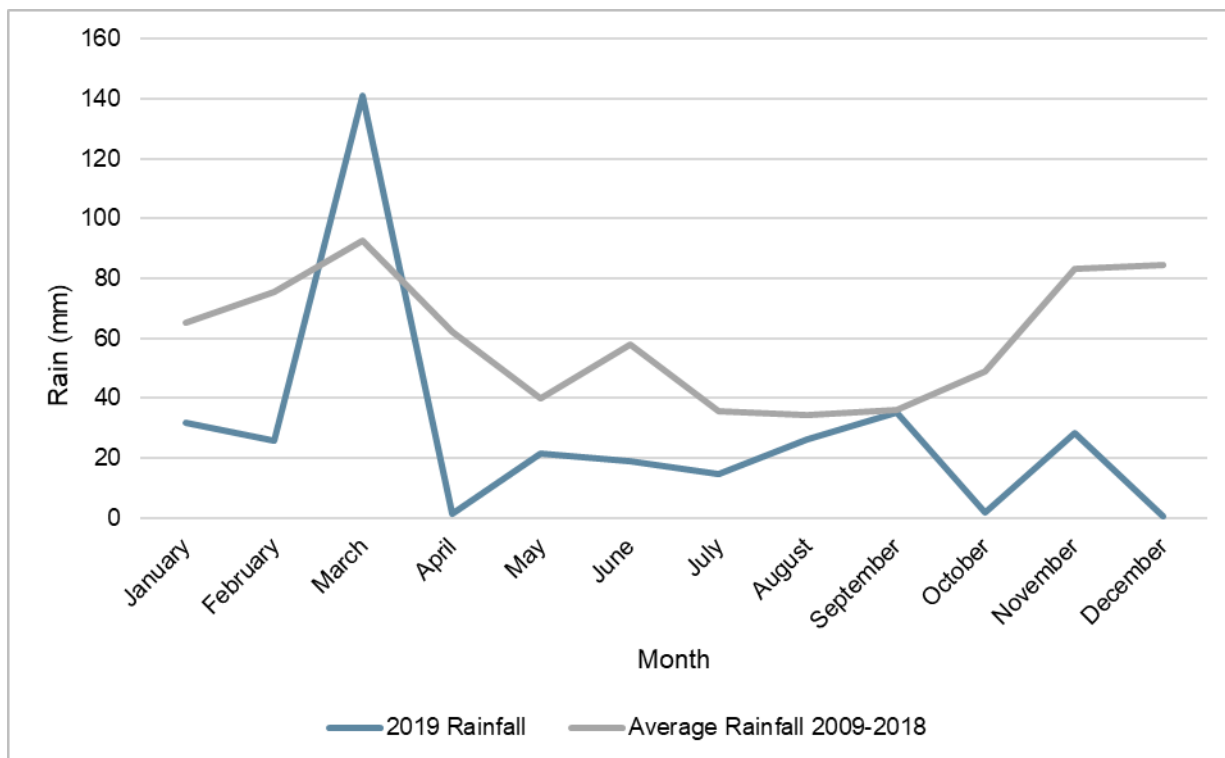
Figure 5. Rain by month for the reporting period with historic comparison

Rainfall recorded during the reporting period was below average. This can be seen in **Figure 5**, which shows monthly rainfall during the reporting period compared to the average monthly rainfall for the previous 10 years. The decrease in rainfall was consistent with the [NSW State Seasonal Update for December 2019](#), published by the NSW Department of Primary Industries Climate Unit, which noted that the Combined Drought Indicator for 12 months to 31 December 2019 in the local area was at an Intense Drought level. Consistent with previous years, rainfall peaked in March, however, the higher seasonal rainfall typically seen in the warmer months did not occur in the reporting period.

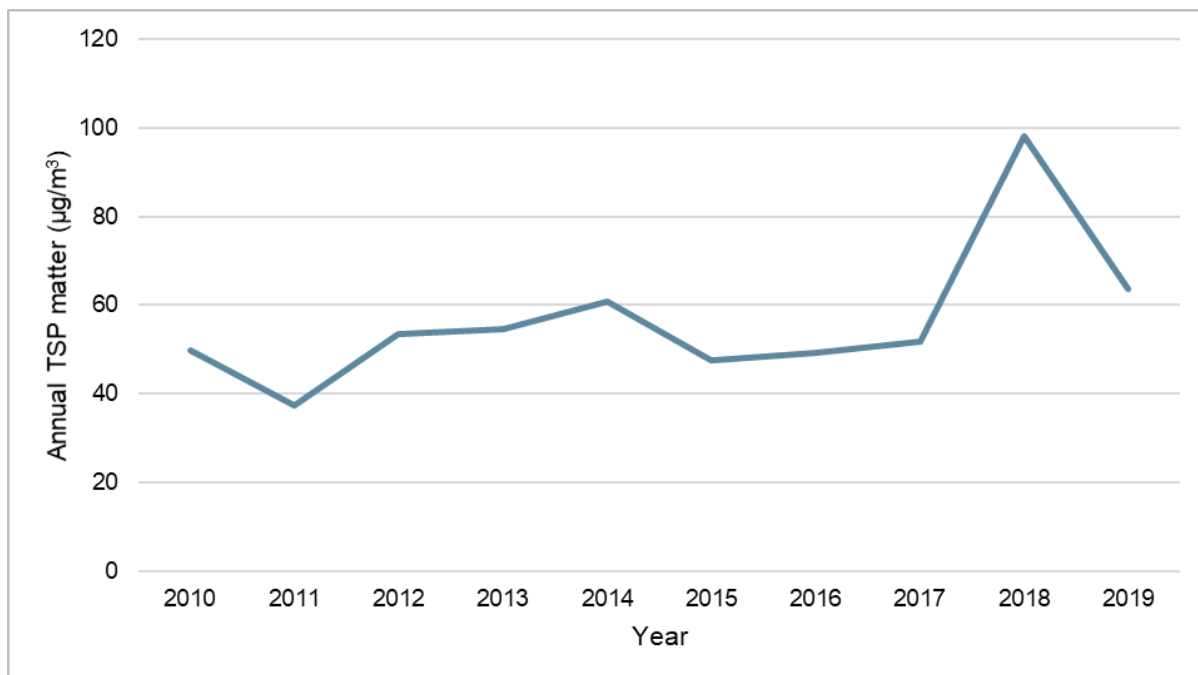
Figure 6. Long-term results for TSP

The long-term trend for the annual TSP level, over a 10-year period, is shown in **Figure 6** and shows an upward trend, particularly since 2015. This trend is likely to be associated with regional air quality, consistent with drought conditions, and not attributable to impacts from the Maxwell Infrastructure site, where activities have decreased significantly since mining ceased in October 2016. TSP is not recorded across the region by the Upper Hunter Air Quality Monitoring Network (UHAQMN), however PM₁₀ levels monitored by the UHAQMN, which can generally be correlated with TSP levels, have shown a similar upward trend across the region since 2015.

The exception to this is the annual TSP result recorded by Maxwell Infrastructure in 2018, which was particularly high. An investigation into the 2018 result found the elevated levels were being influenced by a leasee feeding cattle in an exposed area immediately adjacent to and were not attributable to impacts from the Maxwell Infrastructure site nor indicative of regional conditions. The monitor used to calculate TSP is no longer located near this source.

Note: Following investigations, it was determined that the elevated 2018 result was not attributable to impacts from the Maxwell Infrastructure site.

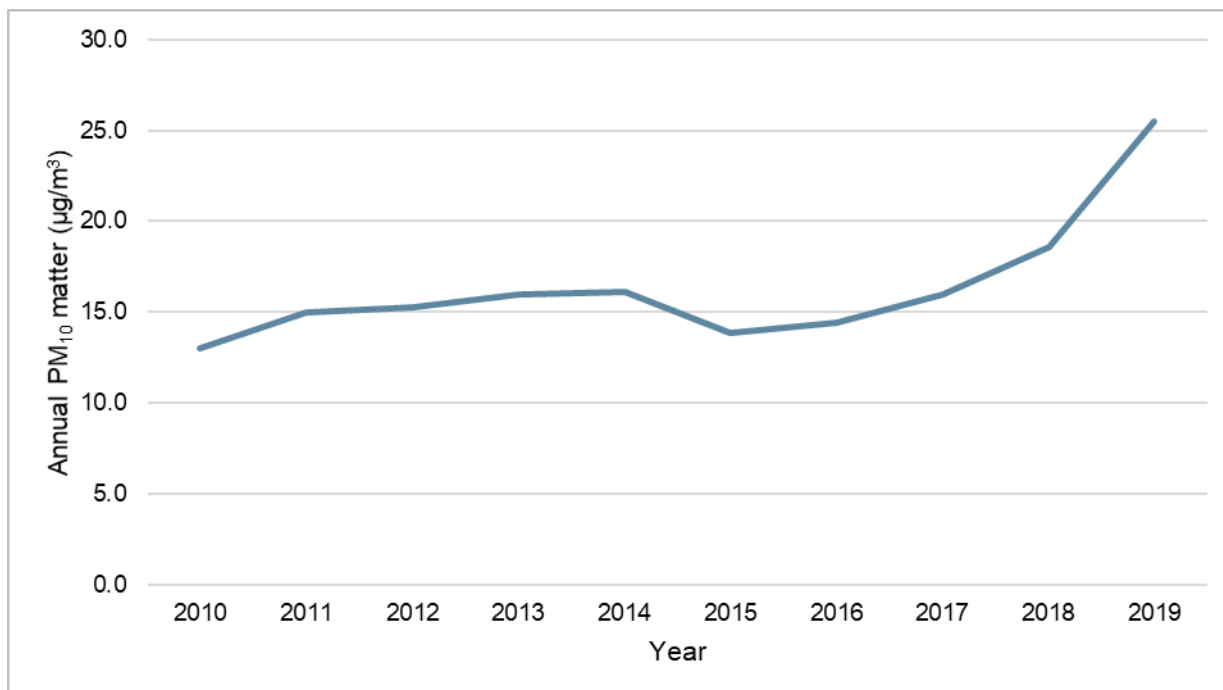
Figure 7. Long-term results for PM₁₀

The long-term trend in annual PM₁₀ levels, shown in **Figure 7**, illustrates an upward trend since 2015. This trend is likely to be associated with regional air quality, consistent with drought conditions, and not attributable to impacts from the Maxwell Infrastructure site, where activities have decreased significantly since mining ceased in October 2016. PM₁₀ levels monitored by the UHAQMN have shown a similar upward trend across the region since 2015.

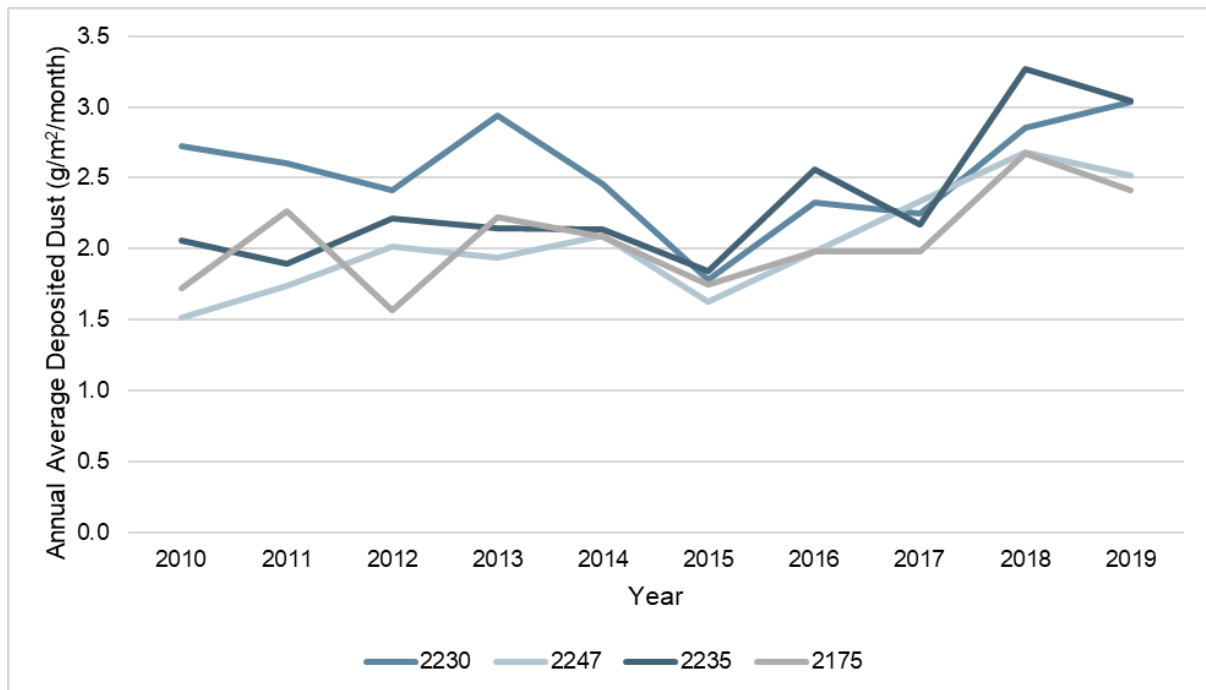
Figure 8. Long-term results for deposited dust

The long-term trend in annual average deposited dust levels are shown in **Figure 8**. Like other air quality parameters, deposited dust results have shown an upward trend since 2015. This trend is likely to be associated with regional air quality, consistent with drought conditions, and not attributable to impacts from the Maxwell Infrastructure site, as activities have decreased significantly since mining ceased in October 2016.

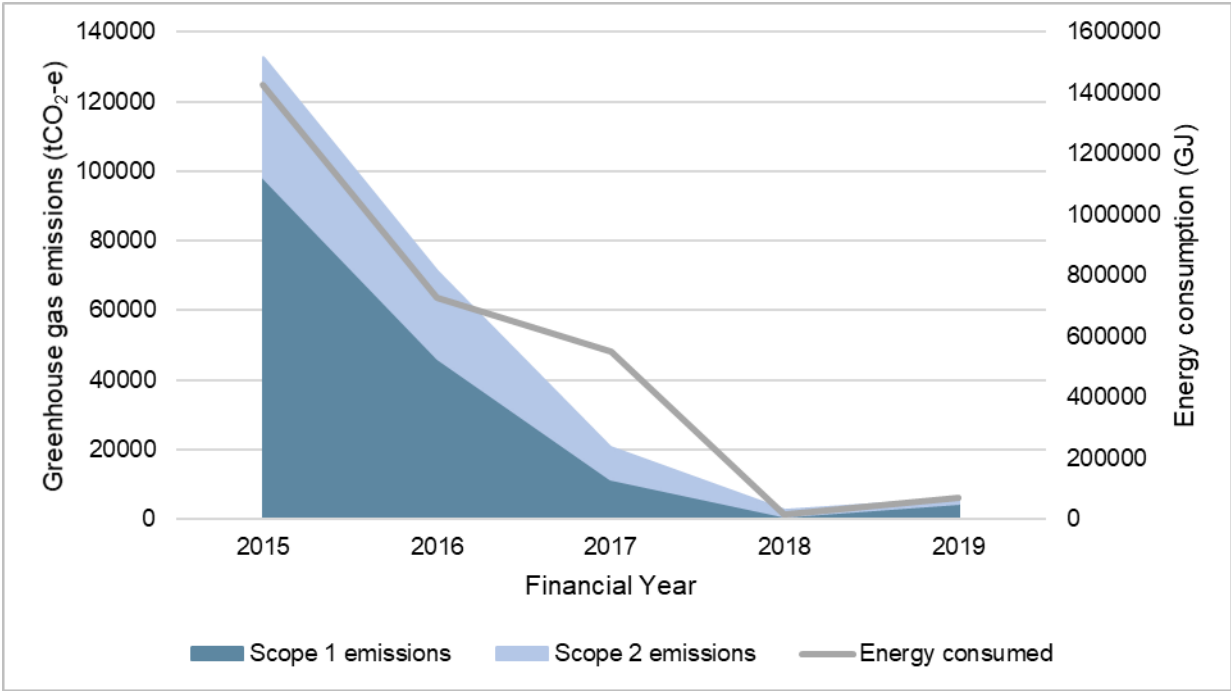
Figure 9. Long-term greenhouse gas emissions and energy consumption

As shown in **Figure 9**, GHG emissions and energy use decreased substantially following the cessation of mining during FY17. In FY19, GHG emissions and energy consumption remained low, but there was an increase in scope 1 emissions and energy use from the previous reporting period. This was due to an increase in the movement of material to achieve final landforms, which required greater diesel use. Diesel use is expected to decrease during the next reporting period as less movement of material is required, resulting in a reduction of GHG emissions and energy use.

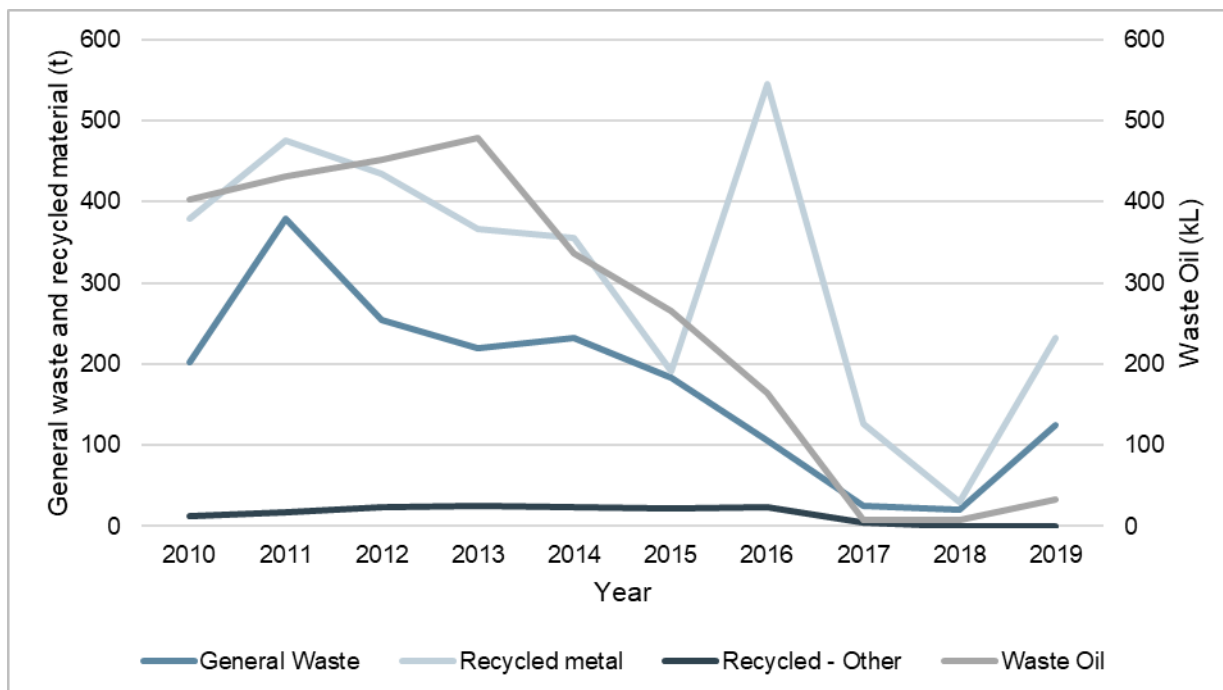
Figure 10. Long-term waste stream quantities

Waste and recycling streams are monitored monthly at the Maxwell Infrastructure site. Quantities of the major waste and recycling streams over the past 10 years are shown in **Figure 10**. This comparison shows that waste significantly reduced with the cessation of mining in late 2016. This is commensurate with the reduction in resource use associated with the reduced operational activity at the site. During this reporting period, there was an increase in waste disposed compared to the previous reporting period. This was due to a focus on removing unused resources on site.

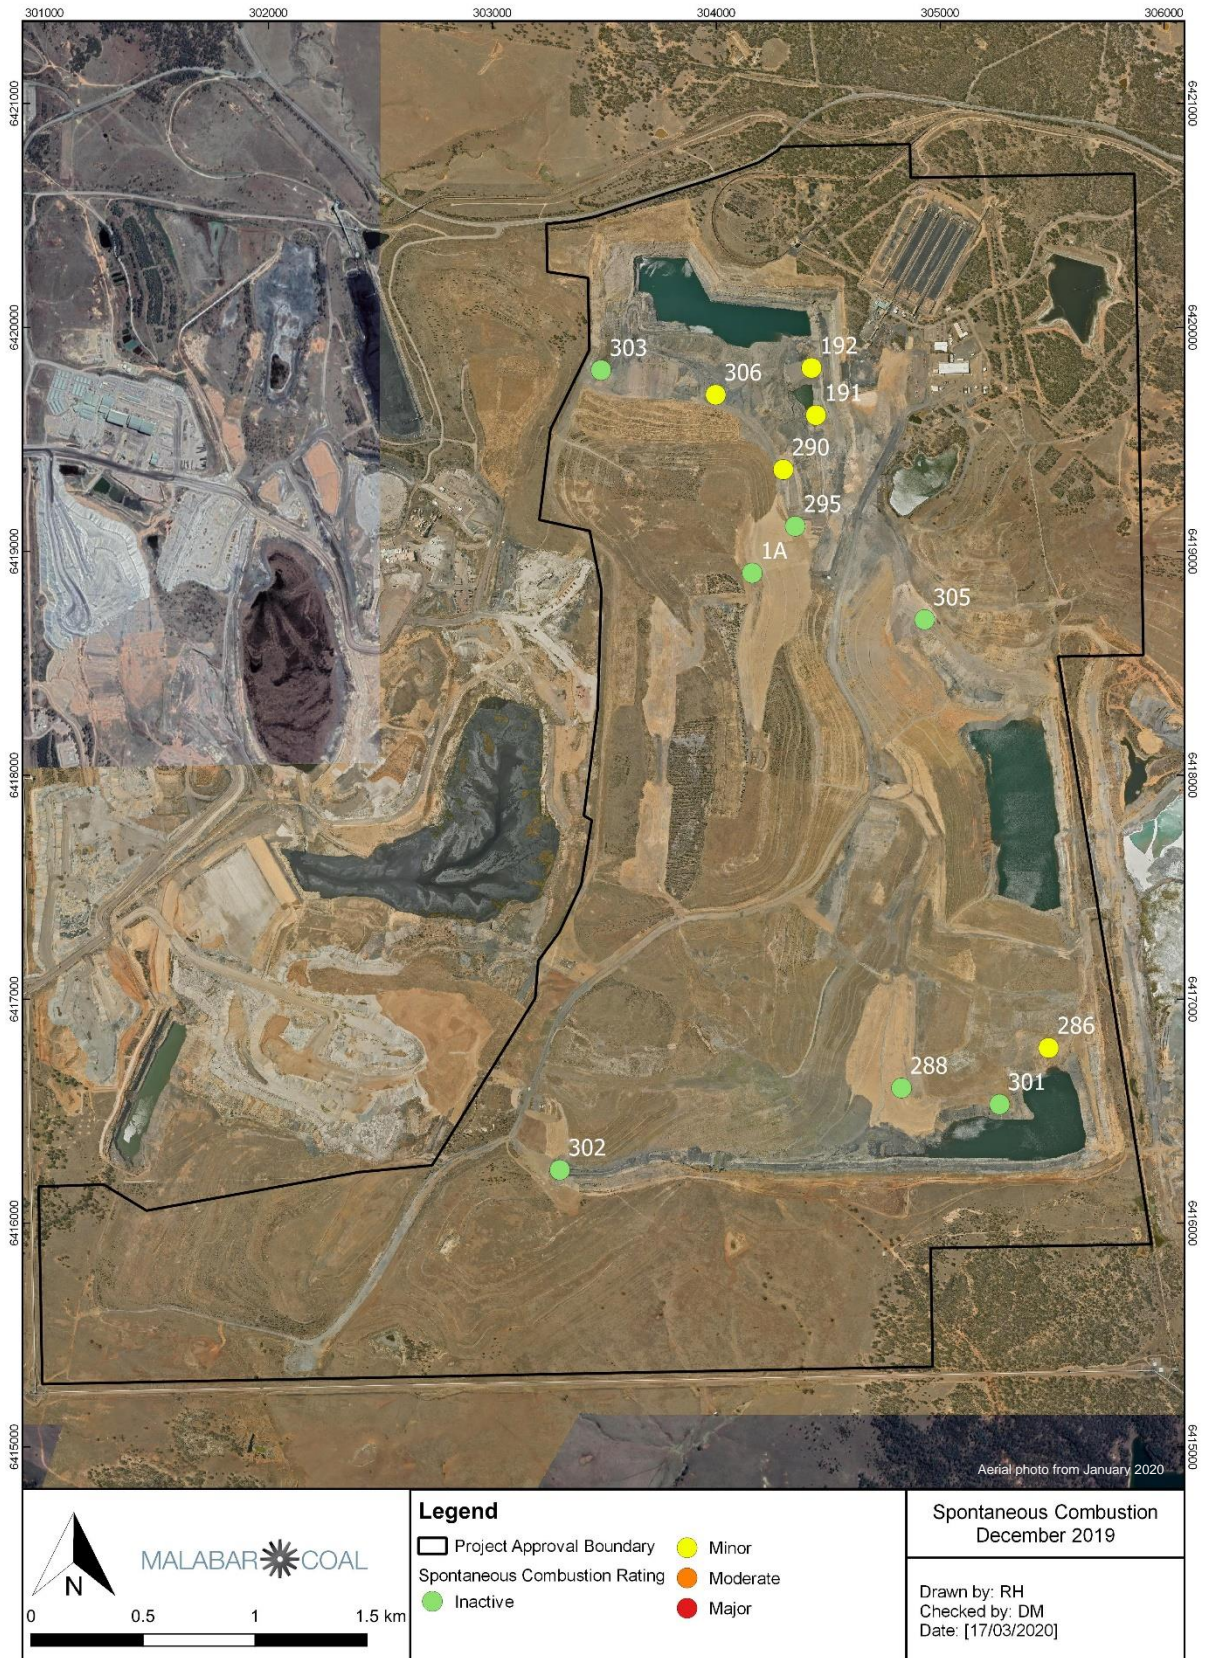
Figure 11. Locations affected by spontaneous combustion

As shown in **Table 10**, approximately 320 m² was estimated to be affected by spontaneous combustion outbreaks across the site at the end of the reporting period. This is less than previous years and reflects the extensive preventative and remedial works undertaken. The annual aerial infrared survey in July 2019 also showed a substantial decrease of 5,894m² in heated areas overall across the site compared to the same survey in September 2018.

Remedial works were also undertaken at areas 191, 1A, 288, 295, 302 and 305 during the reporting period. Works involved pushing out carbonaceous material and capping with inert material. These areas were all inactive at the end of the reporting period. In addition, as a preventative measure, during rehabilitation activities, approximately 61 ha of land was capped with inert material prior to the application of soil ameliorants and seeding.

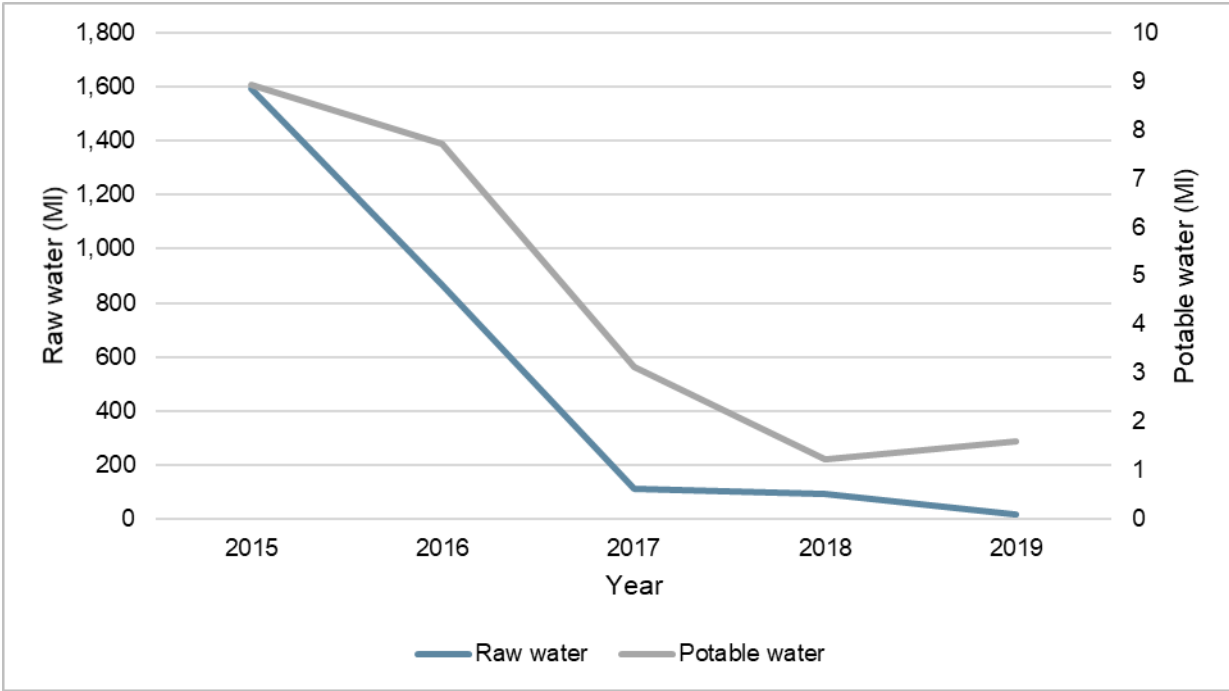
Figure 12. Long-term water consumption

As **Figure 12** shows, water consumption has reduced substantially over the long-term, particularly since mining ceased in 2016. The associated reduction in operational activity has decreased raw water demand and the reduction in the number of people on site has decreased demand for potable water.

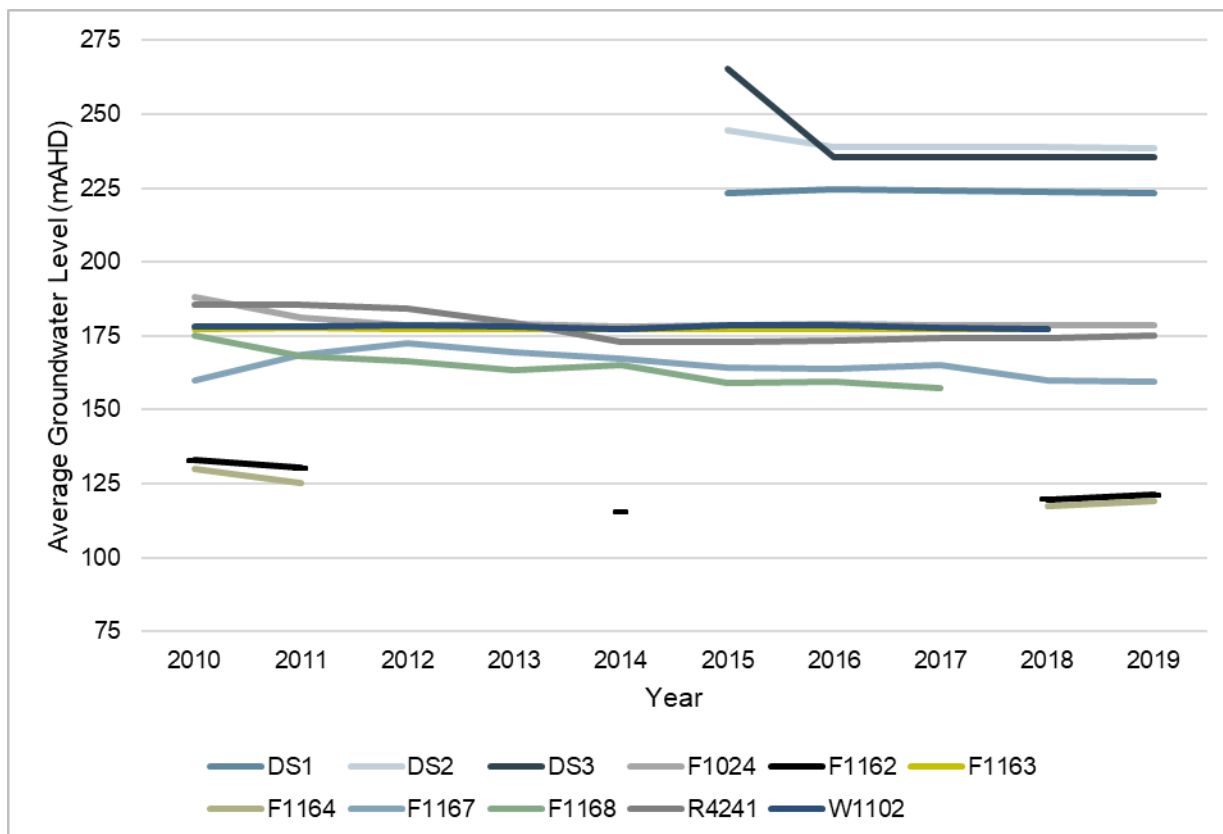
Figure 13. Long-term groundwater levels

Groundwater levels, measured monthly at Maxwell Infrastructure, have remained stable over the reporting period. The long-term groundwater levels at monitoring locations over the past 10 years is displayed in **Figure 13**. This shows that, consistent with the predicted “cone of depression” around the mine area, groundwater levels have lowered or remained stable at monitoring locations surrounding the mine over this time.

The elevation of groundwater levels has also remained above the elevation of the water surface in the voids, indicating that there is likely to be an inflow of aquifer water into the voids as predicted in the EA and supported by the site water balance model discussed in **Section 8.1**.

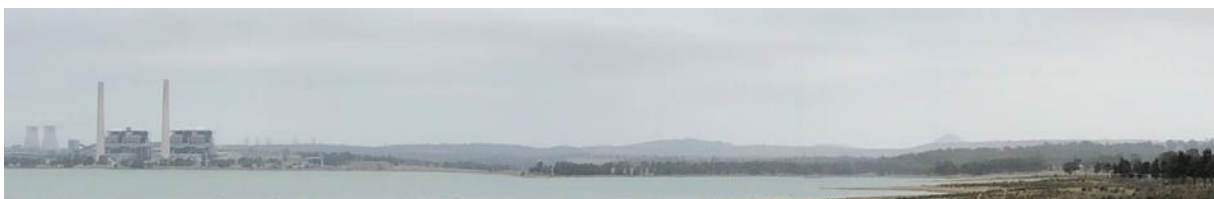
Figure 25. Current view from Lake Liddell

Note. Due to access restrictions the photo in Figure 25 has been taken from a higher vantage.
