# ANNUAL ENVIRONMENTAL MANAGEMENT REPORT

2020

MAXWELL INFRASTRUCTURE

Name of operation	Maxwell Infrastructure
Name of operator	Maxwell Ventures (Management) Pty Ltd
Development consent / project approvals	PA 06_0202, DA 106-04-00
Name of holder of development consent / project approval	Maxwell Ventures (Management) Pty Ltd
Mining leases	A173, CL229, CL395, ML1531
Name of holder of mining leases	Maxwell Ventures (Management) Pty Ltd
Water licences	20BL171953, 20BL171954, 20BL171955, 20BL171956, 20BL171957, 20BL174016, 20BL174017, 20BL174018, WAL 41559, WAL 41491*
Name of holder of water licences	Maxwell Ventures (Management) Pty Ltd *WAL 41491 is held by AGL Macquarie Pty Ltd
MOP start date	1 July 2015
MOP end date	30 June 2021
Annual Review start date	1 January 2020
Annual Review end date	31 December 2020
<p><b>I, Robert Hayes, certify that this audit report is a true and accurate record of the compliance status of Maxwell Infrastructure for the period 1 January 2020 to 31 December 2020 and that I am authorised to make this statement on behalf of Maxwell Ventures (Management) Pty Ltd.</b></p> <p><i>Note.</i></p> <p><i>a) The Annual Review is an 'environmental audit' for the purp

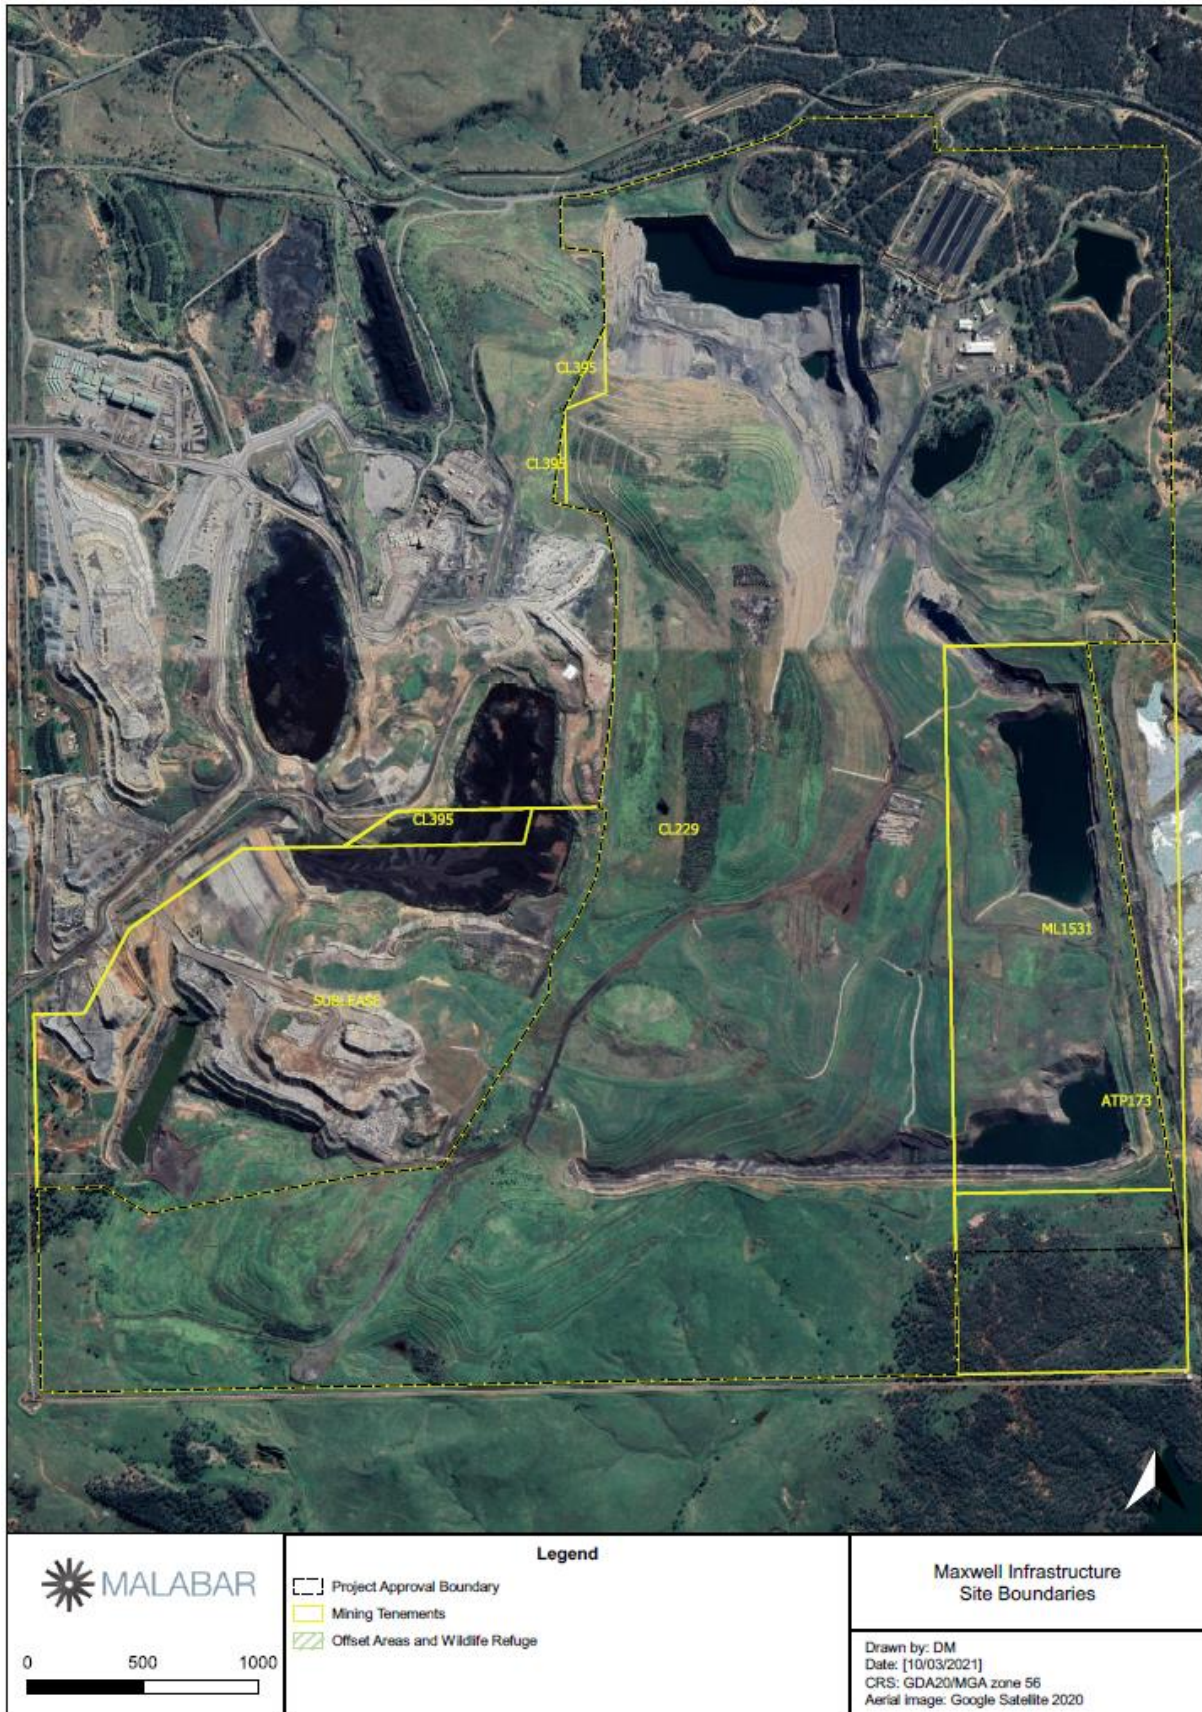
Figure 2. Site boundaries

The regional context of the site is shown in **Figure 1**. The Maxwell Infrastructure site is bordered by Mt Arthur Coal to the west and AGL Macquarie's Bayswater and Liddell Power Stations adjoining the eastern and southern boundaries. The Antiene rural residential area exists to the north of the site. The project approval (PA) boundary, lease boundaries and biodiversity offset areas for the site are shown in **Figure 2**. This figure also shows the current operational disturbance footprint.

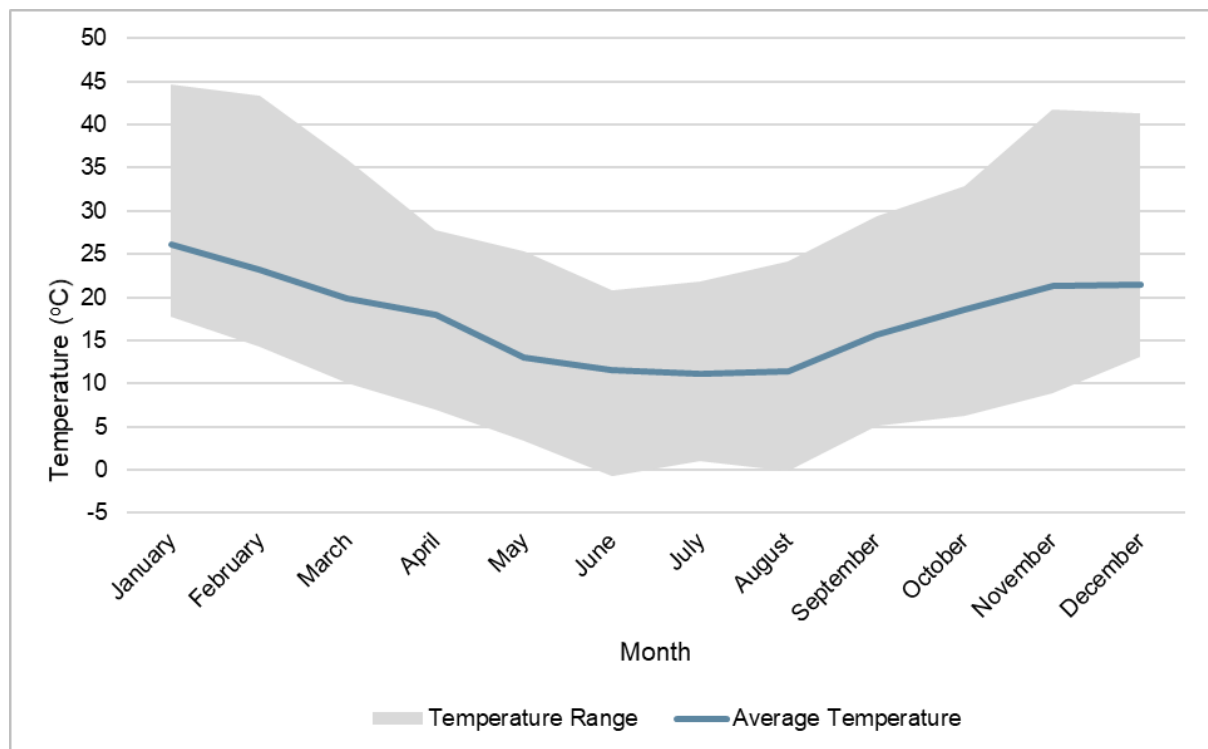
**Figure 3. Temperature by month for the reporting period**

During the reporting period, temperature trends were similar to previous years with a peak in summer and trough in winter. This is shown in **Figure 3**. Average temperatures were similar to the previous five years, being within 1.3 degrees Celsius (°C) of the five-year average for all months. The exception to this was December which was 2.3°C cooler than the five-year average, reflecting the onset of La Niña conditions in late 2020.

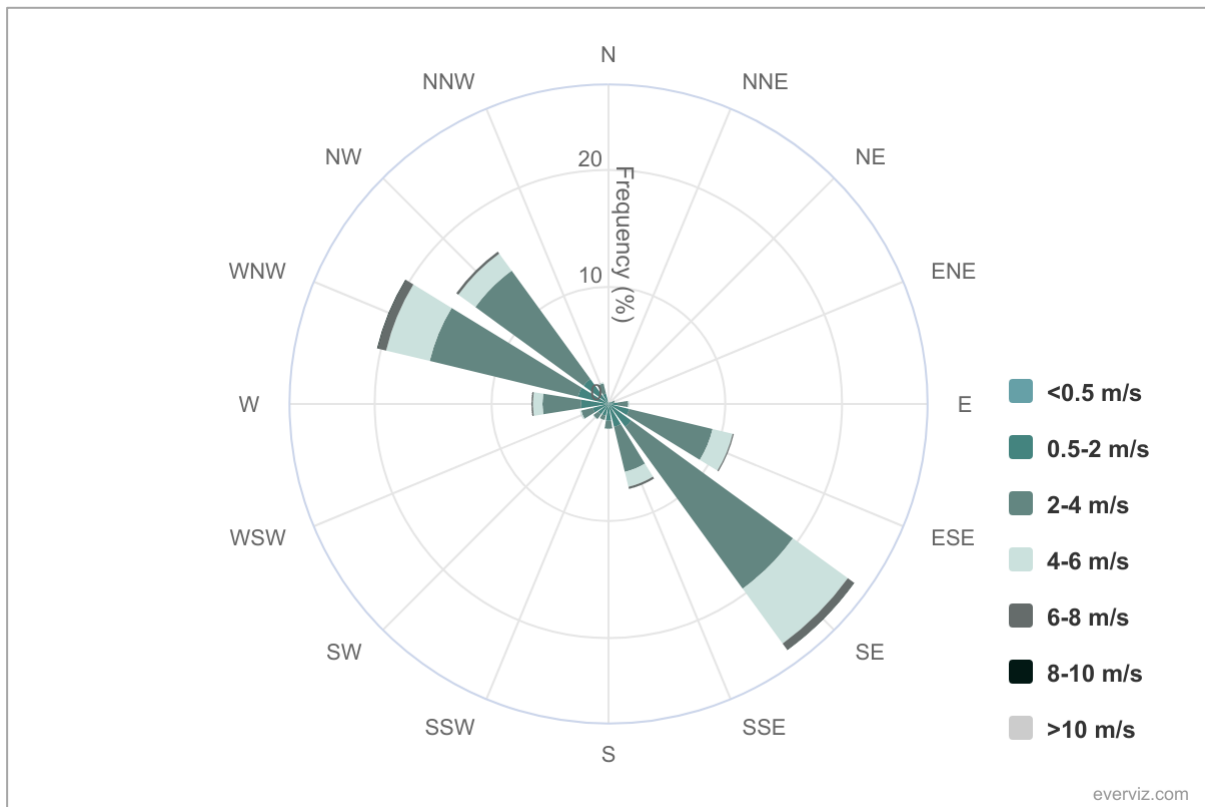
**Figure 4. Wind speed and direction for the reporting period**

A summary of wind monitoring over the reporting period is presented in **Figure 4**. Consistent with previous years, and consistent with the geography of the Hunter Valley, the predominant winds were from the south-east and north-west to west-north-west. As in previous years, winds from the south-east generally dominated during the warmer months and winds from the north-west generally dominated during the cooler months. In total 82 per cent of wind speeds throughout the reporting period were in the range of 0.5 to 4 metres per second (m/s).

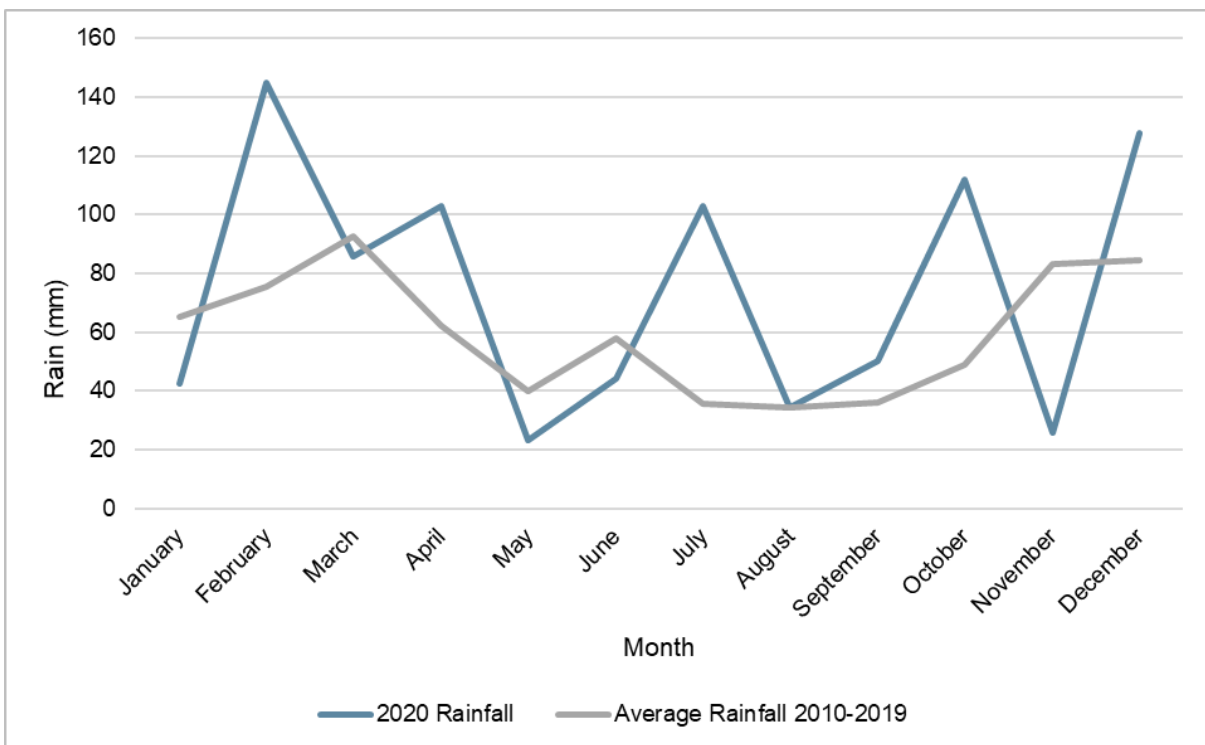
**Figure 5. Rain by month for the reporting period with historic comparison**

Rainfall recorded during the reporting period was above average. This can be seen in **Figure 5**, which shows monthly rainfall during the reporting period compared to the average monthly rainfall for the previous 10 years. The increase in rainfall was consistent with the [NSW State Seasonal Update for December 2020](#), published by the NSW Department of Primary Industries Climate Unit, which noted that the recovery as a result increased rainfall from the 2017 to 2020 drought event continued across most of NSW during December 2020. This reflects the influence of a La Niña event that typically increases the chance of higher than median rainfall across NSW, however high rainfall variability or irregularity can still be

common due to the influence of localised short-term synoptic weather patterns, such as can be seen for November in **Figure 5**.

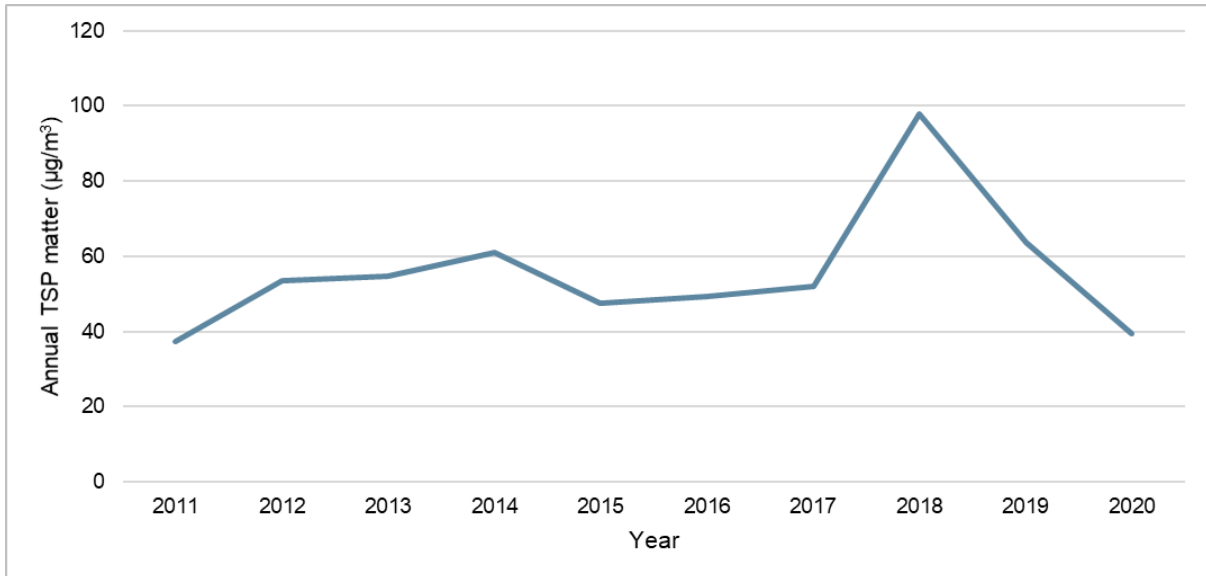
**Figure 6. Long-term results for TSP**

The long-term trend for the annual TSP level, over a 10-year period, is shown in **Figure 6**. The data shows a significant reduction from 2019 which is likely attributed to the higher-than-average rainfall received during 2020 across regional NSW.

The TSP result recorded in 2018 was particularly high. An investigation at the time into the 2018 result found the elevated levels were being influenced by a lessee feeding cattle in an exposed area immediately adjacent to the monitor and were not attributable to impacts from the Maxwell Infrastructure site nor indicative of regional conditions.

*Note: Following investigations, it was determined that the elevated 2018 result was not attributable to impacts from the Maxwell Infrastructure site.*

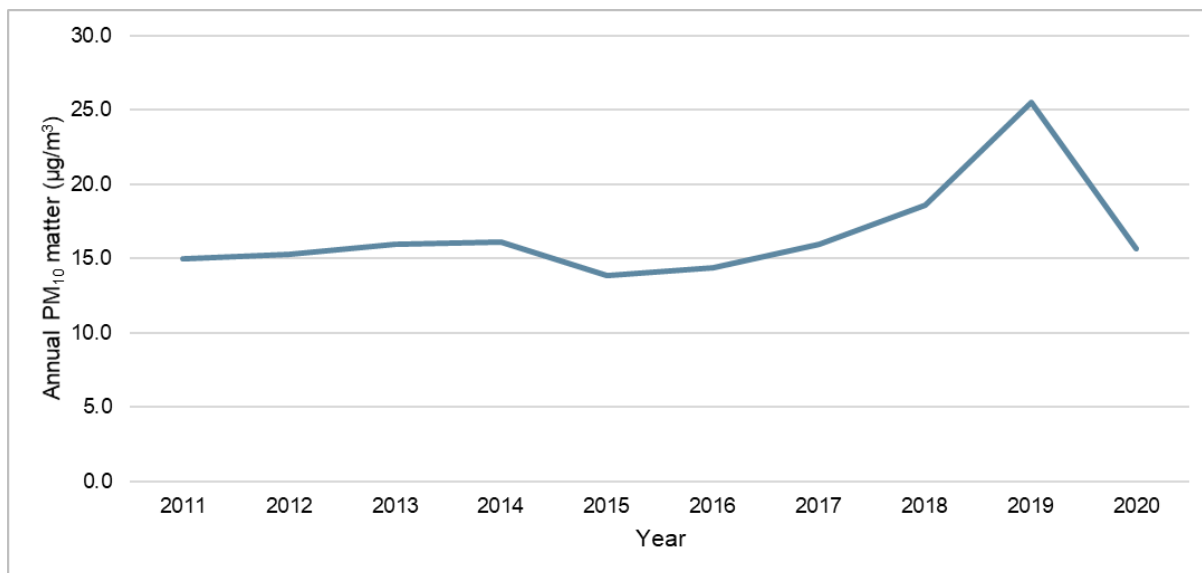
**Figure 7. Long-term results for PM<sub>10</sub>**

With the exception of 2020, the long-term trend in annual PM<sub>10</sub> levels, shown in **Figure 7**, illustrates an upward trend since 2015. This trend is primarily associated with regional air quality, consistent with drought conditions and not attributable to impacts from the Maxwell Infrastructure site, where activities have decreased since mining ceased in October 2016. PM<sub>10</sub> levels monitored by the UHAQMN have shown a similar trend across the region since 2015.

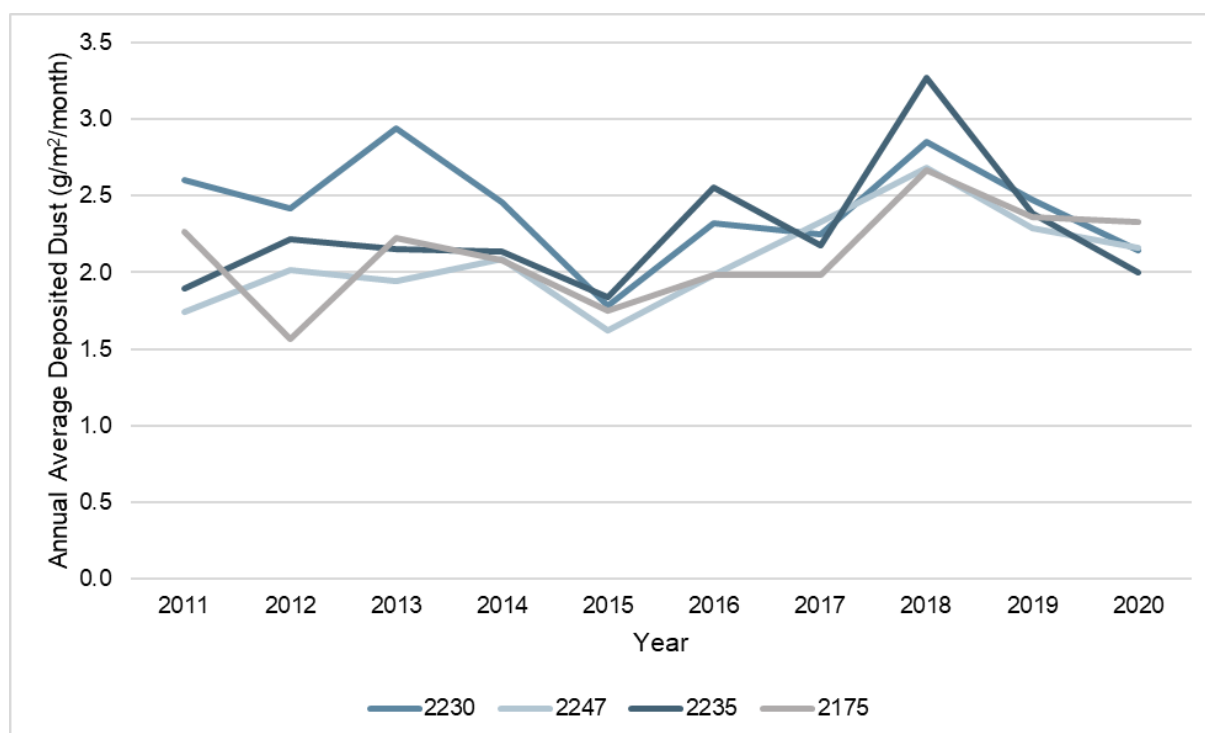
**Figure 8. Long-term results for deposited dust**

The long-term trend in annual average deposited dust levels is shown in **Figure 8**. Like other air quality parameters, deposited dust results were previously trending upwards between 2015 and 2018. This trend was likely to be associated with regional air quality, consistent with drought conditions and not attributable to impacts from the Maxwell Infrastructure site, as activities have decreased significantly since mining ceased in October 2016. Results for 2019 and 2020 show a reduction in deposited dust levels.

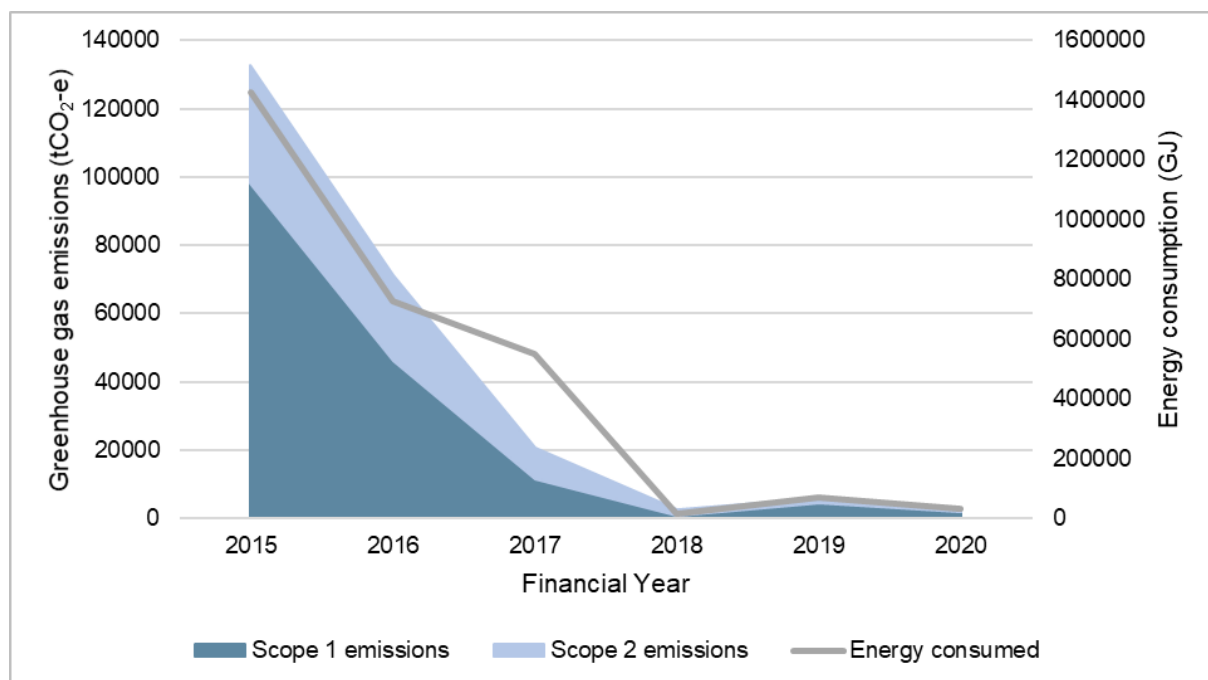
**Figure 9. Long-term greenhouse gas emissions and energy consumption**

As shown in **Figure 9**, GHG emissions and energy use decreased substantially following the cessation of mining during FY17. In FY20, GHG emissions and energy consumption were lower than FY19 reflecting lower diesel usage associated with a lower movement of material to achieve final landforms.

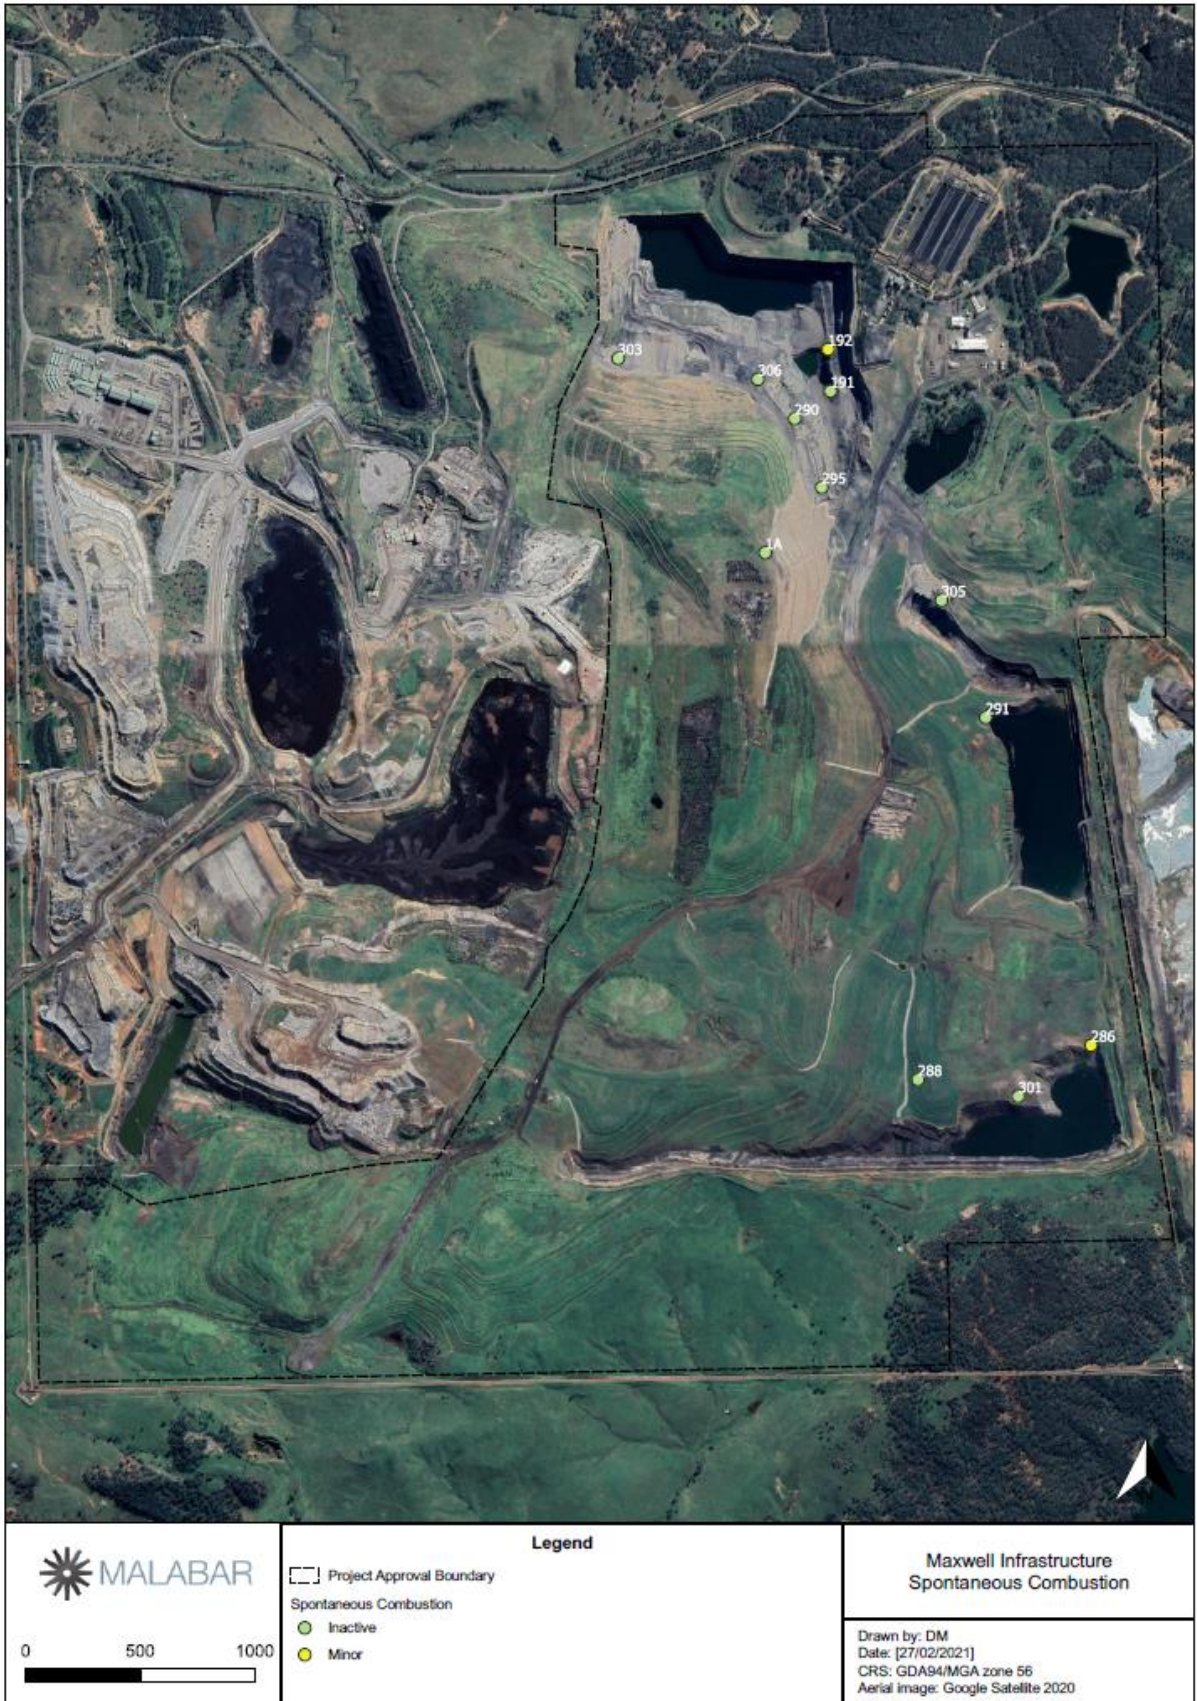
Figure 11. Locations affected by spontaneous combustion

As shown in **Figure 11**, all spontaneous combustion outbreaks identified during the reporting period were inactive or of a minor intensity. Area 191 was subject to capping which was completed in May 2020 and continues to be monitored. Area 305 was subject to remedial works, including capping and seeding. This was completed at the end of the June 2020 and continues to be monitored.

As shown in **Table 10**, approximately 50 m<sup>2</sup> was estimated to be affected by spontaneous combustion outbreaks across the site at the end of the reporting period. This is less than previous years and reflects the extensive preventative and remedial works undertaken over the past number of years. The annual aerial infrared survey in June 2020 allowed confirmation of the success of mitigation works to date in addition to informing planning for future activity.

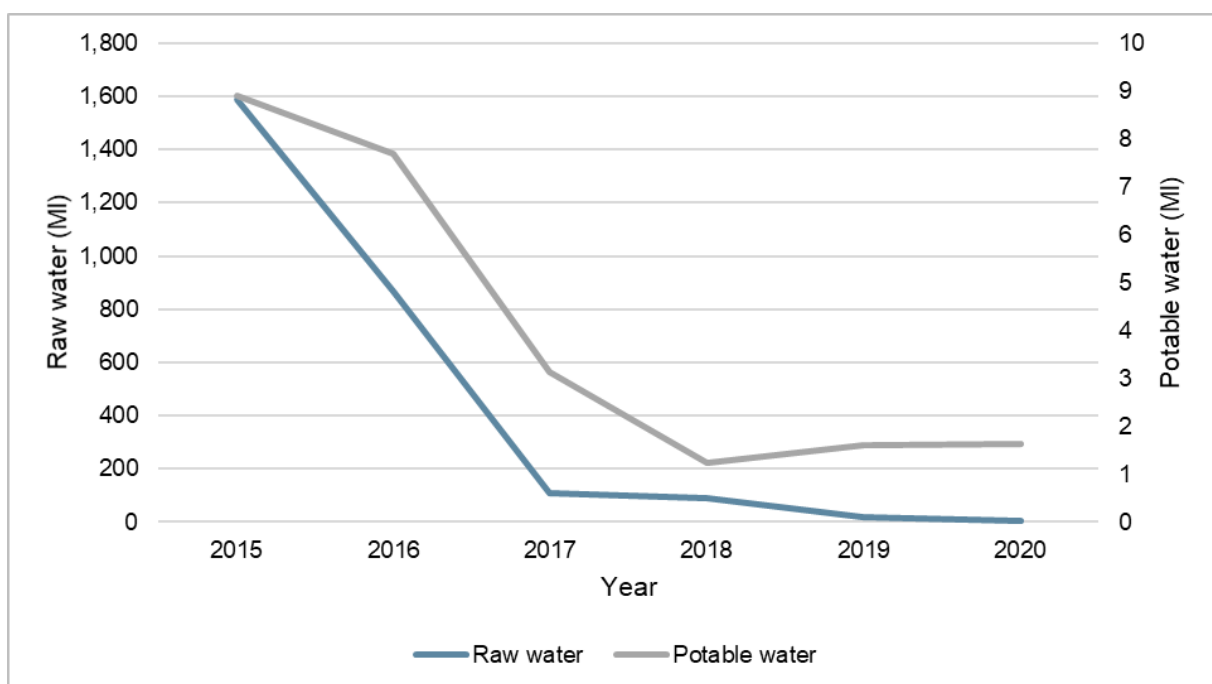
**Figure 12. Long-term water consumption**

As **Figure 12** shows, water consumption has reduced substantially over the long-term, particularly since mining ceased in 2016. The associated reduction in operational activity has decreased raw water demand and the reduction in the number of people on site has decreased demand for potable water.

Water stored on site in storages increased from approximately 12,815 ML to 14,362 ML during the reporting period, indicating that water consumption was well within the limits required to maintain the site's closed raw water system, with no active intake or output of water. This is also demonstrated by the input-output statement of the water accounting framework in **Appendix 8**.

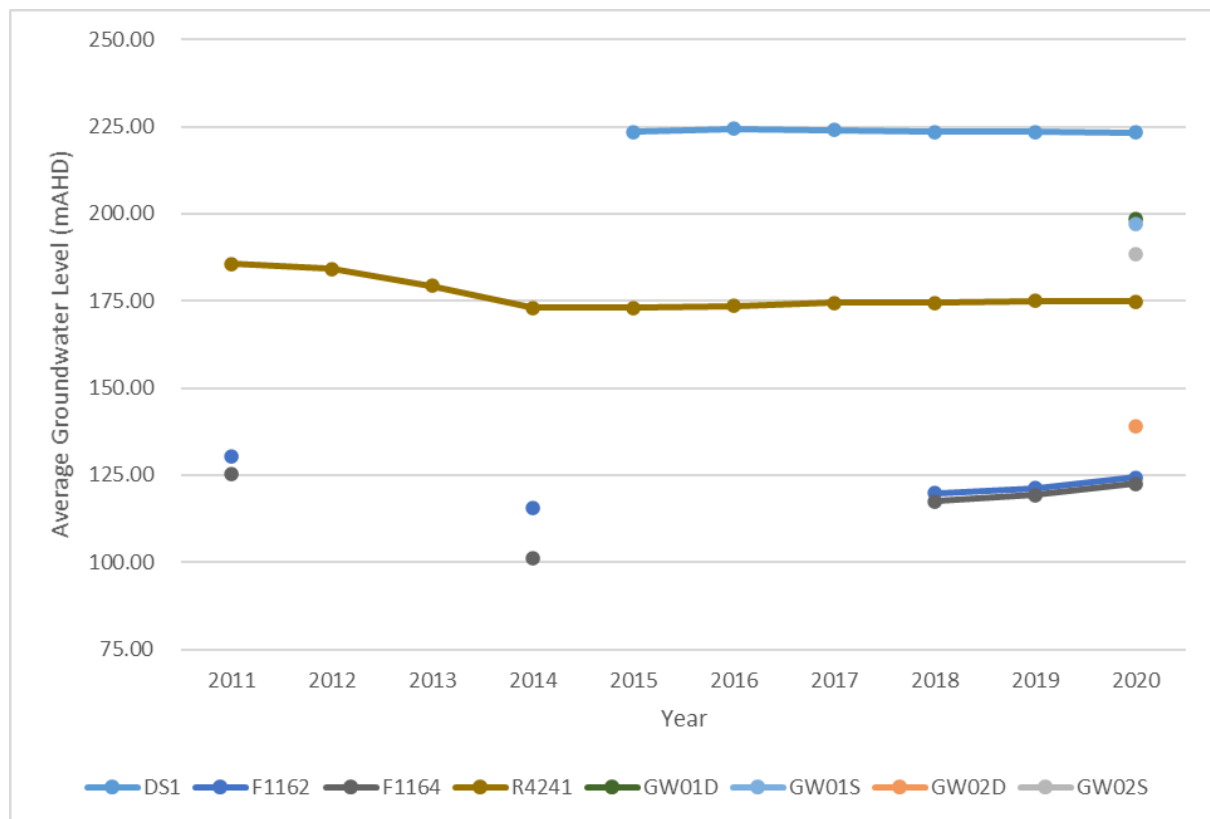
Figure 13. Long-term groundwater levels

Groundwater levels, measured monthly at Maxwell Infrastructure, have remained stable over the reporting period. The long-term groundwater levels at monitoring locations over the past 10 years is displayed in **Figure 13**. This shows that, consistent with the predicted “cone of depression” around the mine area, groundwater levels have lowered or remained stable at monitoring locations surrounding the mine over this time.

The elevation of groundwater levels has also remained above the elevation of the water surface in the voids, indicating that there is likely to be an inflow of aquifer water into the voids as predicted in the EA and supported by the site water balance model discussed in **Section 8.1**.

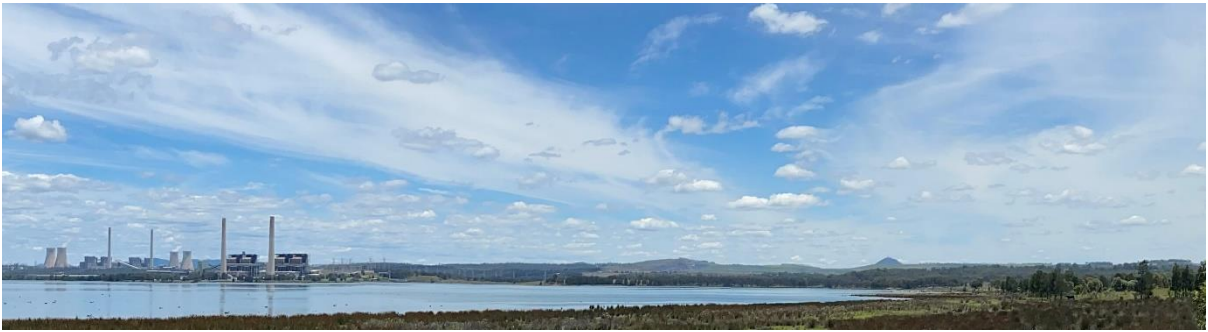
**Figure 25. Current view from Lake Liddell**

**Note. Due to access restrictions the photo in Figure 25 has been taken from a higher vantage.**
