# MAXWELL UNDERGROUND COAL MINE PROJECT

# Annual Review 2021

<b>Name of operation</b>	Maxwell Underground Coal Mine Project
<b>Name of operator</b>	Maxwell Ventures (Management) Pty Ltd
<b>Development consent / project approvals</b>	SSD 9526, PA 06_0202, DA 106-04-00
<b>Name of holder of development consent / project approval</b>	Maxwell Ventures (Management) Pty Ltd
<b>Mining leases</b>	A173, CL229, CL395, ML1531, ML1820, ML1822
<b>Name of holder of mining leases</b>	Maxwell Ventures (Management) Pty Ltd
<b>Water licences</b>	WAL41559, WAL41491*, WAL41234, WAL43166, WAL39739, WAL43160, WAL39792, 20BL171953, 20BL171954, 20BL171955, 20BL171956, 20BL171957, 20BL174016, 20BL174017, 20BL174018
<b>Name of holder of water licences</b>	Maxwell Ventures (Management) Pty Ltd *WAL 41491 is held by AGL Macquarie Pty Ltd
<b>MOP start date</b>	1 July 2021
<b>MOP end date</b>	30 June 2023
<b>Annual Review start date</b>	1 January 2021
<b>Annual Review end date</b>	31 December 2021

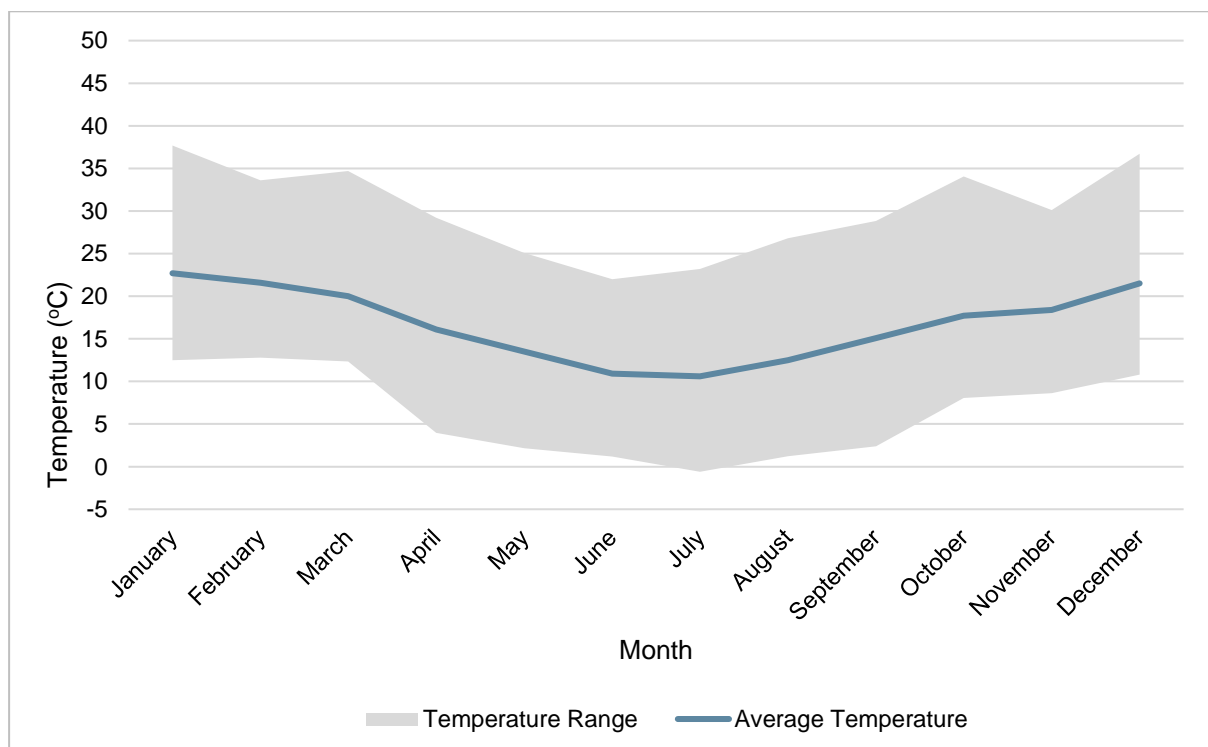
Figure 3. AWS-1 average temperature and temperature range for the reporting period

During the reporting period, temperature trends were similar to previous years with a peak in summer and trough in winter. This is shown in **Figure 3** and **Figure 4**. The average temperatures for AWS-1 were similar to the previous five years, being within 1.5 degrees Celsius (°C) of the five-year average for all months. The exception to this was November which was 8.0 °C cooler than the five-year average, reflecting that this month was the wettest November in NSW since records began in 1900 (source: Australian Government Bureau of Meteorology (BoM)).

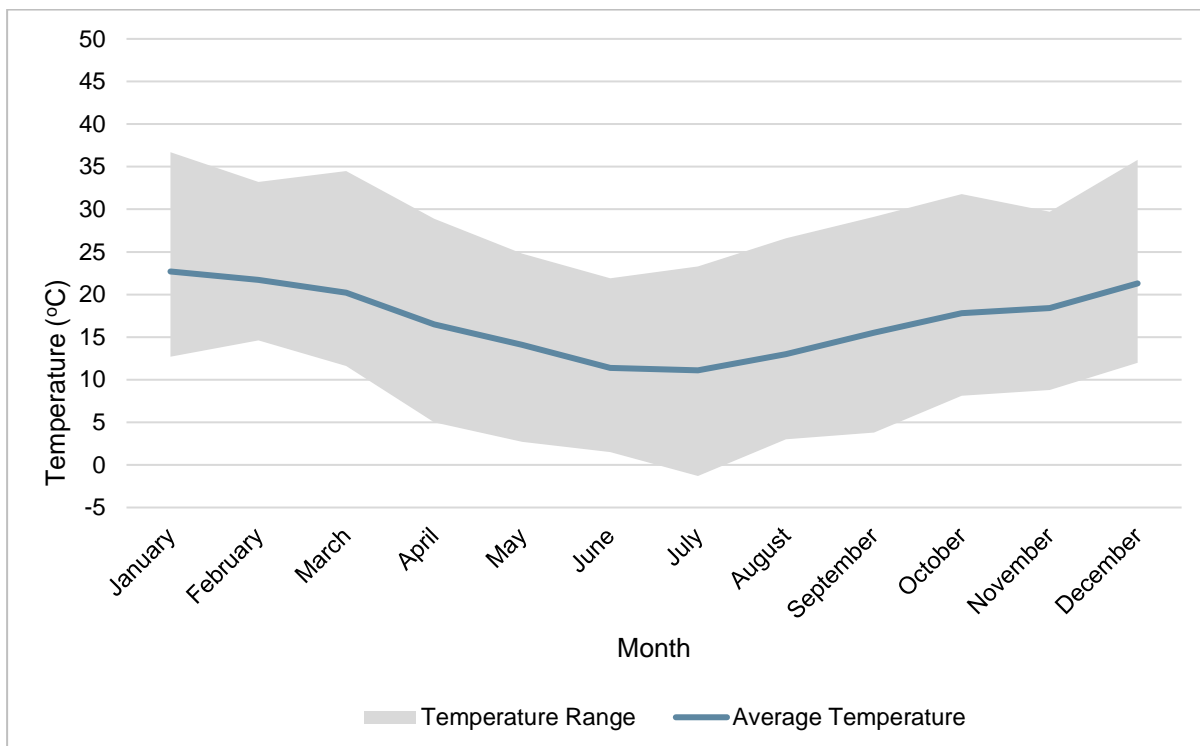
**Figure 4. AWS-2 average temperature and temperature range for the reporting period**

The average temperatures for AWS-2 were also similar to the previous five years, being within 1.91 °C of the five-year average for all months. The exception to this was also November which was 6.2 °C cooler than the five-year average.

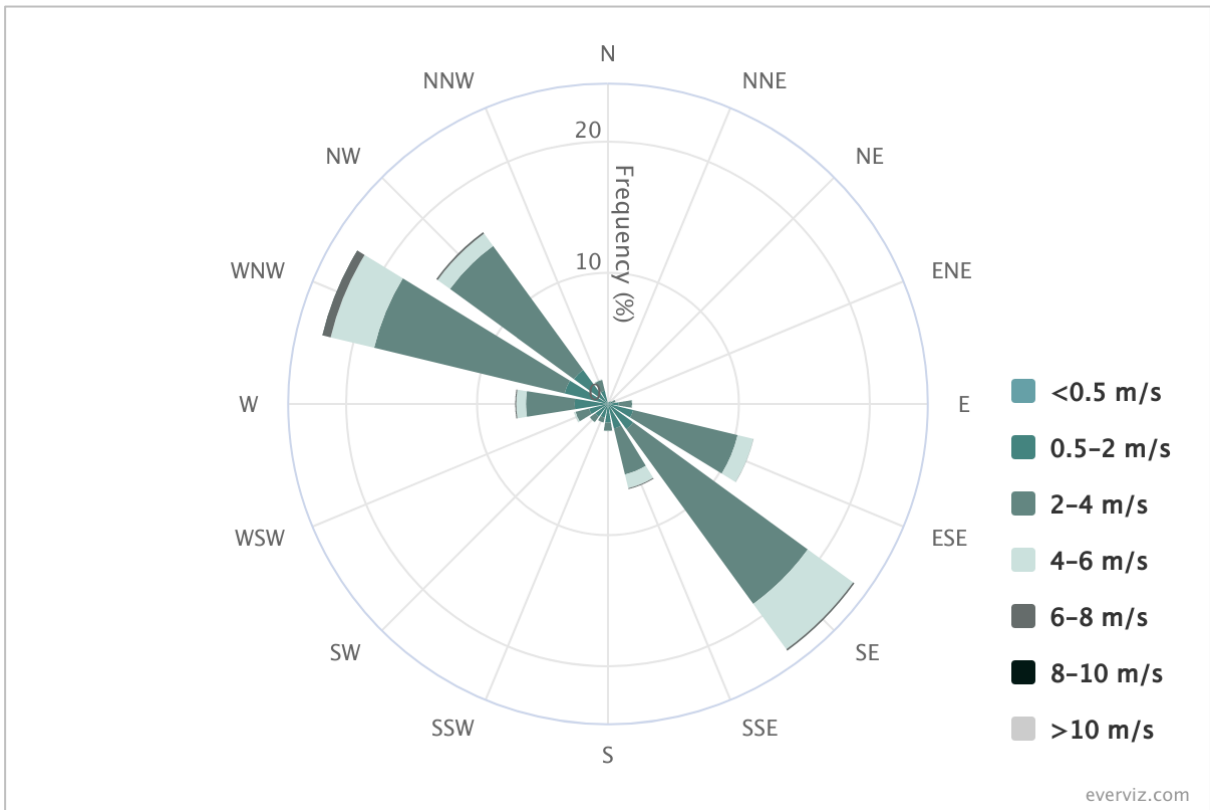
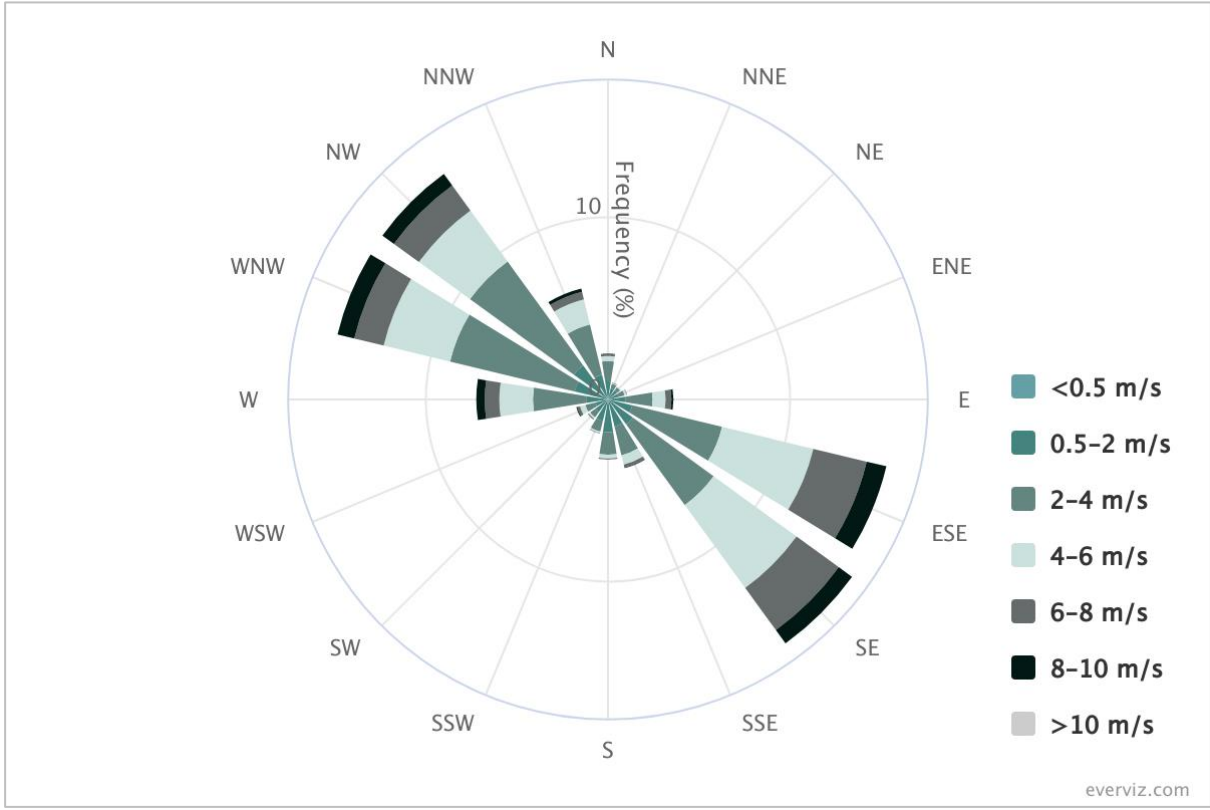
A summary of wind monitoring over the reporting period is presented in **Figure 5** and **Figure 6**. Consistent with previous years, and consistent with the geography of the Hunter Valley, the predominant winds were from the south-east and north-west to west-north-west. As in previous years, winds from the south-east generally dominated during the warmer months and winds from the north-west generally dominated during the cooler months. In total 87 per cent of wind speeds throughout the reporting period were in the range of 0.5 to 4 metres per second (m/s).

Figure 5. Wind speed and direction for the reporting period at AWS-1

Figure 6. Wind speed and direction for the reporting period at AWS-2

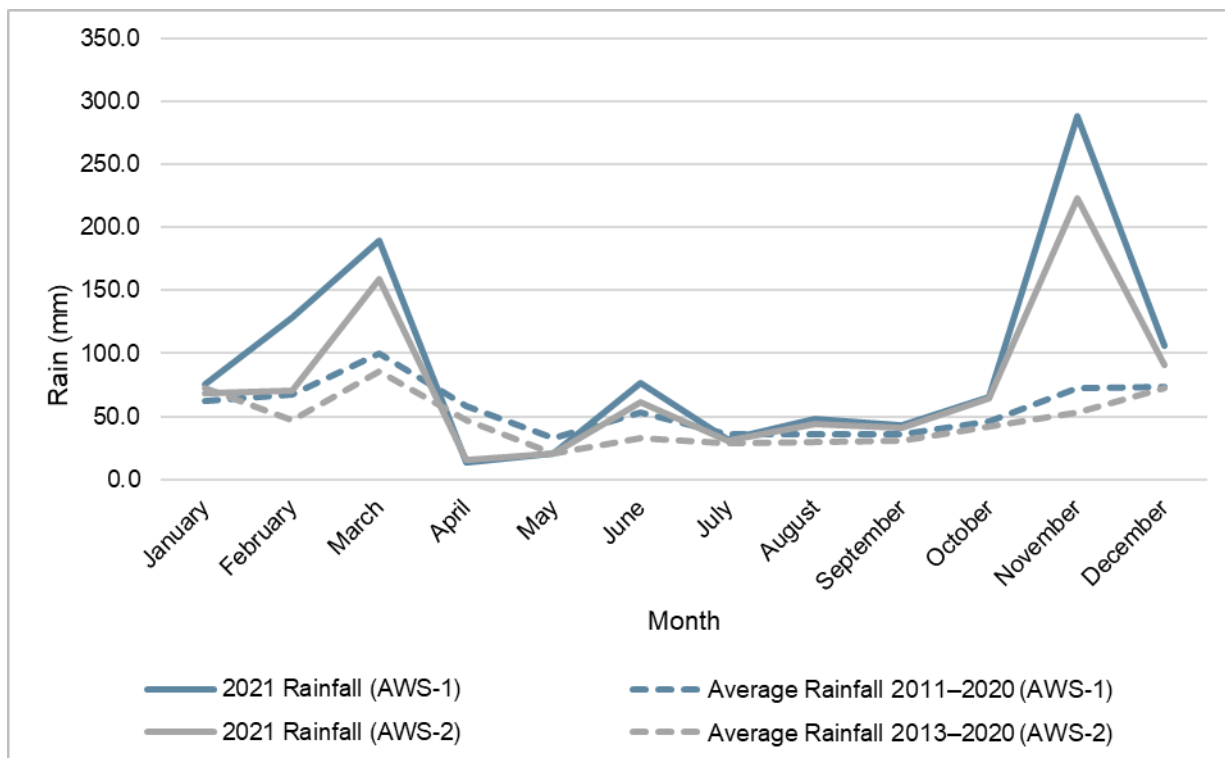
**Figure 7. Rain for the reporting period with historic comparison**

Rainfall recorded during the reporting period was above average. This can be seen in **Figure 7** which shows monthly rainfall during the reporting period compared to the average monthly rainfall for the previous 10 years. The increase in rainfall was consistent with the [NSW State Seasonal Update for December 2021](#), published by the NSW Department of Primary Industries Climate Unit, which noted that most of NSW is currently in non-drought. November 2021 had an exceptionally high rainfall, and the BoM advised in Special Climate Statement 75 that it was Australia's wettest November on record. The extremely wet conditions were primarily associated with a developing La Niña in the Pacific Ocean that typically increases the chance of higher than median rainfall across NSW. However high rainfall variability or irregularity can still be common due to the influence of localised short-term synoptic weather patterns, such as can be seen for April in **Figure 7** when lower than average rainfall occurred.

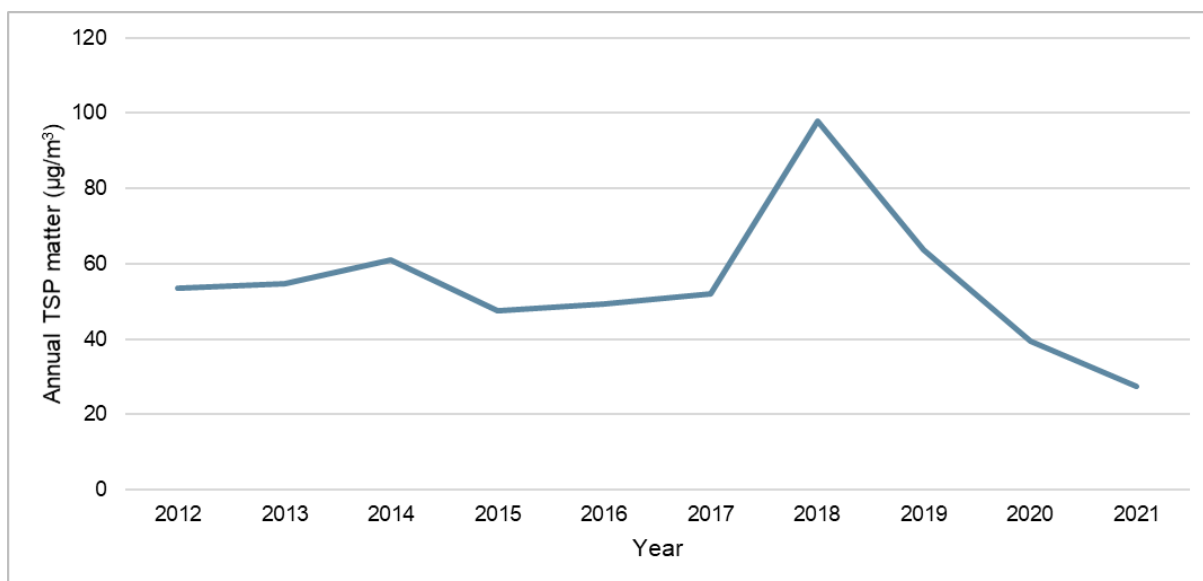
**Figure 8. Long-term results for TSP calculated from PM<sub>10</sub> results at TEOM-1**

The long-term trend for the annual TSP level, over a 10-year period, is shown in **Figure 8**. The data shows a significant reduction from 2019 which is likely attributed to the higher-than-average rainfall received during 2020 and 2021 across regional NSW in addition to the cessation of widespread bushfires in 2019–20.

The TSP result recorded in 2018 was particularly high. An investigation at the time into the 2018 result found the elevated levels were being influenced by a lessee feeding cattle in an exposed area immediately adjacent to the monitor and were not attributable to impacts from the site nor indicative of regional conditions.

*Notes: Following investigations, it was determined that the elevated 2018 result was not attributable to impacts from the Maxwell Infrastructure site.*

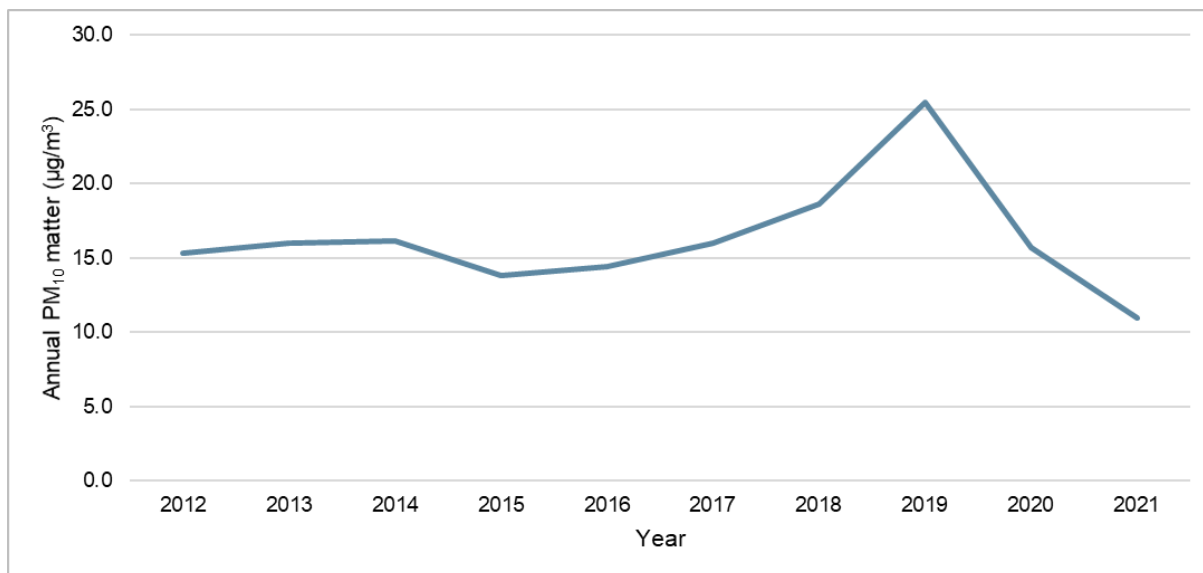
**Figure 9. Long-term results for PM<sub>10</sub> at TEOM-1**

All 24-hour PM<sub>10</sub> levels for the reporting period are presented in **Appendix 4**. The 24-hour criterion of 50 micrograms per cubic metre (µg/m<sup>3</sup>) was not exceeded on any day during the reporting period.

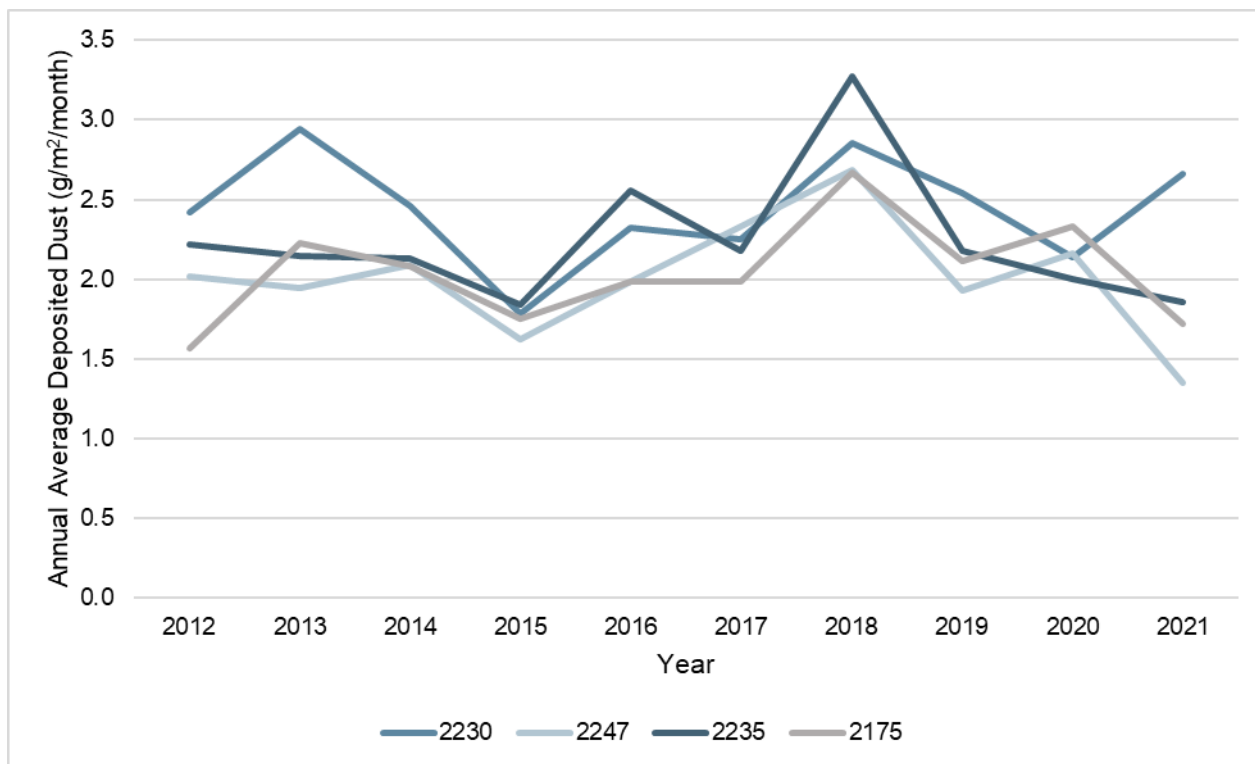
**Figure 10. Long-term results for deposited dust**

The long-term trend in annual average deposited dust levels is shown in **Figure 10**. Like other air quality parameters, deposited dust has been trending down since 2018 consistent with drought conditions and not attributable to impacts from the Maxwell UG Project, as activities have decreased significantly since open cut mining ceased in October 2016.

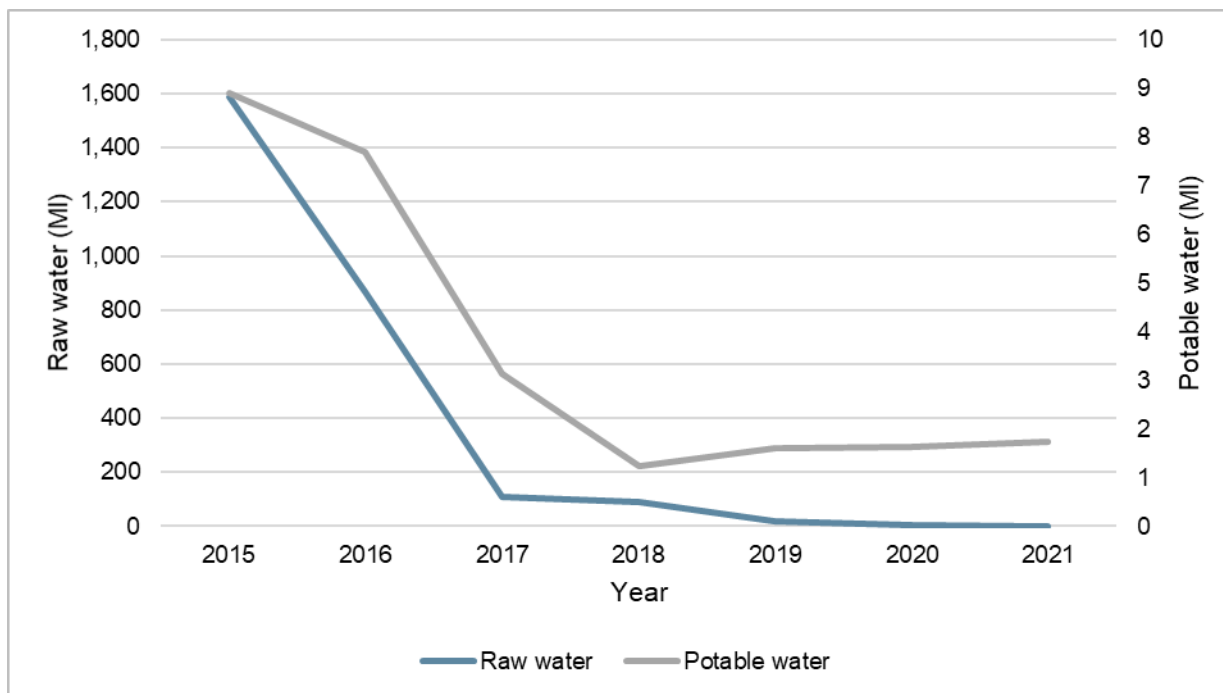
Figure 14. Long-term water consumption

As **Figure 14** shows, water consumption has reduced over the long-term, particularly since open cut mining ceased in 2016. The reduction in operational activity has decreased raw water demand and the reduction in the number of people on site has decreased demand for potable water.

Water stored on site increased from approximately 14,362 ML to 16,727 ML during the reporting period, indicating that water consumption was well within the limits required to maintain the site's closed raw water system, with no active intake or output of water. This is also demonstrated by the input-output statement of the water accounting framework in **Appendix 8**.

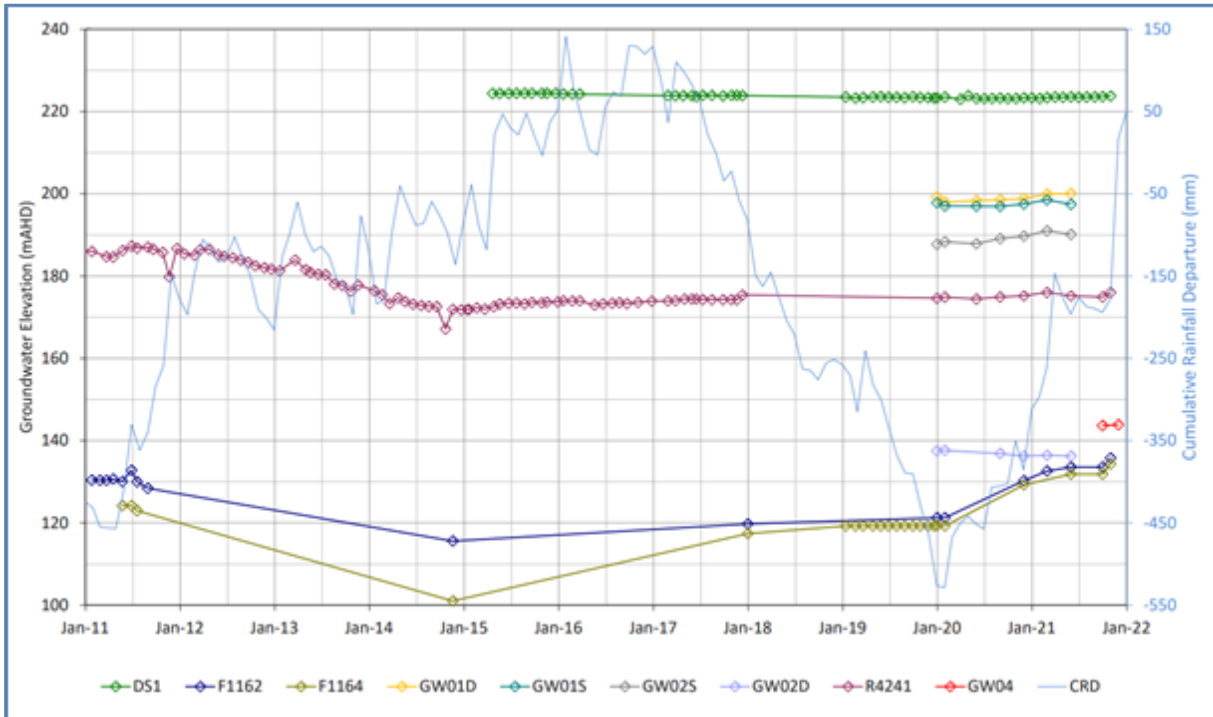
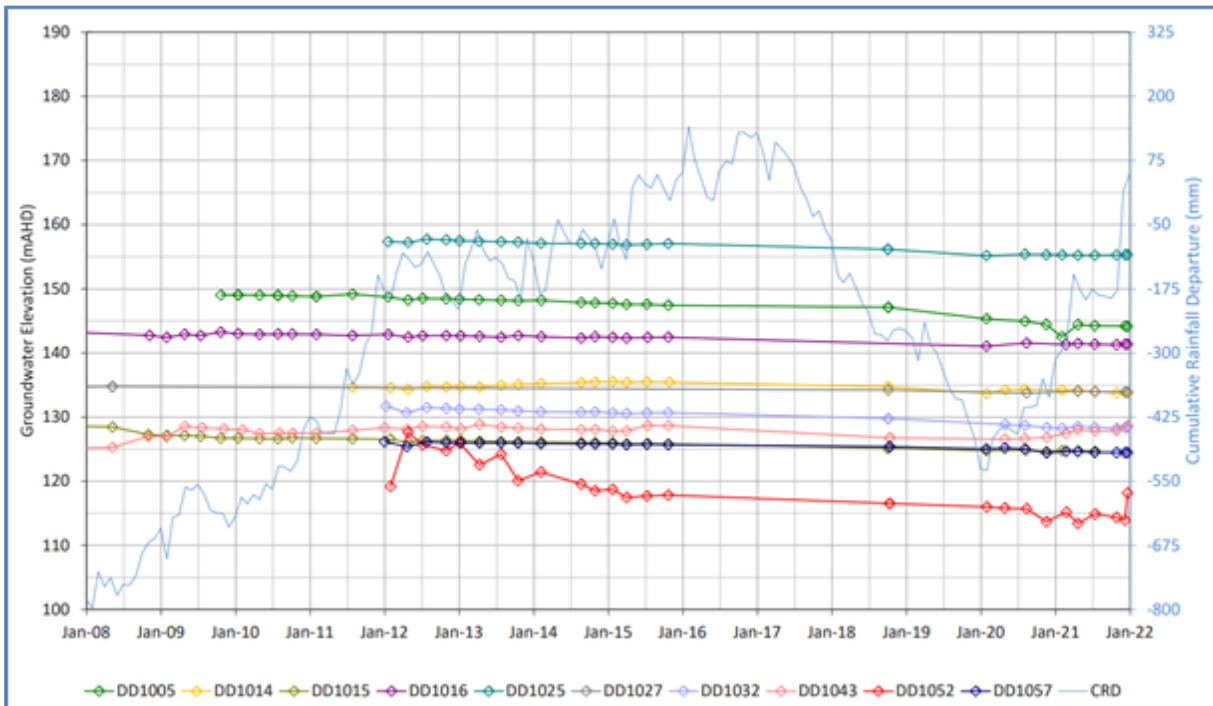
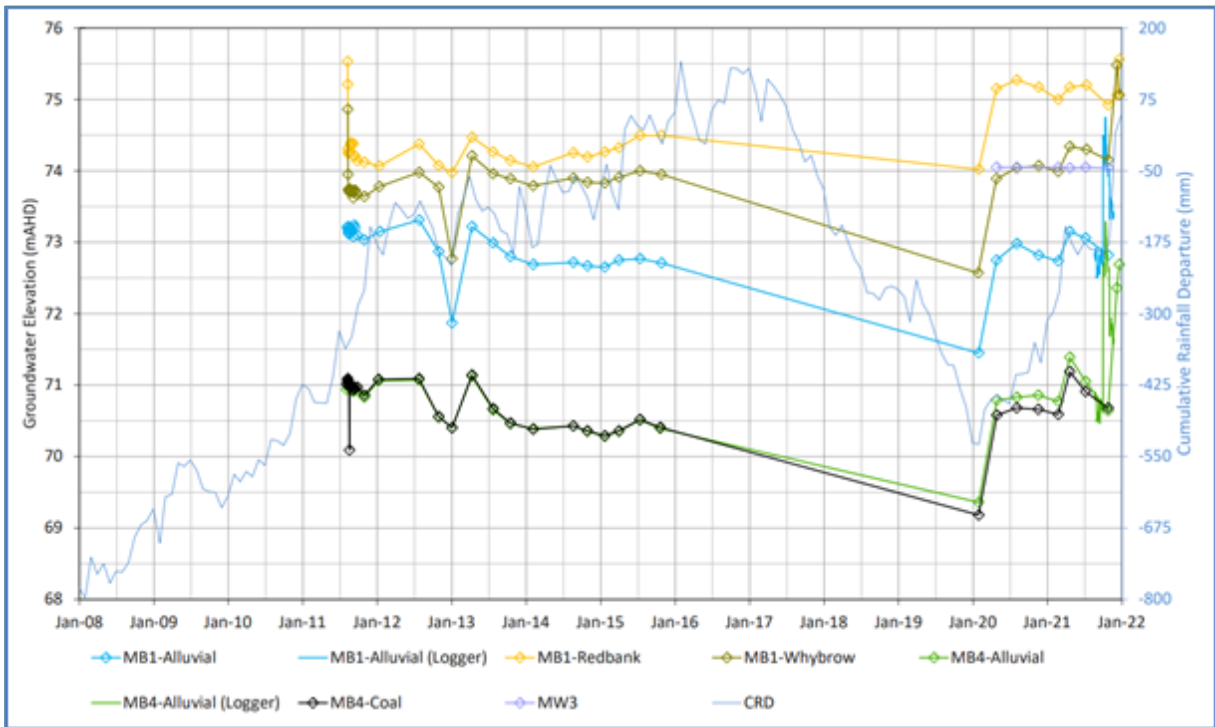
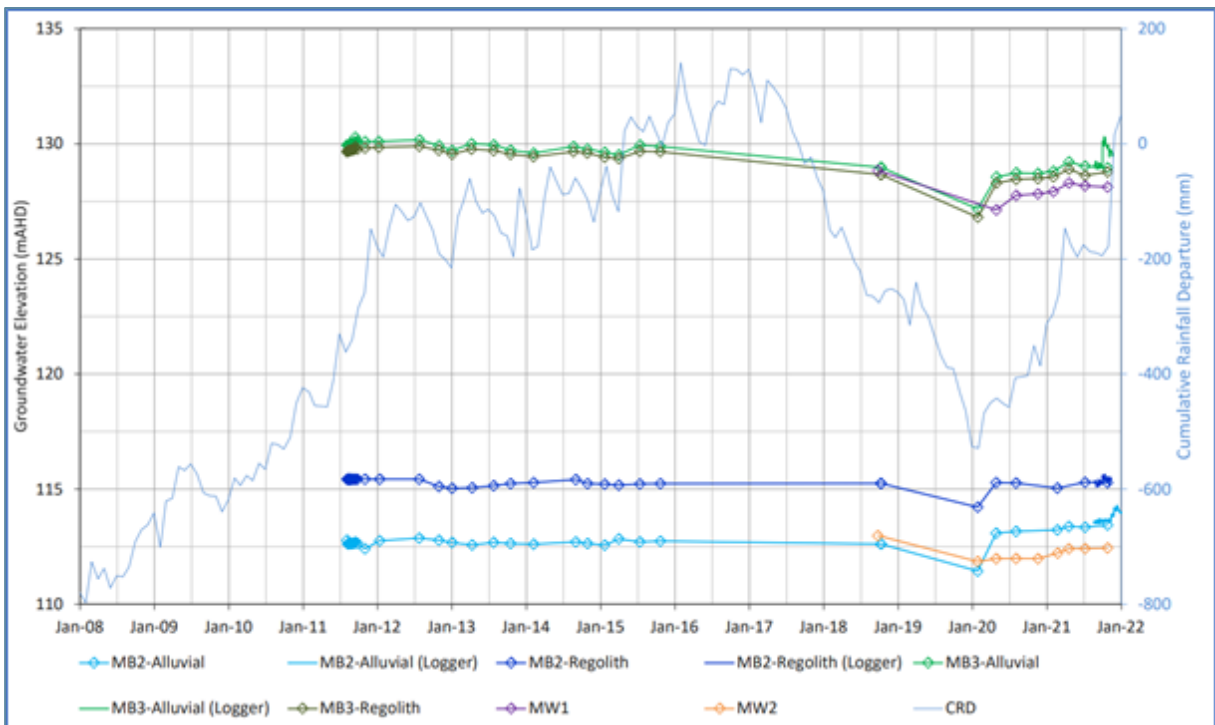
and increases in water levels over the reporting period generally reflect the significantly higher than average rainfall in 2021.

The elevation of groundwater levels has also remained above the elevation of the water surface in the voids, indicating that there is likely to be an inflow of aquifer water into the voids as predicted in the EA and supported by the site water balance model discussed in **Section 8.1**.

Figure 15. Long-term groundwater levels – Maxwell Infrastructure

Figure 16. Long-term groundwater levels – Maxwell Underground – non-alluvial (generally deeper) bores

Figure 17. Long-term groundwater levels – Maxwell Underground – Hunter River Catchment bores

Figure 18. Long-term groundwater levels – Maxwell Underground – Saddlers Creek bores
