# MAXWELL UNDERGROUND MINE

# Annual Review 2022

<b>Name of operation</b>	Maxwell Underground Mine
<b>Name of operator</b>	Maxwell Ventures (Management) Pty Ltd
<b>Development consent / project approvals</b>	SSD 9526, PA 06_0202, DA 106-04-00
<b>Name of holder of development consent / project approval</b>	Maxwell Ventures (Management) Pty Ltd
<b>Mining leases</b>	A173, CL229, CL395, ML1531, ML1820, ML1822
<b>Name of holder of mining leases</b>	Maxwell Ventures (Management) Pty Ltd
<b>Water licences</b>	WAL41559, WAL41491*, WAL41234, WAL43166, WAL39739, WAL43160, WAL39792, 20BL171953, 20BL171954, 20BL171955, 20BL171956, 20BL171957, 20BL174016, 20BL174017, 20BL174018
<b>Name of holder of water licences</b>	Maxwell Ventures (Management) Pty Ltd *WAL 41491 is held by AGL Macquarie Pty Ltd
<b>Forward Program start date</b>	3 February 2022
<b>Forward Program end date</b>	2 February 2025
<b>Annual Review start date</b>	1 January 2022
<b>Annual Review end date</b>	31 December 2022

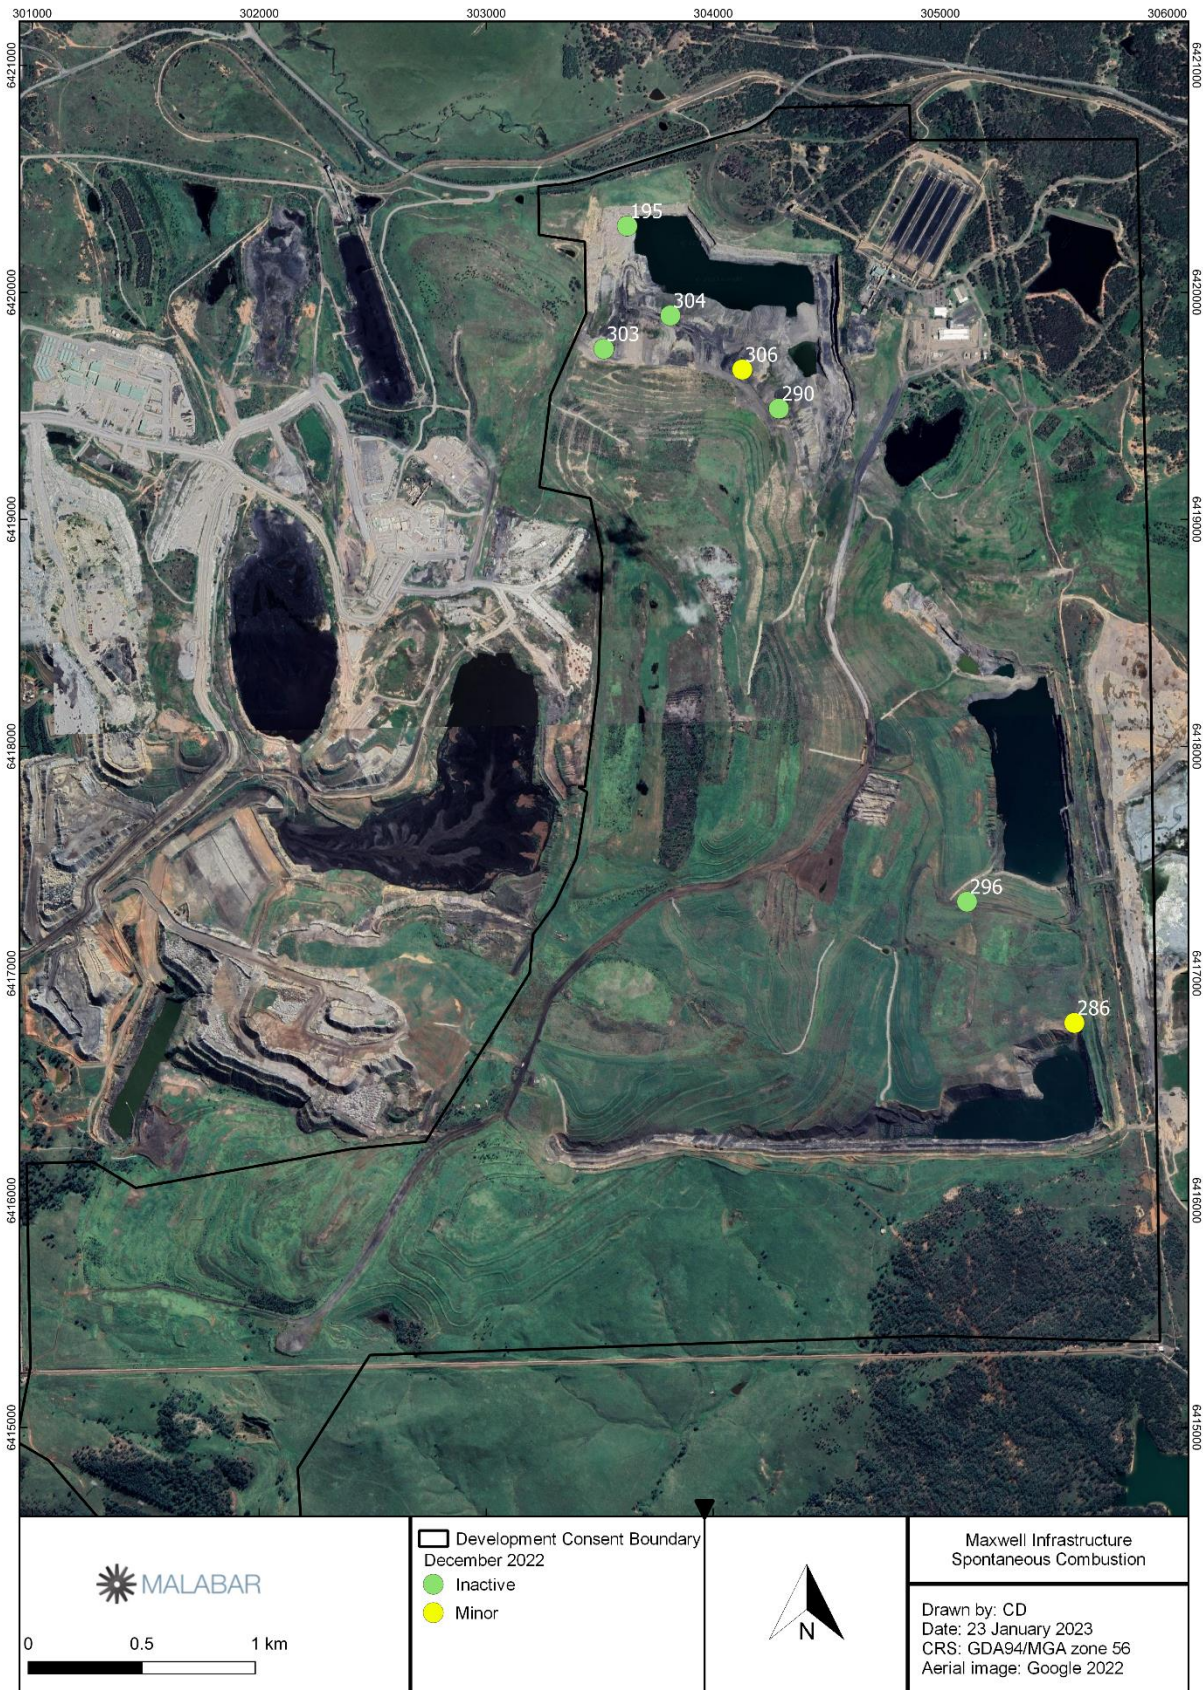
Figure 12. Locations affected by spontaneous combustion at the end of the reporting period

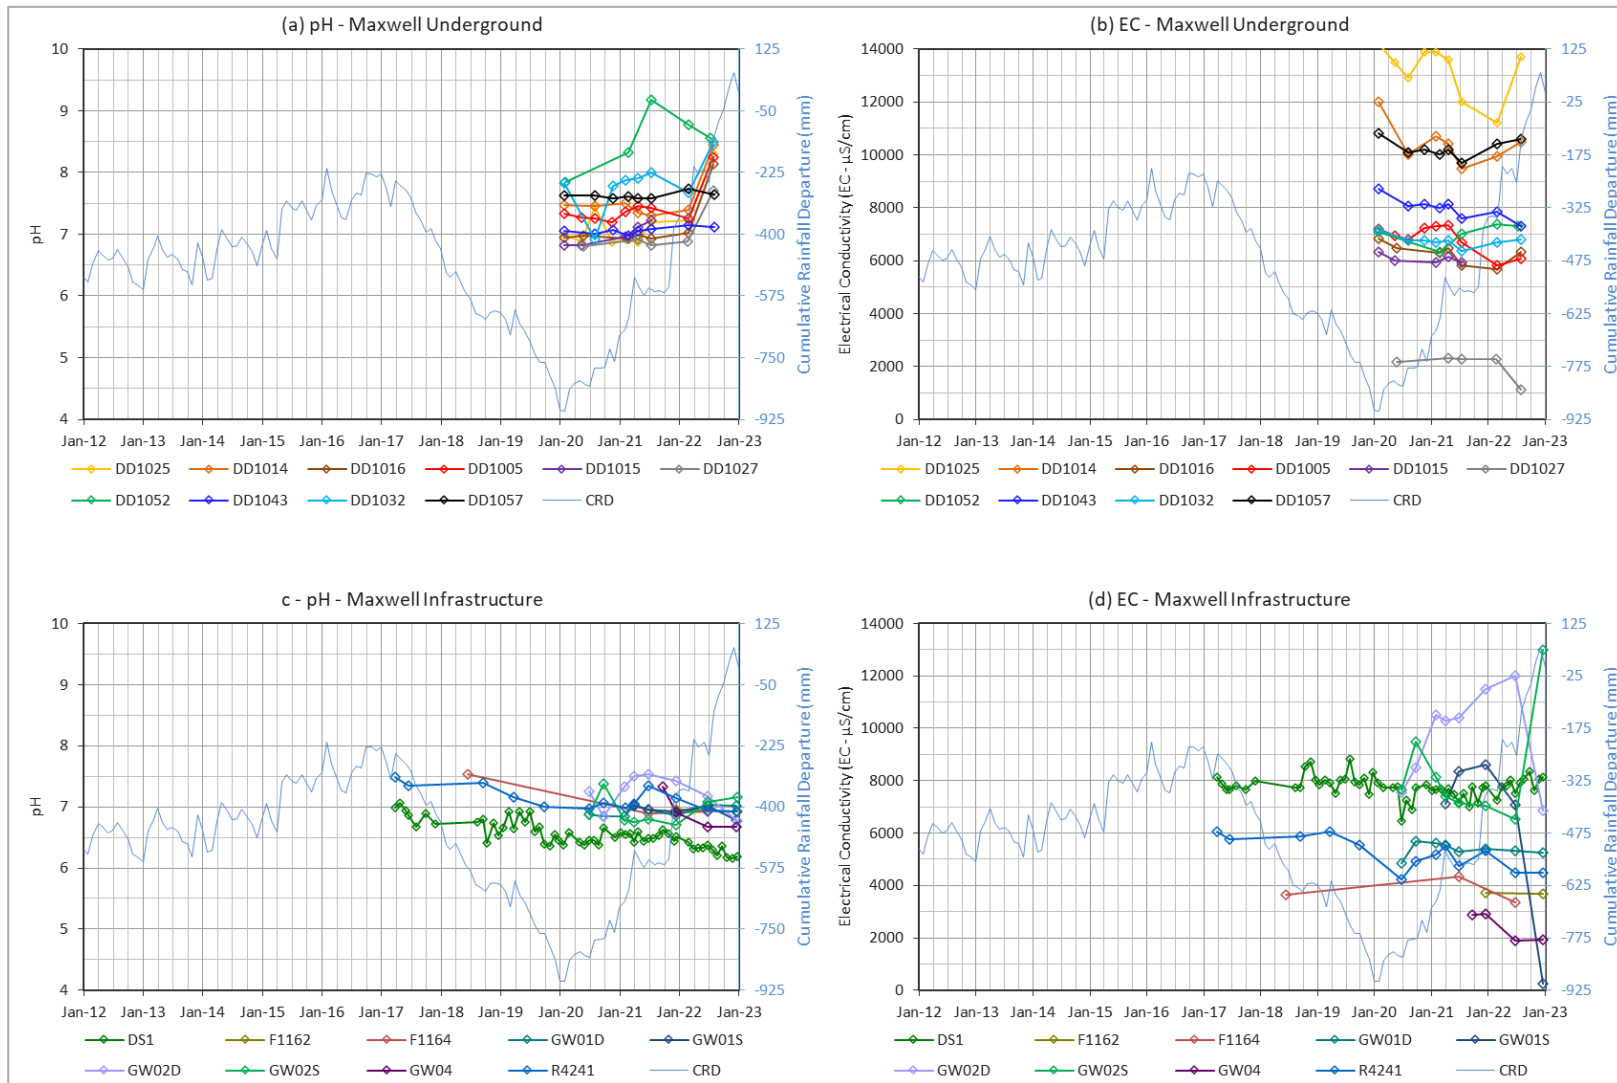
Figure 23 Groundwater pH and Electrical Conductivity (EC) across Maxwell Underground Mine and Maxwell Infrastructure
