# ANNUAL ENVIRONMENTAL MANAGEMENT REPORT -2013 (AMENDED) DRAYTON MINE

# Annual Environmental Management Report - 2013

Name of Mine:	ANGLO COAL (DRAYTON MANAGEMENT) PTY LTD	
Titles / Mining Leases:	CL229, ML395, ML1531	
MOP Commencement Date:	OCTOBER 2013	
MOP Completion Date:	OCTOBER 2015	
AEMR Commencement Date:	JANUARY 2013	
AEMR Completion Date:	DECEMBER 2013	
Name of Leaseholder:	ANGLO COAL (DRAYTON MANAGEMENT) PTY LTD	
Name of mine operator (if different):		
Reporting Officer:	JAMES BENSON	
Title:	ENVIRONMENT COORDINATOR	
Signature:		
Date:	28 / 3 / 2014

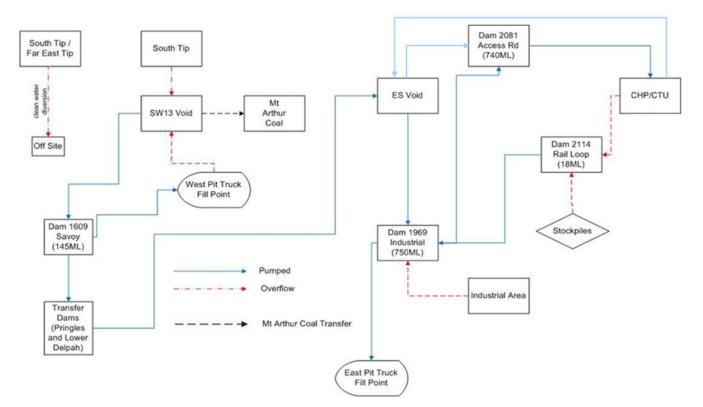
Figure 1: Water Management Flow Diagram

As predicted in the EA Drayton's mine water management system has been expanded for the project, and while the volume of water managed through the system has increased, the water balance has remained substantially unchanged. Unlike many other mines in the Upper Hunter, the Drayton water management system is a closed system which sources all of its process water internally from within the existing mining operational area, rather than direct extraction from the Hunter River. Potable water however, is supplied by pipeline from the MSC. The Drayton water management system consists of a series of on-site dams and in-pit water storage areas (see Figure 1).

The total storage capacity of the water management system was 7,135ML at the end of the 2013 reporting period. This consisted of 1,635ML capacity in major mine water storage dams and 5,500ML in the voids. Water volumes in major storages are given in Table 8 below.

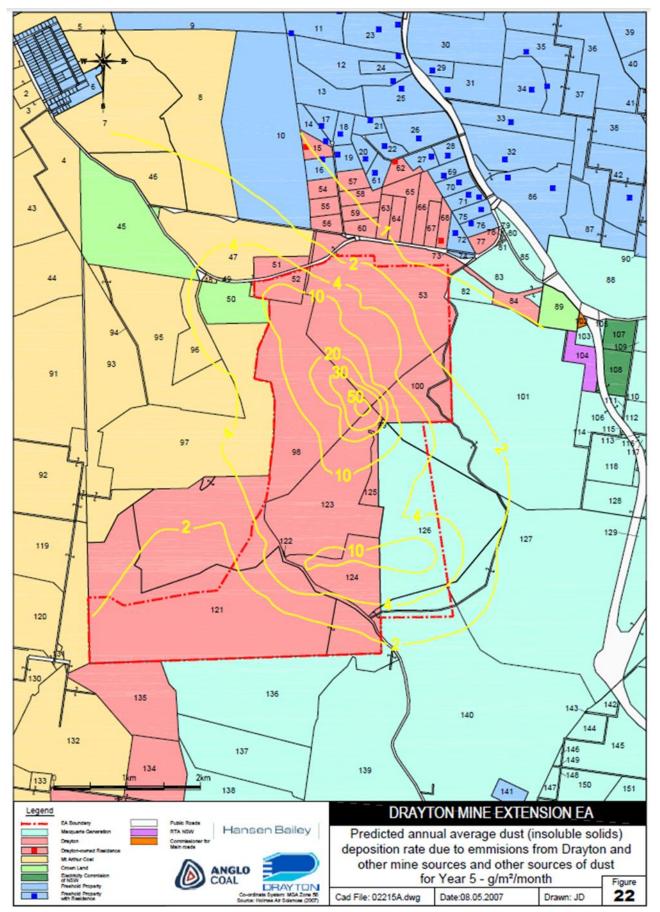
Figure 3: Predicted Annual Average Deposited Dust - Year 5

The 2007 EA predicted the average dust (insoluble solids) deposition due to Drayton and other sources at specific residences would be within acceptable limits. The actual monitoring results compared to those predicted in the EA can be found in Table 16.

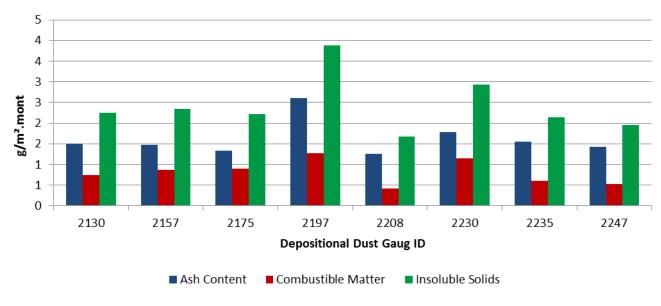
Figure 4: Average Depositional Dust Gauge Results 2013

Figure 4 summarises the year's results of total solids, insoluble solids, ash and combustible matter in the eight compliance gauges. Out of the eight gauges, gauge 2197, to the west of the Antiene area, had the highest average result levels consistent with the previous reporting period. Due to the nature of Dust Deposition Gauges, contamination of samples by bird droppings, insects and vegetation is a common occurrence. Details relating to each individual gauge on a monthly basis are outlined in **Appendix C**.

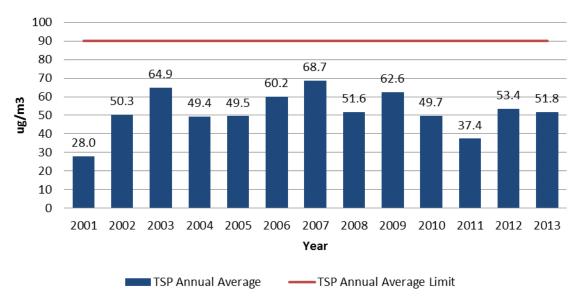
Figure 5: Long Term Annual Average TSP from Lot 22 HVAS

The 2013 annual mean TSP for the Antiene station was well below the annual mean limit of  $90\mu g/m^3$  (see Figure 5). The 2013 annual mean displayed a decrease of  $1.6\mu g/m^3$  in comparison to 2012 figure. The annual mean results are summarised in Table 17 below and the complete results for the 2013 reporting period are in **Appendix C**.

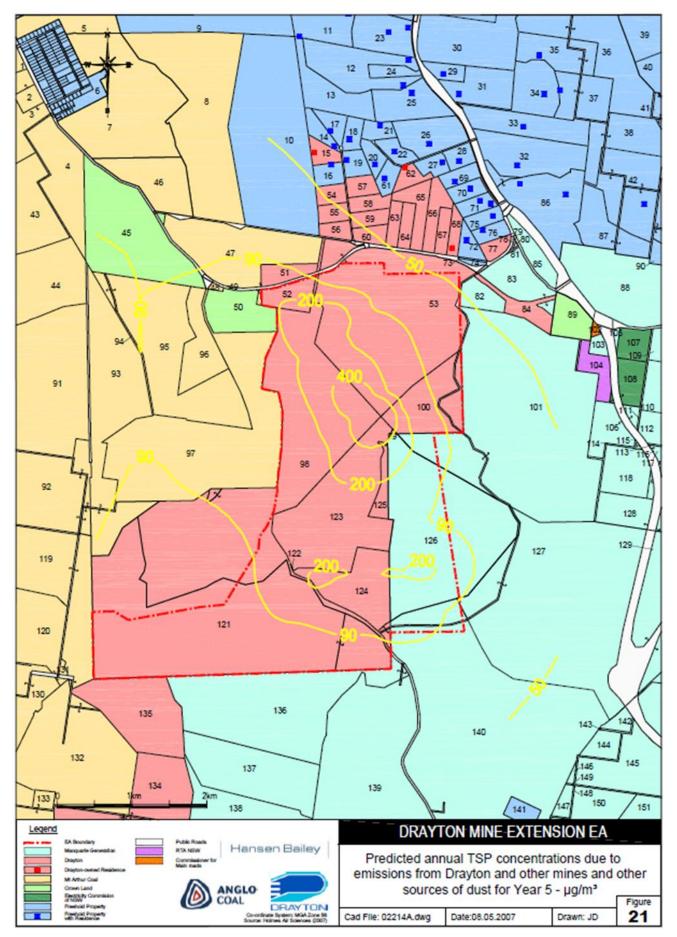
Figure 6: Predicted Annual TSP Concentrations - Year 5

The 2007 EA prediction of the annual TSP concentrations due to emissions from Drayton and other sources for year 5 is presented in Figure 6. The EA predicted that annual average TSP concentrations due to Drayton and other sources for residence 14 in year 5 would be 72.4 $\mu$ g/m<sup>3</sup>. The 2013 annual concentration of 51.8 $\mu$ g/m<sup>3</sup> and the long-term average of 55.9 $\mu$ g/m<sup>3</sup> (see Table 17 above) are below the EA prediction.

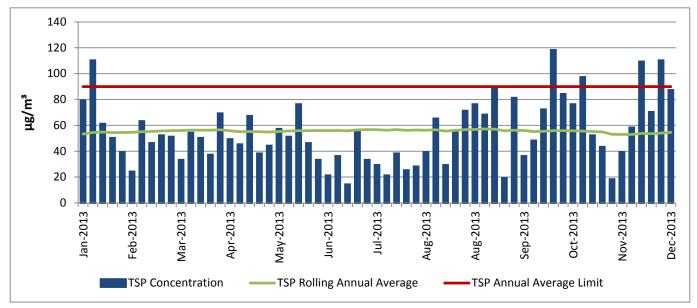
Figure 7: TSP from Lot 22 HVAS 2013

Figure 7 indicates that TSP levels were higher during the second half of 2013, consistent with the previous reporting period. Increases in TSP levels throughout 2013 coincide with decreased rainfall. TSP decreased in November consistent with an intense rainfall event which occurred during the month.

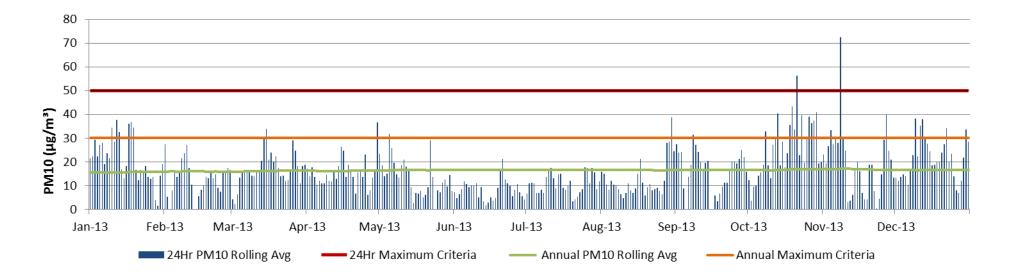
Figure 8: PM10 Data 2013

The real time dust monitoring results show that the annual average criterion of  $30\mu g/m^3$  was not exceeded in 2013 (see Figure 8). The 24-hour average PM<sub>10</sub> was also well below the  $50\mu g/m^3$  criteria throughout the majority of the year. Two high results were recorded on the 21<sup>st</sup> of October and the 8<sup>th</sup> of November 2013 (see Figure 8). Further investigations into these results using wind directional data found that the predominant wind direction on both days was from the west to north-west. As the TEOM was receiving winds not predominantly from the direction of the mine on these days the high results are not attributable to Drayton's operations. Additionally, bushfires occurring in the Hunter region throughout October and November 2013 may have contributed to the PM<sub>10</sub> levels on these days.

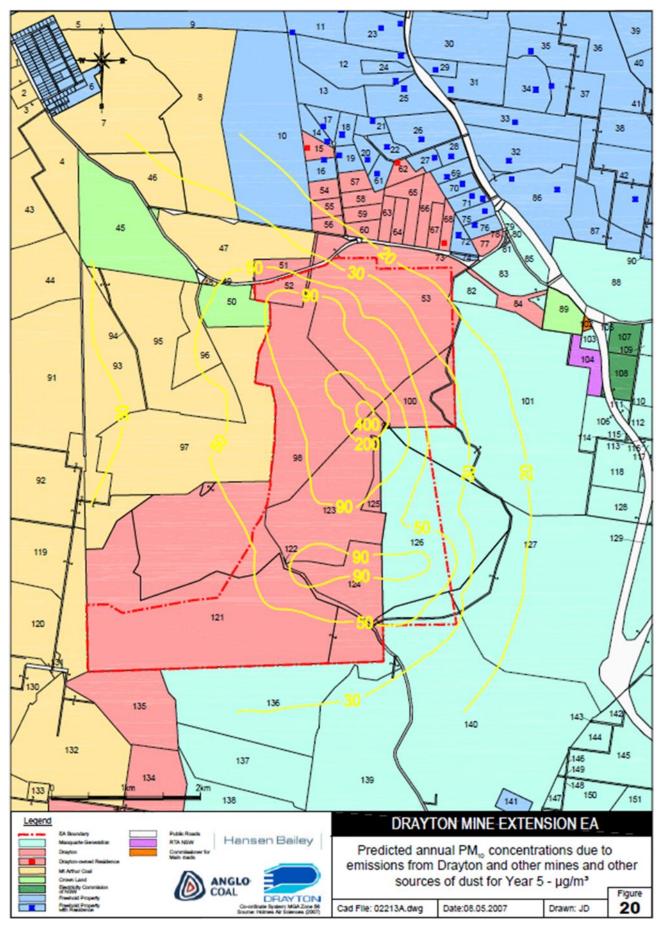
Figure 10: Predicted Annual PM10 Concentrations - Year 5

The 2007 EA prediction of the annual  $PM_{10}$  concentrations due to emissions from Drayton and other sources for year 5 is presented in Figure 10. The EA predicted that the annual average  $PM_{10}$  concentrations from all sources for residence 72 would be  $24.9\mu g/m^3$ . The 2013 annual average concentration of  $PM_{10}$  at the Lot 9 TEOM was  $16\mu g/m^3$  and is below the EA's predicted level.

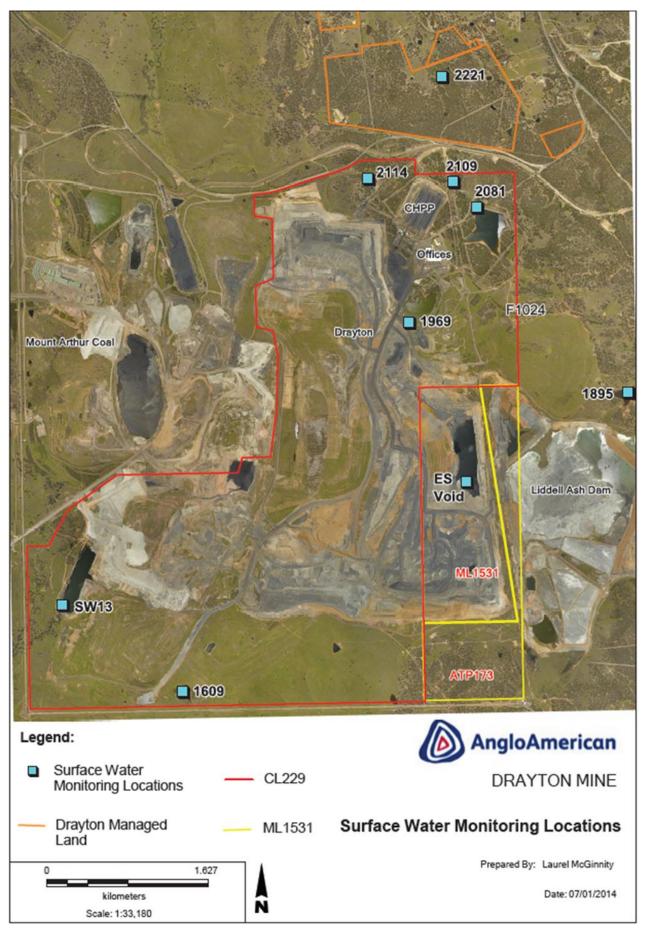
These monitoring locations are illustrated in Figure 11. Most of these dams are mine water dams with the exceptions being dam 2221.

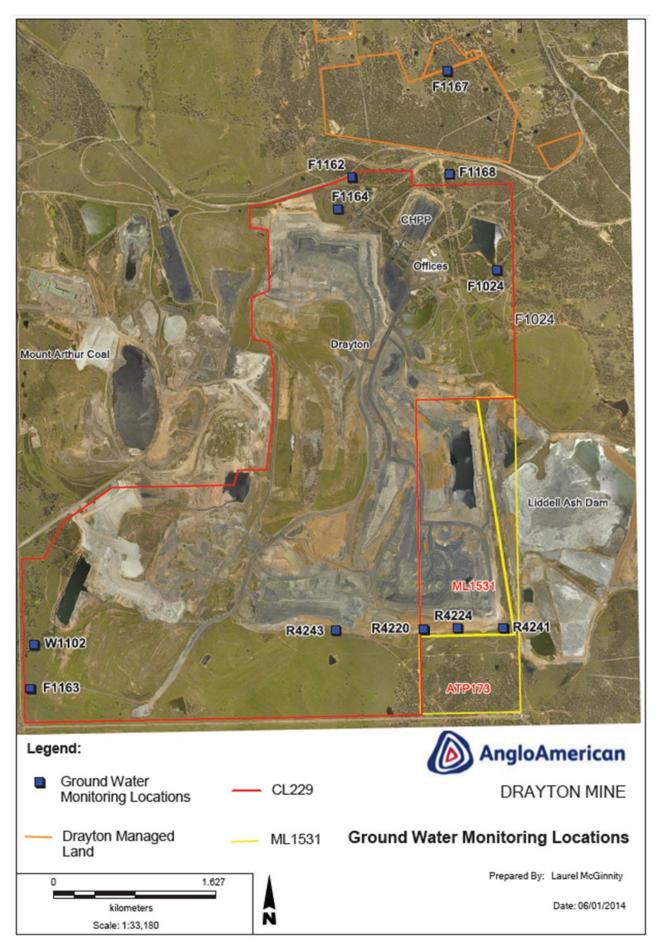
At the end of 2013, 6 piezometers were being monitored on a monthly basis. A water level indicating instrument was used to determine the standing water level in the piezometers. Some piezometers could not be sampled on each monitoring occasion due to insufficient water. The locations of the piezometers monitored are illustrated in Figure 12.

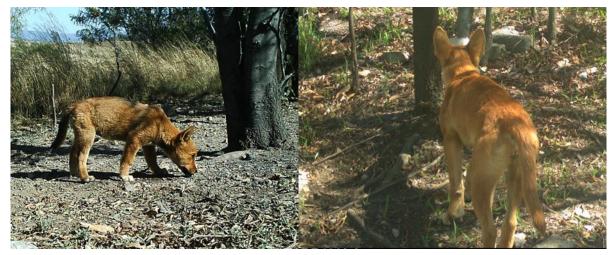
Figure 13: Photo taken during August baiting; Figure 14: Photo taken during December monitoring

Figure 13 and 14 show photos taken using motion detector cameras during monitoring in August and December 2013 in the Southern Offset Area.

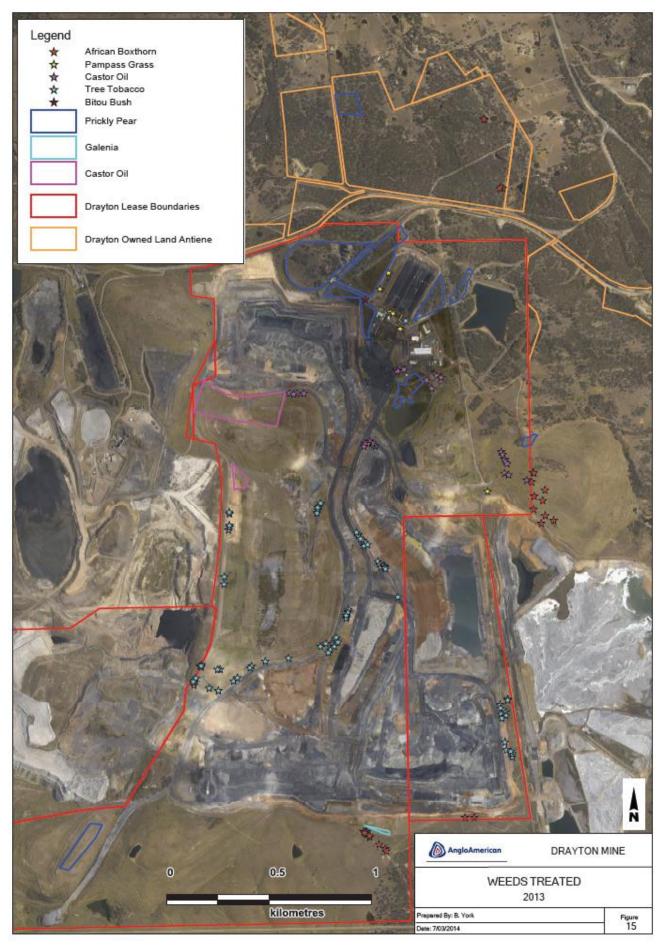
Figure 15: Weed infestations targeted during 2013

In December 2013, Drayton received a Property Inspection Report from the Upper Hunter Weeds Authority regarding an infestation of St John's Wort on land north of Thomas Mitchell Drive. The infestation was mapped by Drayton staff in December 2013 and is scheduled for treatment in January 2014. The infestation will be monitored with follow-up inspections during summer flowering and further treatment where necessary.

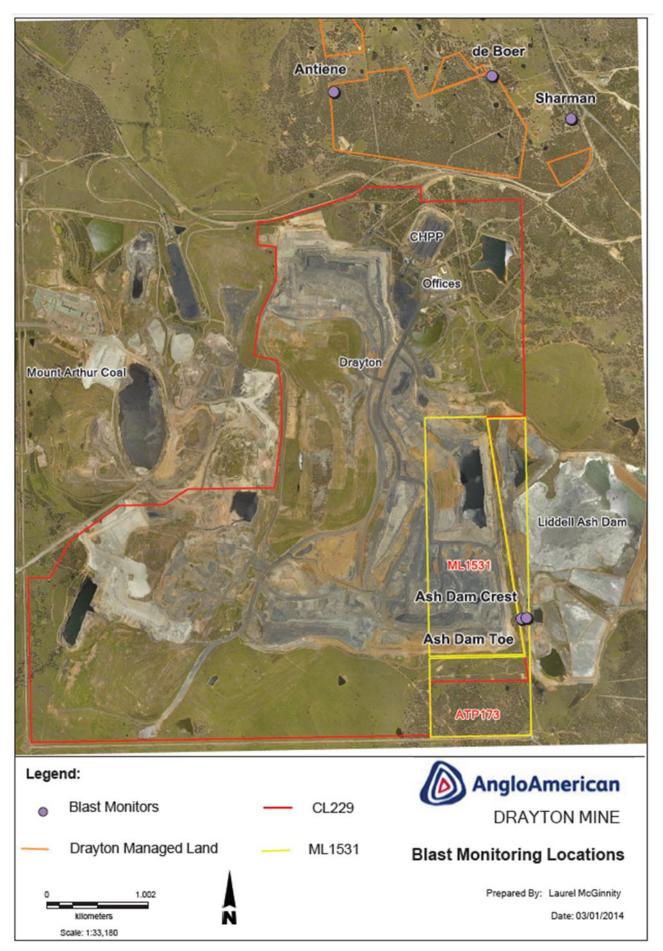
Figure 16: Blast monitoring sites

Drayton utilises an internet based blast monitoring system which gives access to immediate blasting information for all blasts. The blast monitoring units also allow additional monitoring to be undertaken in specific locations as required. The units operate between approved blasting hours and automatically trigger once a vibration or overpressure event is recorded. During the 2013 reporting period, all blast monitors were calibrated. There are three community based blast monitors at locations in the Antiene area and two monitors at the Ash Dam, one on the toe, and one on the crest of the wall. The locations of the five blast monitoring units are shown in Figure 16.

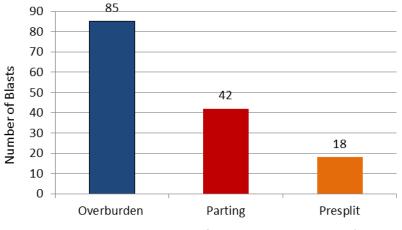
Figure 17: Number of blasts by type

Figure 17 shows that the majority of the blasts occurring in 2013 were overburden shots. Just under half of the remaining shots were either parting or prestrip shots.

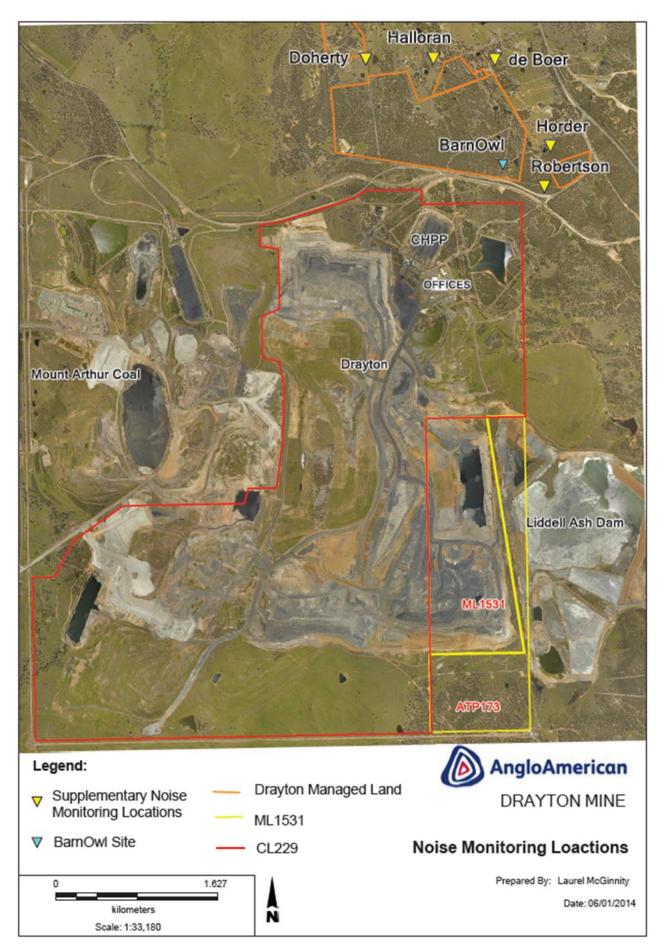
Figure 18: Supplementary and real-time noise monitoring locations

In December 2013, a second BarnOwl® was installed at the end of Balmoral Road in the Antiene area. This monitor is operated in conjunction with Mt Arthur Coal and monitors noise levels representative of Balmoral Road residences. This monitor will send alerts to Drayton personnel in the event of elevated noise levels.

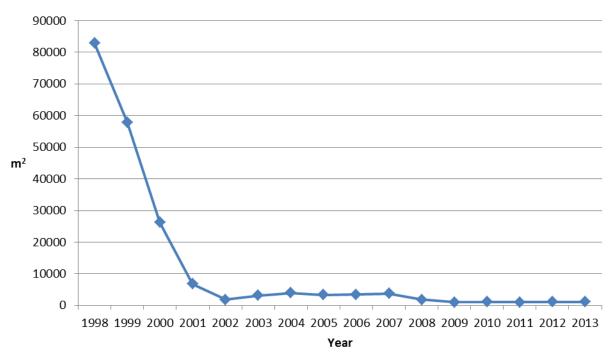
Figure 19: Area affected by spontaneous combustion by year

Table 31 and Figure 19 outline the areas that have been affected by spontaneous combustion since 1998. This demonstrates that spontaneous combustion reduced substantially from the late 1990's. At the end of the reporting period, it was assessed that approximately 1090m<sup>2</sup> of surface area were visibly affected by spontaneous combustion. The areas that continued to burn at the end of the reporting period are being managed through a process of active dumping and/or clay capping.

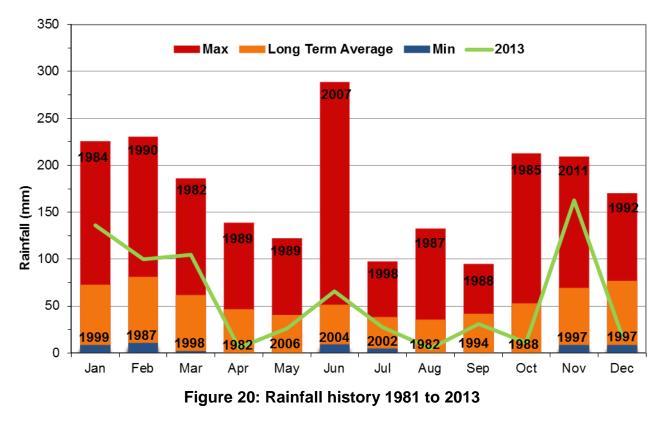
Total annual rainfall for 2013 was 692 millimetres, an increase from the previous year and just above the long term average. The majority of the rainfall occurred in the first quarter of 2013 with November also experiencing an intense rainfall event (see Figure 20).

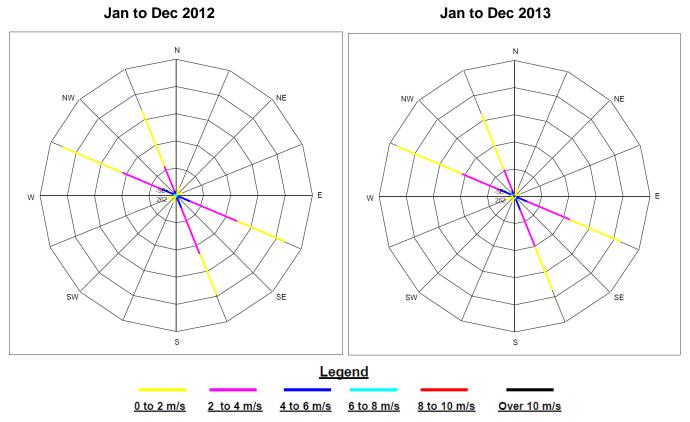
Figure 21 Annual Windroses 2012 and 2013

In 2013 the maximum wind speed recorded at Drayton was 18.6m/sec on the 13<sup>th</sup> of October. Average wind speeds were highest throughout January and February. For the majority of the year, wind speeds generally remained between 0 and 4m/s (see Table 36).

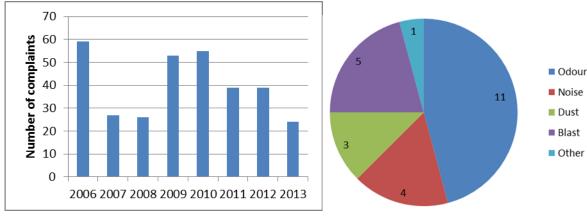
Figure 22: Community Complaints Associated with Drayton (2006 – 2013)

Over the past three years, a low number of complaints has been maintained (Figure 22). A total of 24 complaints were received during the 2013 reporting period. Of these, the majority were odour related complaints (Figure 23). Apart from the 24 complaints logged for the period, there were also six enquiries received regarding blast/vibration that were not related to Drayton operations.

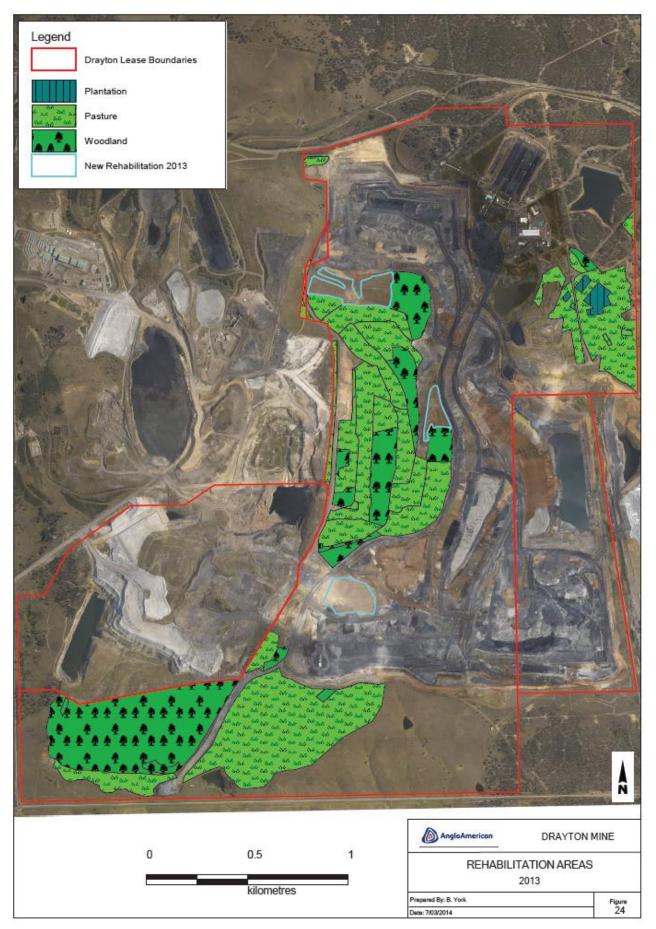
The current extent of rehabilitated areas at Drayton including those completed during the 2013 reporting period are shown below in Figure 24.

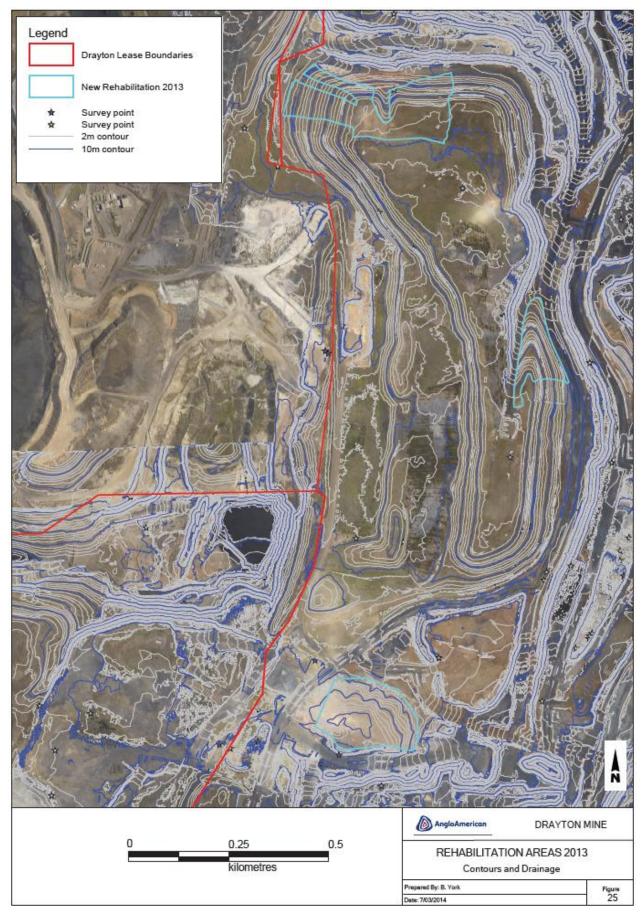
## Contours and drainage of rehabilitated areas are shown below in Figure 25.

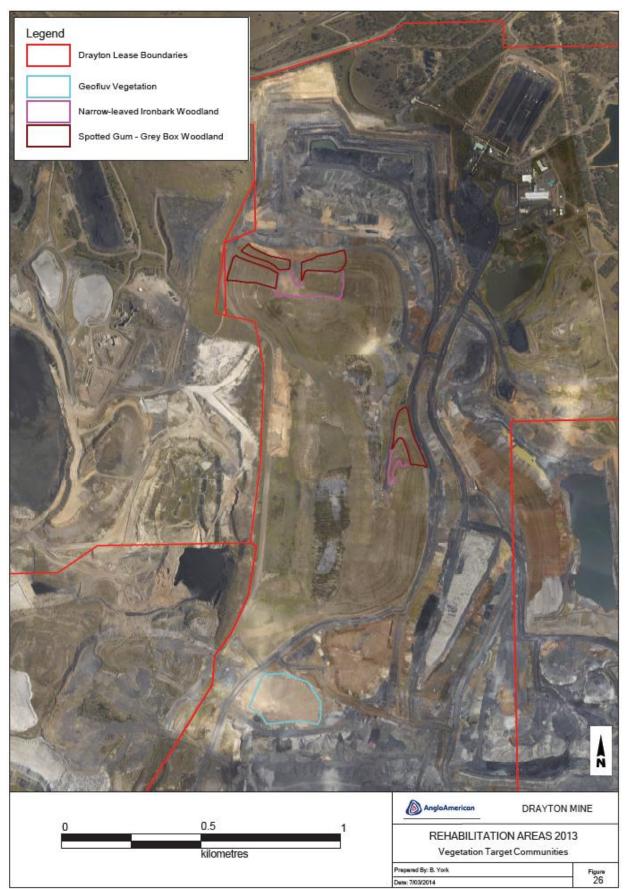
Figure 26: Rehabilitation Area Target Vegetation Communities

Figure 26 below outlines target vegetation communities on the 2013 rehabilitation areas.
